Appendix 29 – Review of hazards at coastal baches

Memorandum

Subject: Review of hazard at coastal baches

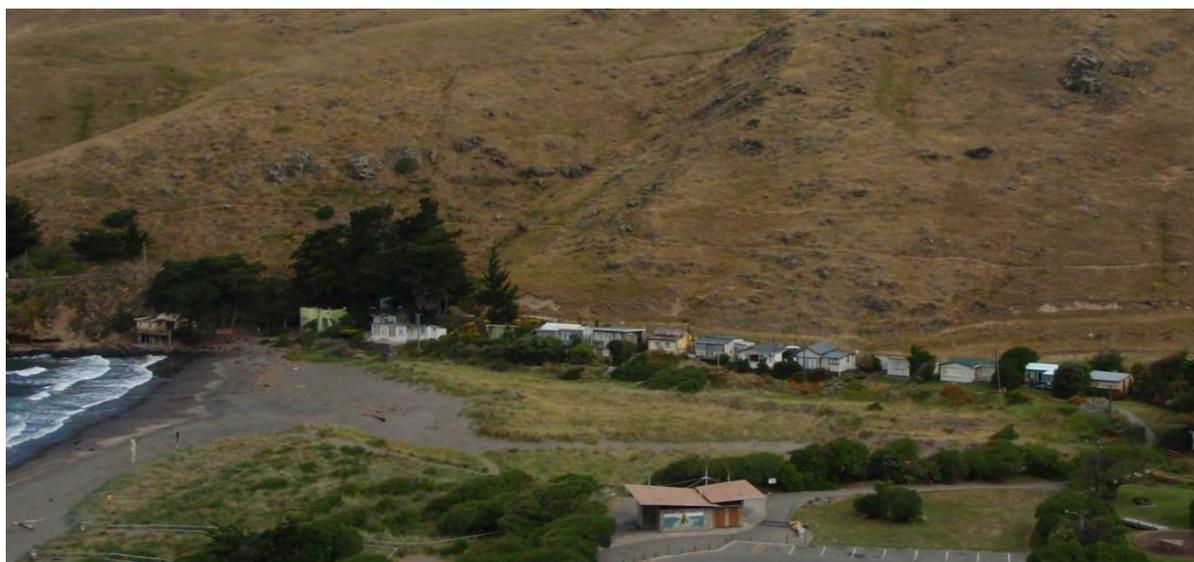
Bach No.	Assessment	Conclusion and/or Recommendation
28	On top of small cliff. Judged not at risk from cliff collapse. No boulder roll hazard evident. Could be affected by future cliff erosion	Site is judged to be relatively 'safe'
30	Hazard is from collapse of low cliff adjacent the bach that could impact dwelling. Low rockfall (boulder roll) hazard.	Hazard at site is adjacent to rather than directly above bach
31-32	Direct hazard from rockfall, viable source of rocks in outcrops above these baches at the base of a gully that will focus boulders rolling down the slope.	Clear hazard area
33-43	Minor areas of rock outcrop indicate limited hazard from rockfall. A number of boulders have reached the flat area behind these baches during (and before) the earthquakes.	Sites are relatively safe

Overview, Taylor's Mistake baches. No.30 at left of photo; No.45 at right. No's 31-33 are in the trees at the end of the beach.

Taylor's Mistake - Bach 28 should be removed Cliff Hazard Management Area 2

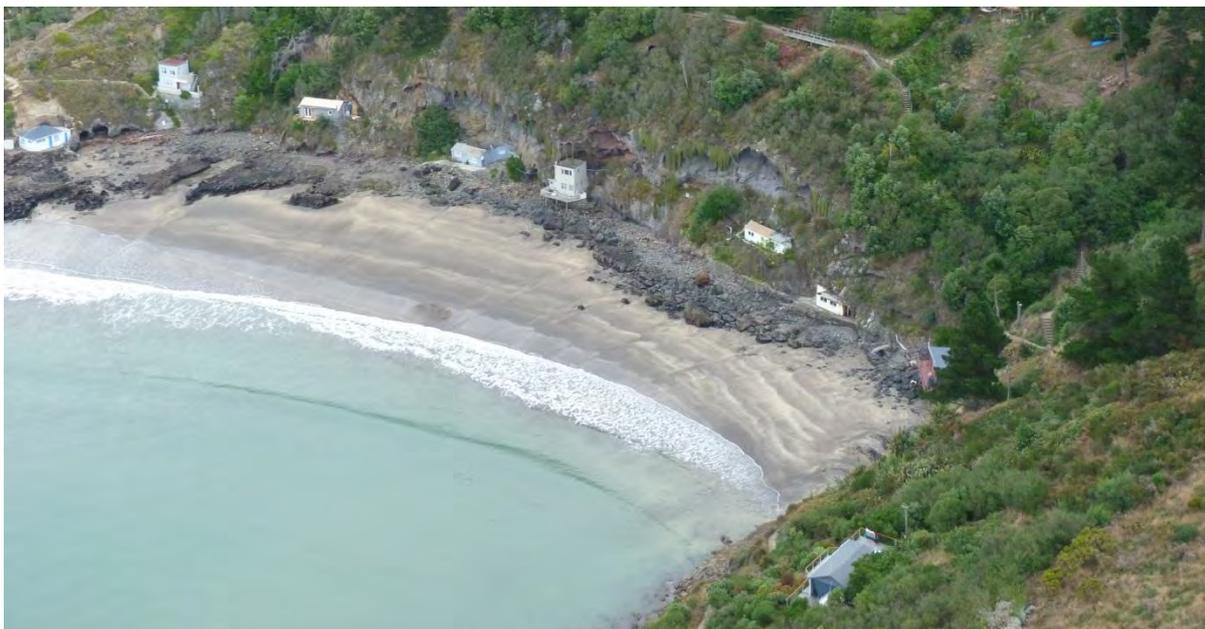
Bach No.	Assessment	Conclusion and/or Recommendation
55-58	Judged not at risk from cliff collapse. No boulder roll hazard evident.	Outside hazardous area
59	Hazard is from collapse of low loess cliff adjacent the bach that previously impacted dwelling. Has been excavated and is currently stable. No rockfall (boulder roll) hazard.	No significant current hazard
60	No hazard from cliff collapse inundation. Failure has affected slope below bach but does not undermine the structure.	Further undermining could affect stability of structure but could be remediated
62	Limited stabilisation work has been completed (shotcrete and ineffective catch fence). Building is located under a cliff which shows evidence for instability.	Site is within hazardous area. Direct cliff collapse hazard.
63, 64, 67, 68	Baches immediately under overhanging cliff which shows signs of instability, full extent of which is hidden by vegetation. Direct hazard from cliff collapse (overhanging) at all 4 sites. No.63 has been hit and badly damaged by debris that has fallen from cliff since mid 2012.	All sites within hazardous area (cliff overhangs dwelling)

Overview, Hobson Bay baches, Feb 2011. Pale blue bach at centre left is No.63

Hobson Bay - Baches 55 to 59 and bach 60 should be removed from Cliff Hazard Management Area 2

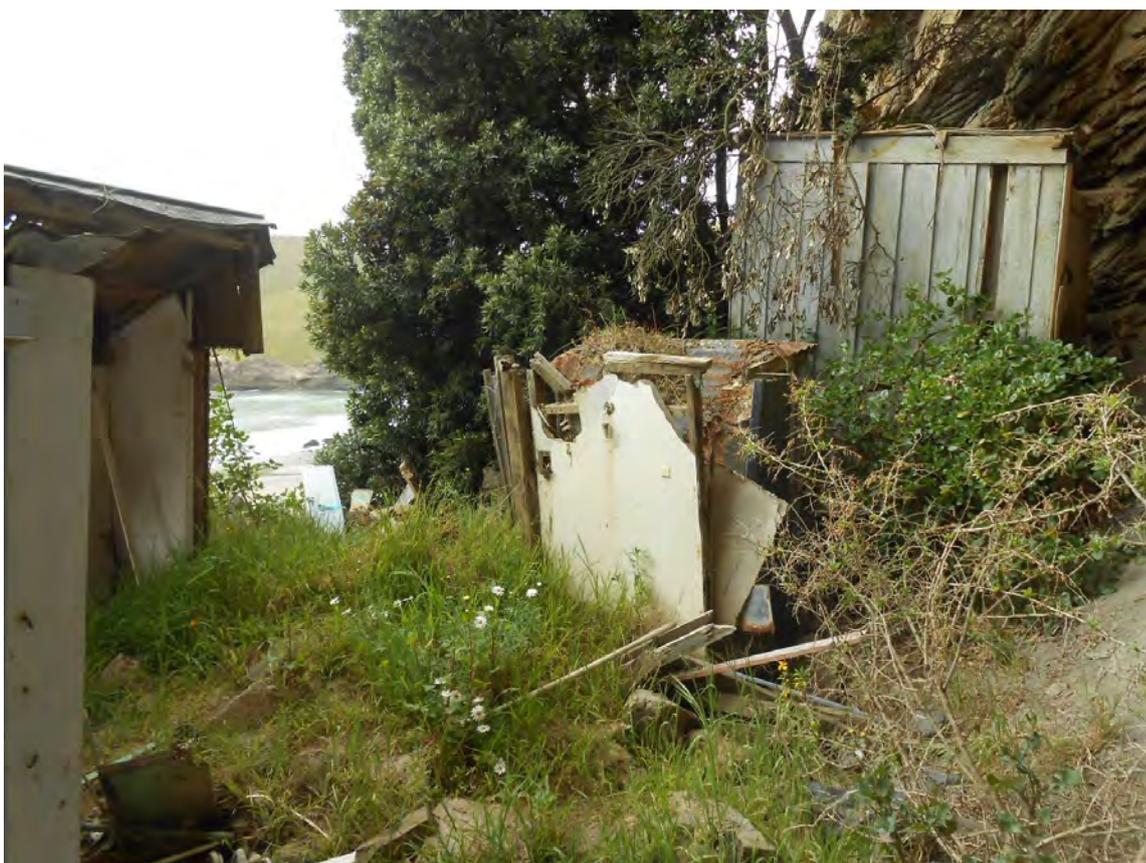
Destruction caused by rockfall debris hitting rear of bach at No.63 Hobsons Bay

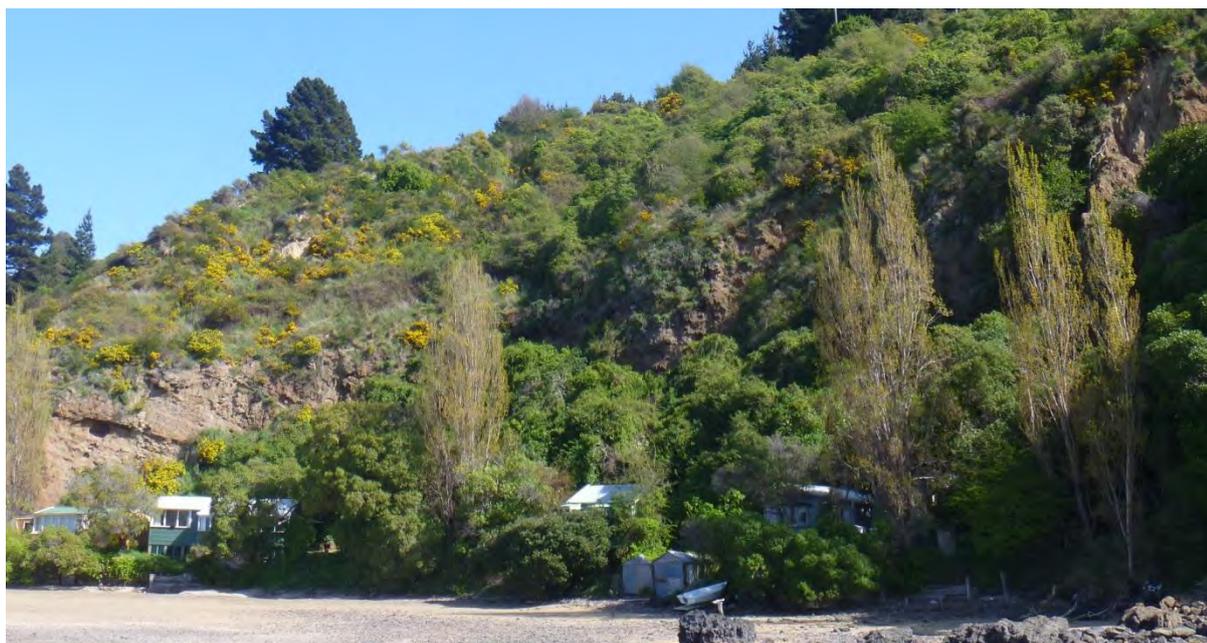
These four baches are located under a cliff face. Where exposed, the rock is weathered and of variable quality. The cliff shed some rocks in the earthquakes and is clearly capable of shedding rocks and debris at other times. One bach appears to have been struck by mud/earth flow debris quite recently.

Bach No.	Assessment	Conclusion and/or Recommendation
A	Exposed to hazard of rockfall from cliff behind the bach; loose rocks/open fractures evident. Some protection from vegetation. Small debris flow/slump immediately to N of dwelling	Clearly hazardous site.
B	Exposed to hazard of rockfall from cliff behind the bach; loose rocks/open fractures evident. Some protection from vegetation.	Clearly hazardous site.
C	Cliff face >15m high immediately behind bach.	Clearly hazardous site (cliff collapse or rockfall).
D	Cliff face is immediately behind bach which has been struck by recent small debris flow (approx. 0.5m deep at rear wall judging from soil marks).	Clearly hazardous site (cliff collapse or rockfall).

Baches at Maori Gardens with cliff behind (Bach A at right, D at left of photo)

Maori Gardens - No changes. Cliff Hazard Management Area 2 is appropriate for all four baches.
