## Appendix H: CEHZ result maps

CHRISTCHURCH CITY COUNCIL		
COASTAL HAZARD ASSESSMENT		
Open Coast - 2065		
Erosion Hazard Zones		
FIGURE No.	Figure H - 1(a)	Rev. 0

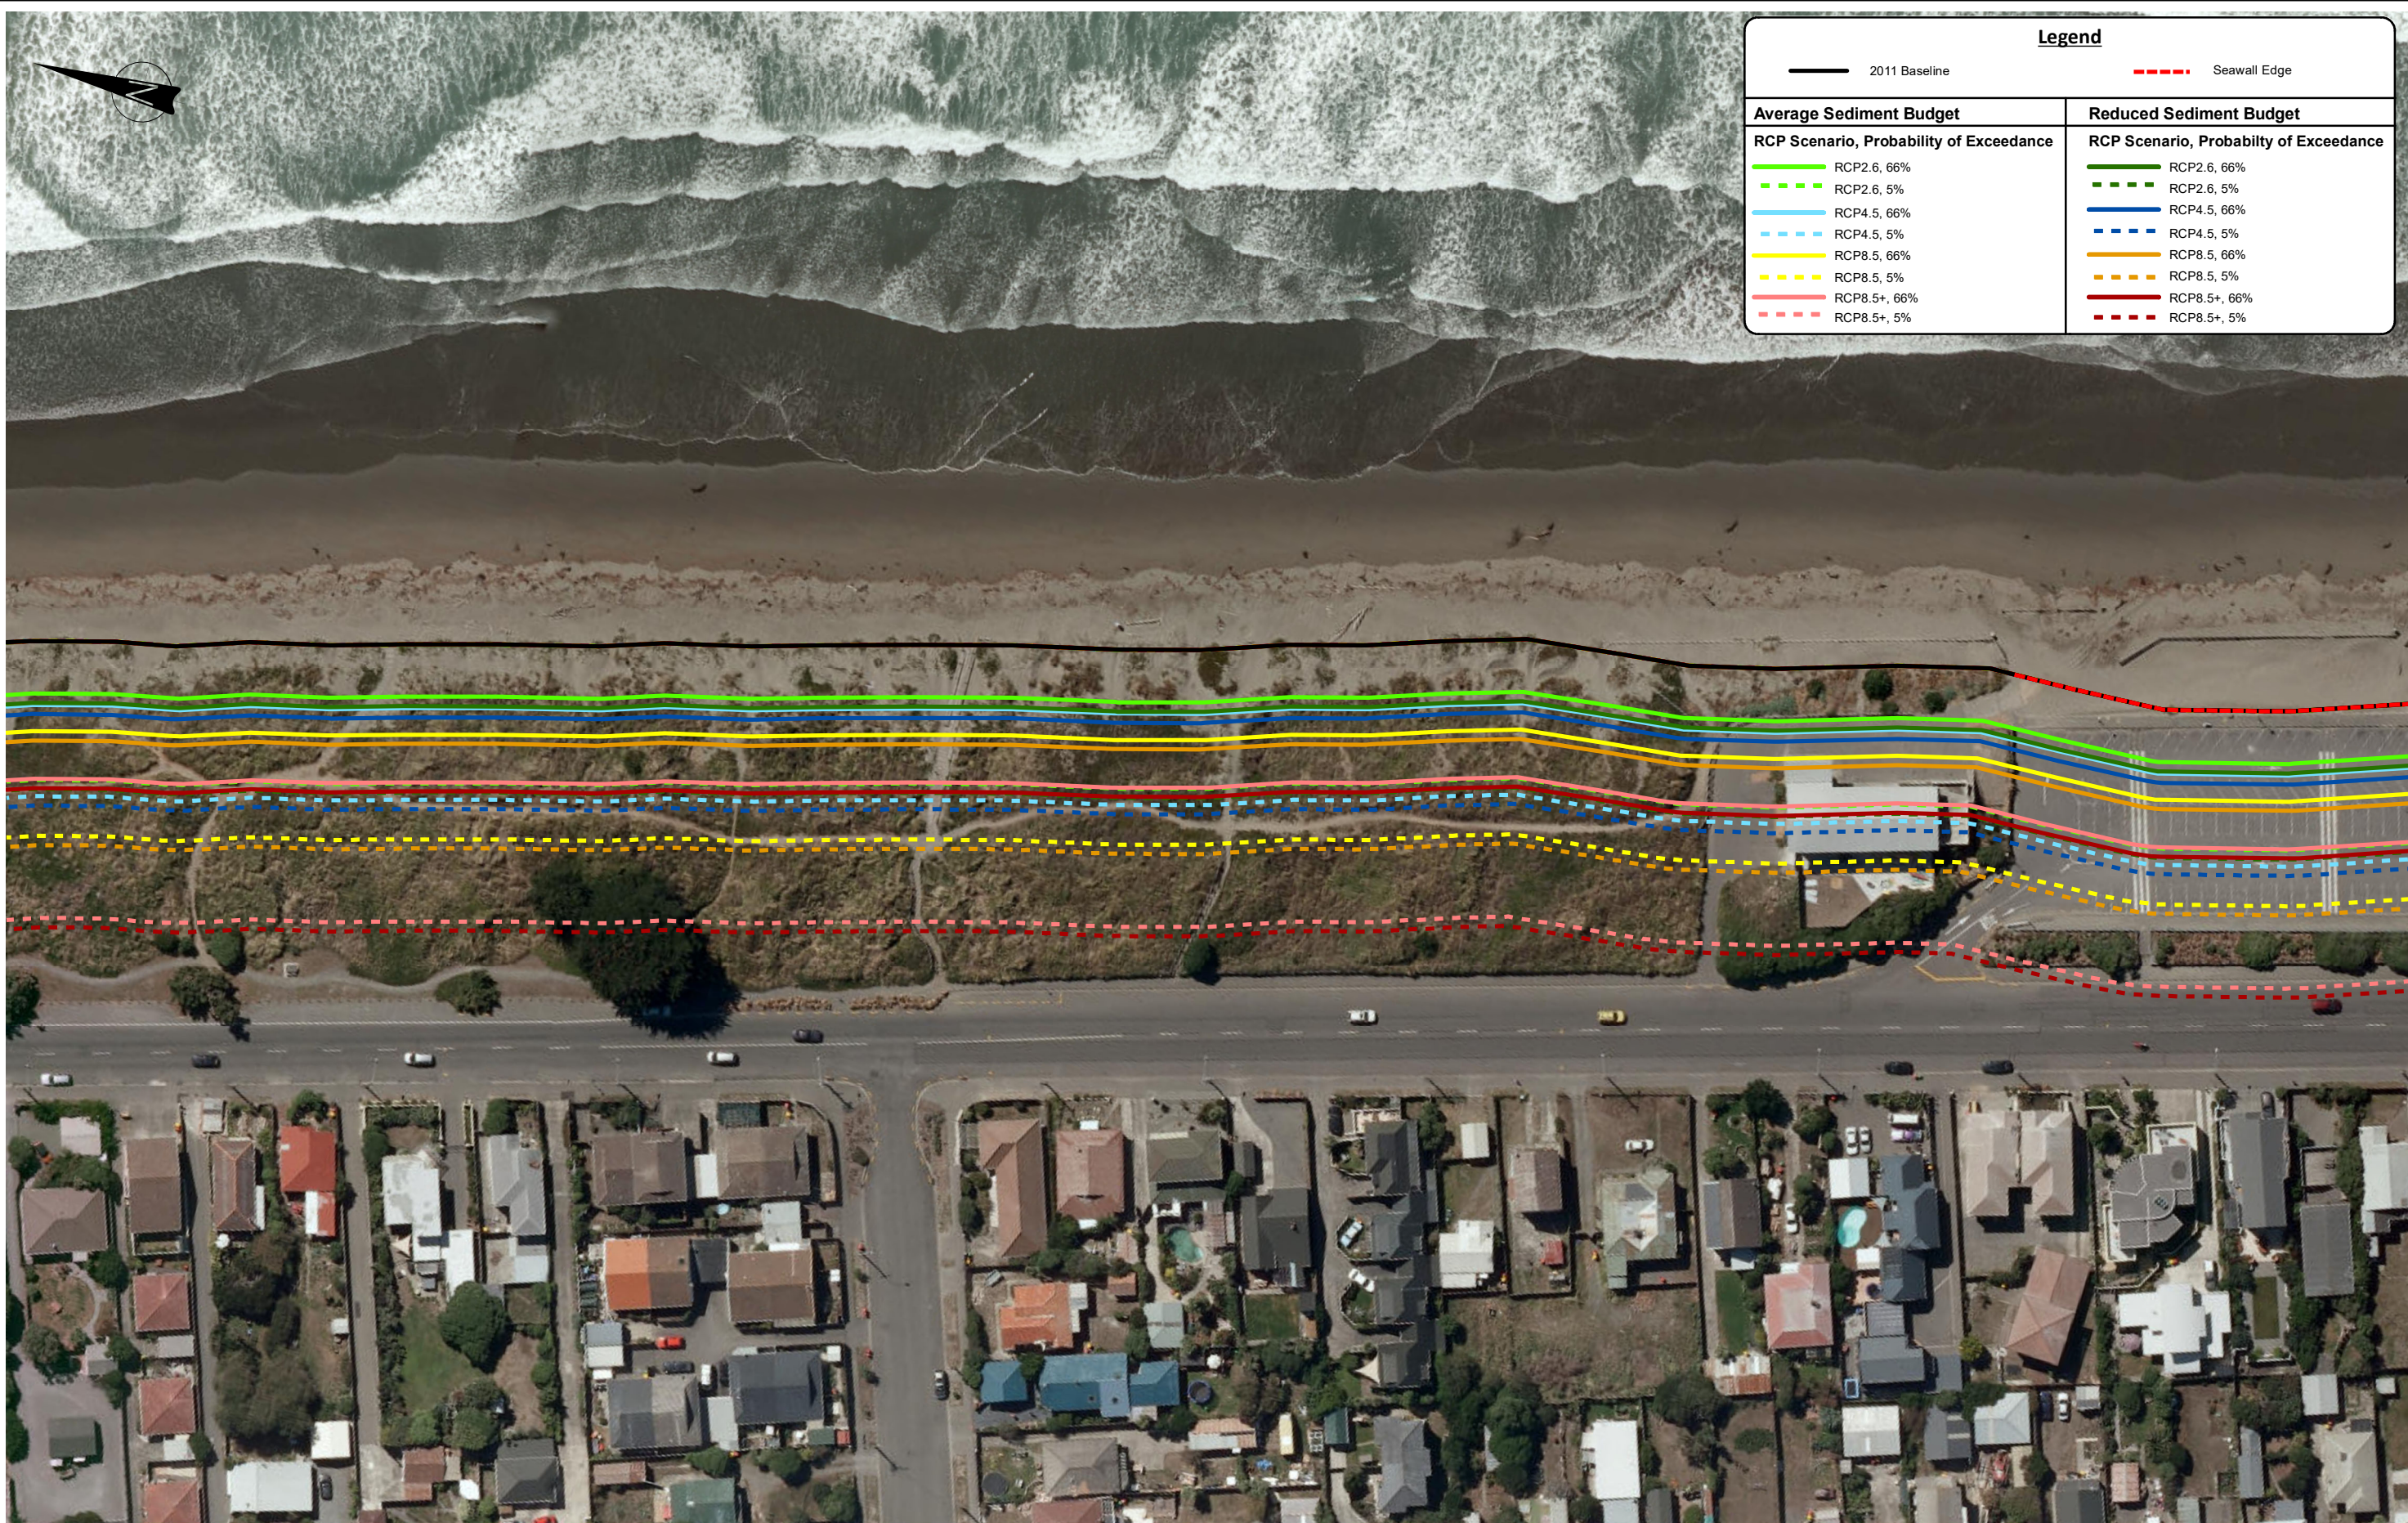
The CEHZs have been assessed by splitting up the shoreline in behaviour cells with the end/boundary of a coastal behaviour cell indicated with a shoreline-perpendicular CEHZ line. The CEHZs are only mapped for the study area (refer to report).  
Refer to note on map limitations on the front page of Appendix H.

CHRISTCHURCH CITY COUNCIL COASTAL HAZARD ASSESSMENT Open Coast - 2065 Erosion Hazard Zones	
FIGURE No. Figure H - 10(a)	Rev. 0

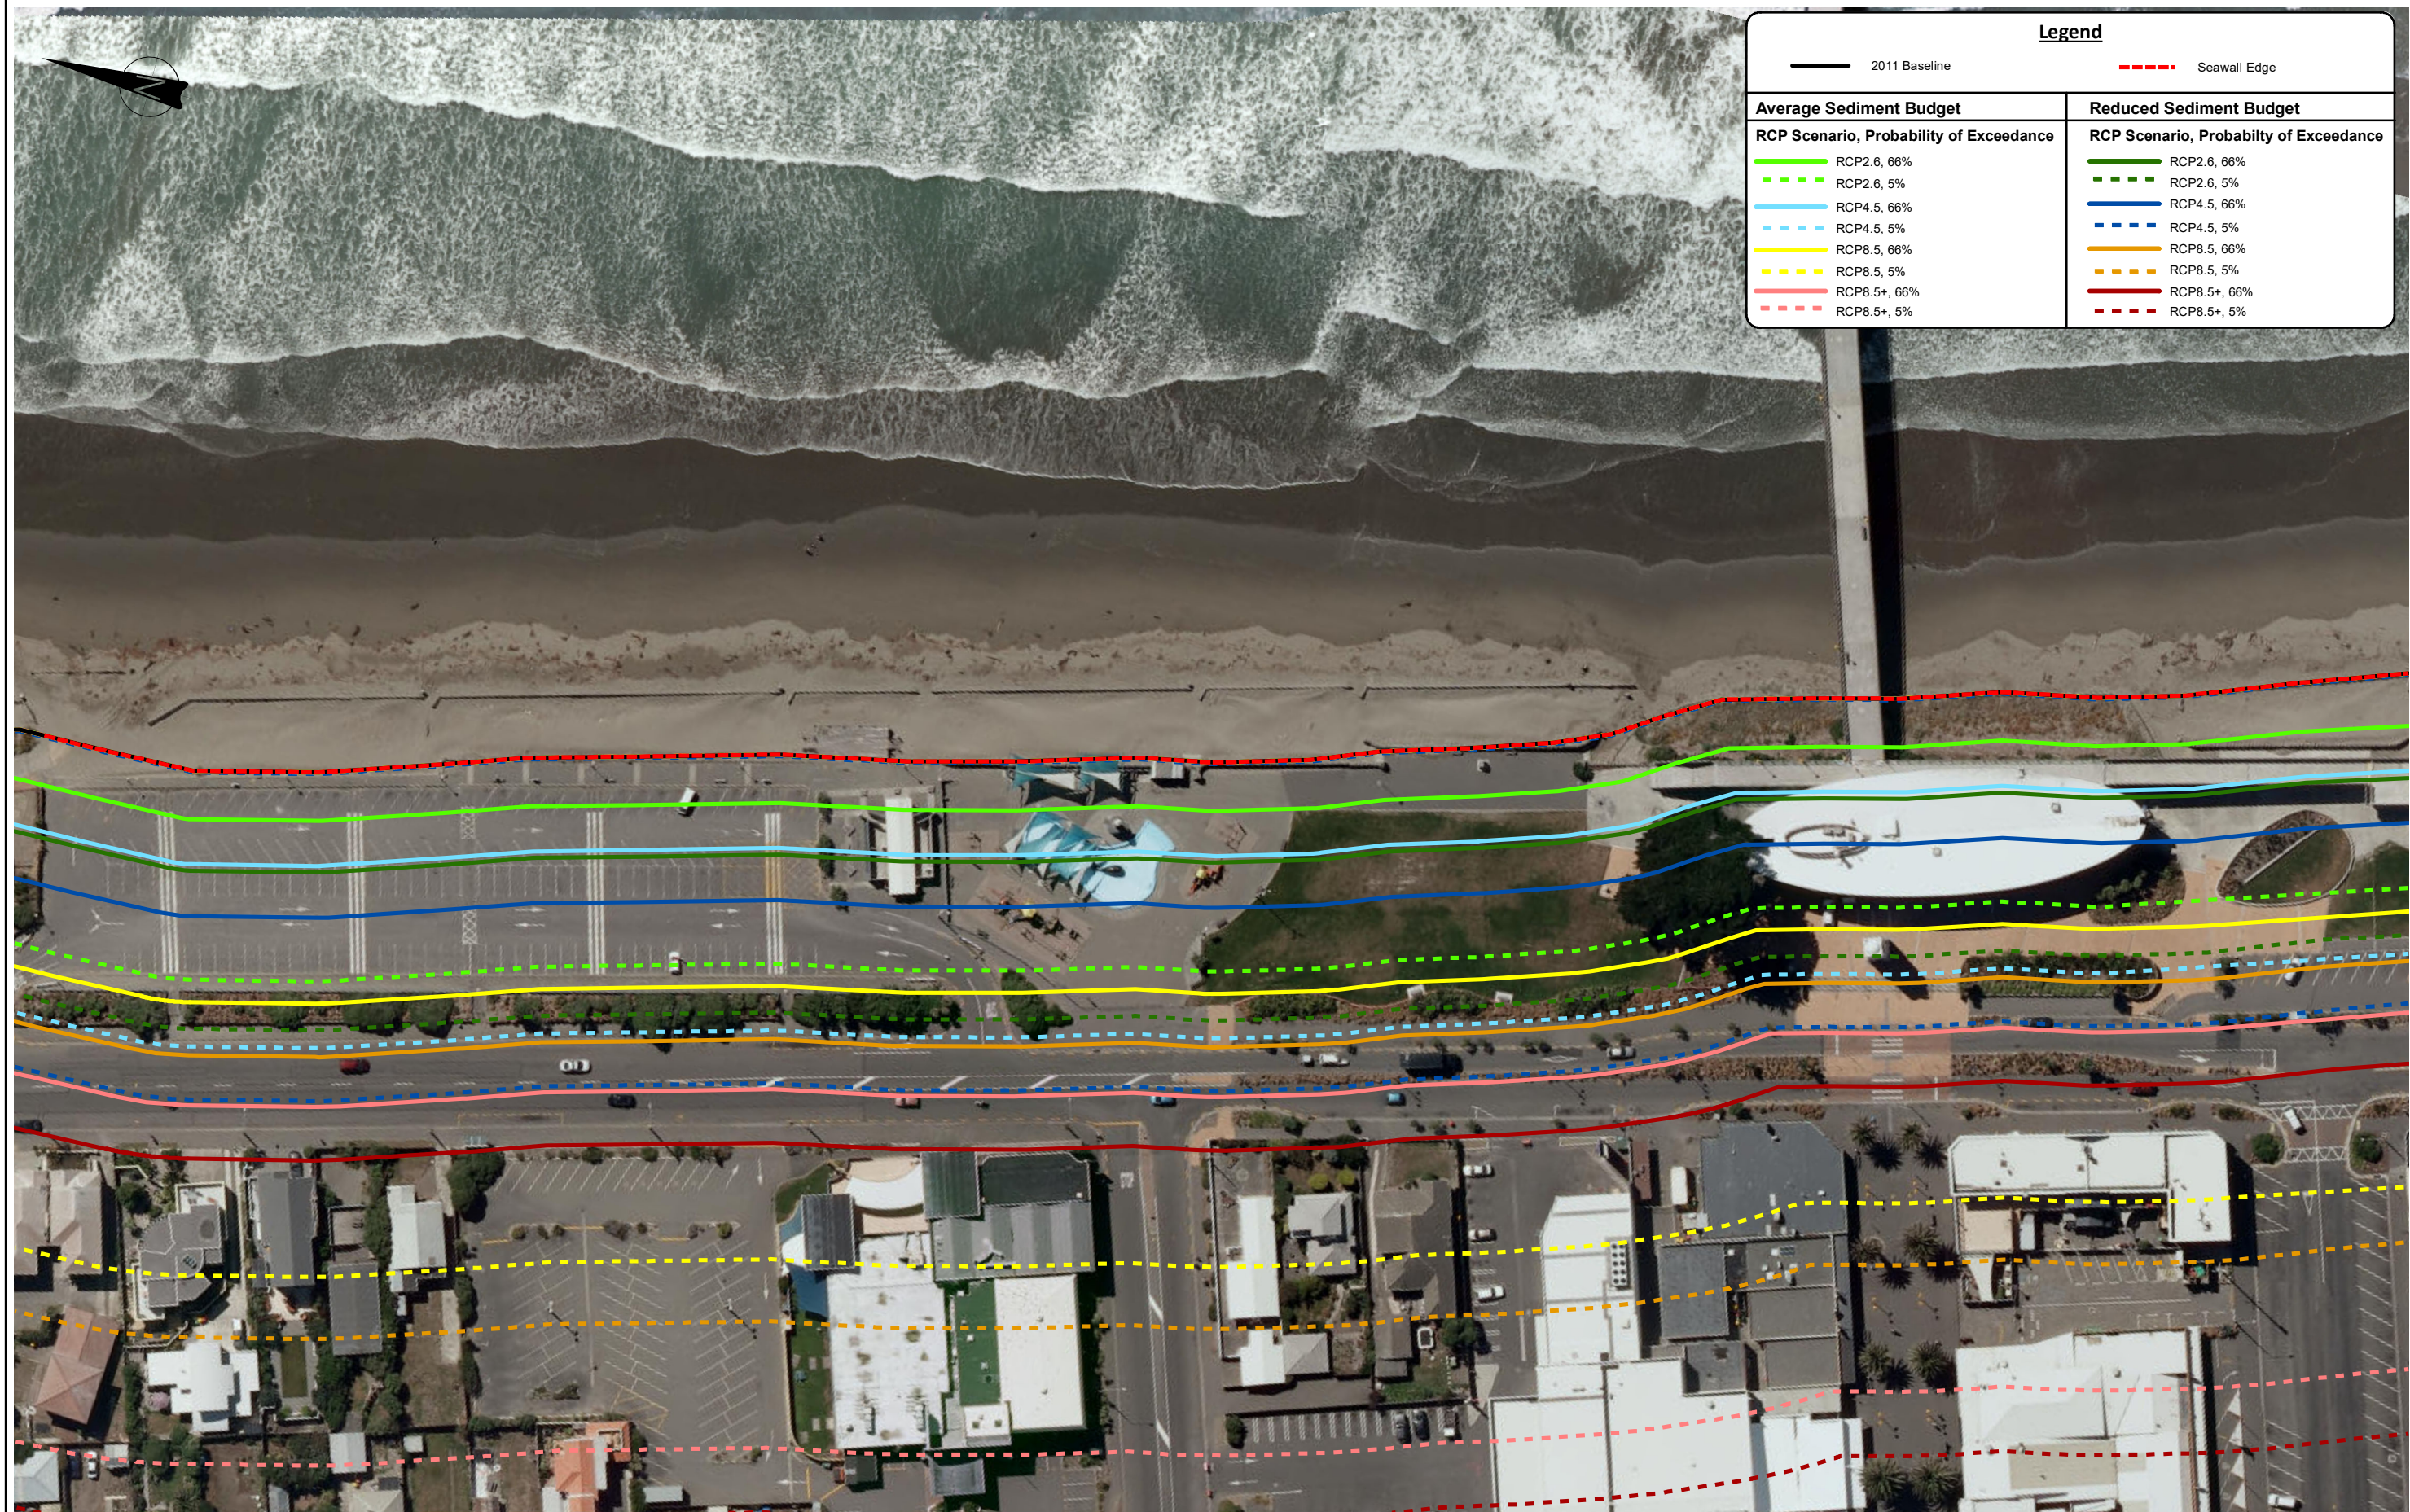
The CEHZs have been assessed by splitting up the shoreline in behaviour cells with the end/boundary of a coastal behaviour cell indicated with a shoreline-perpendicular CEHZ line. The CEHZs are only mapped for the study area (refer to report).  
Refer to note on map limitations on the front page of Appendix H.

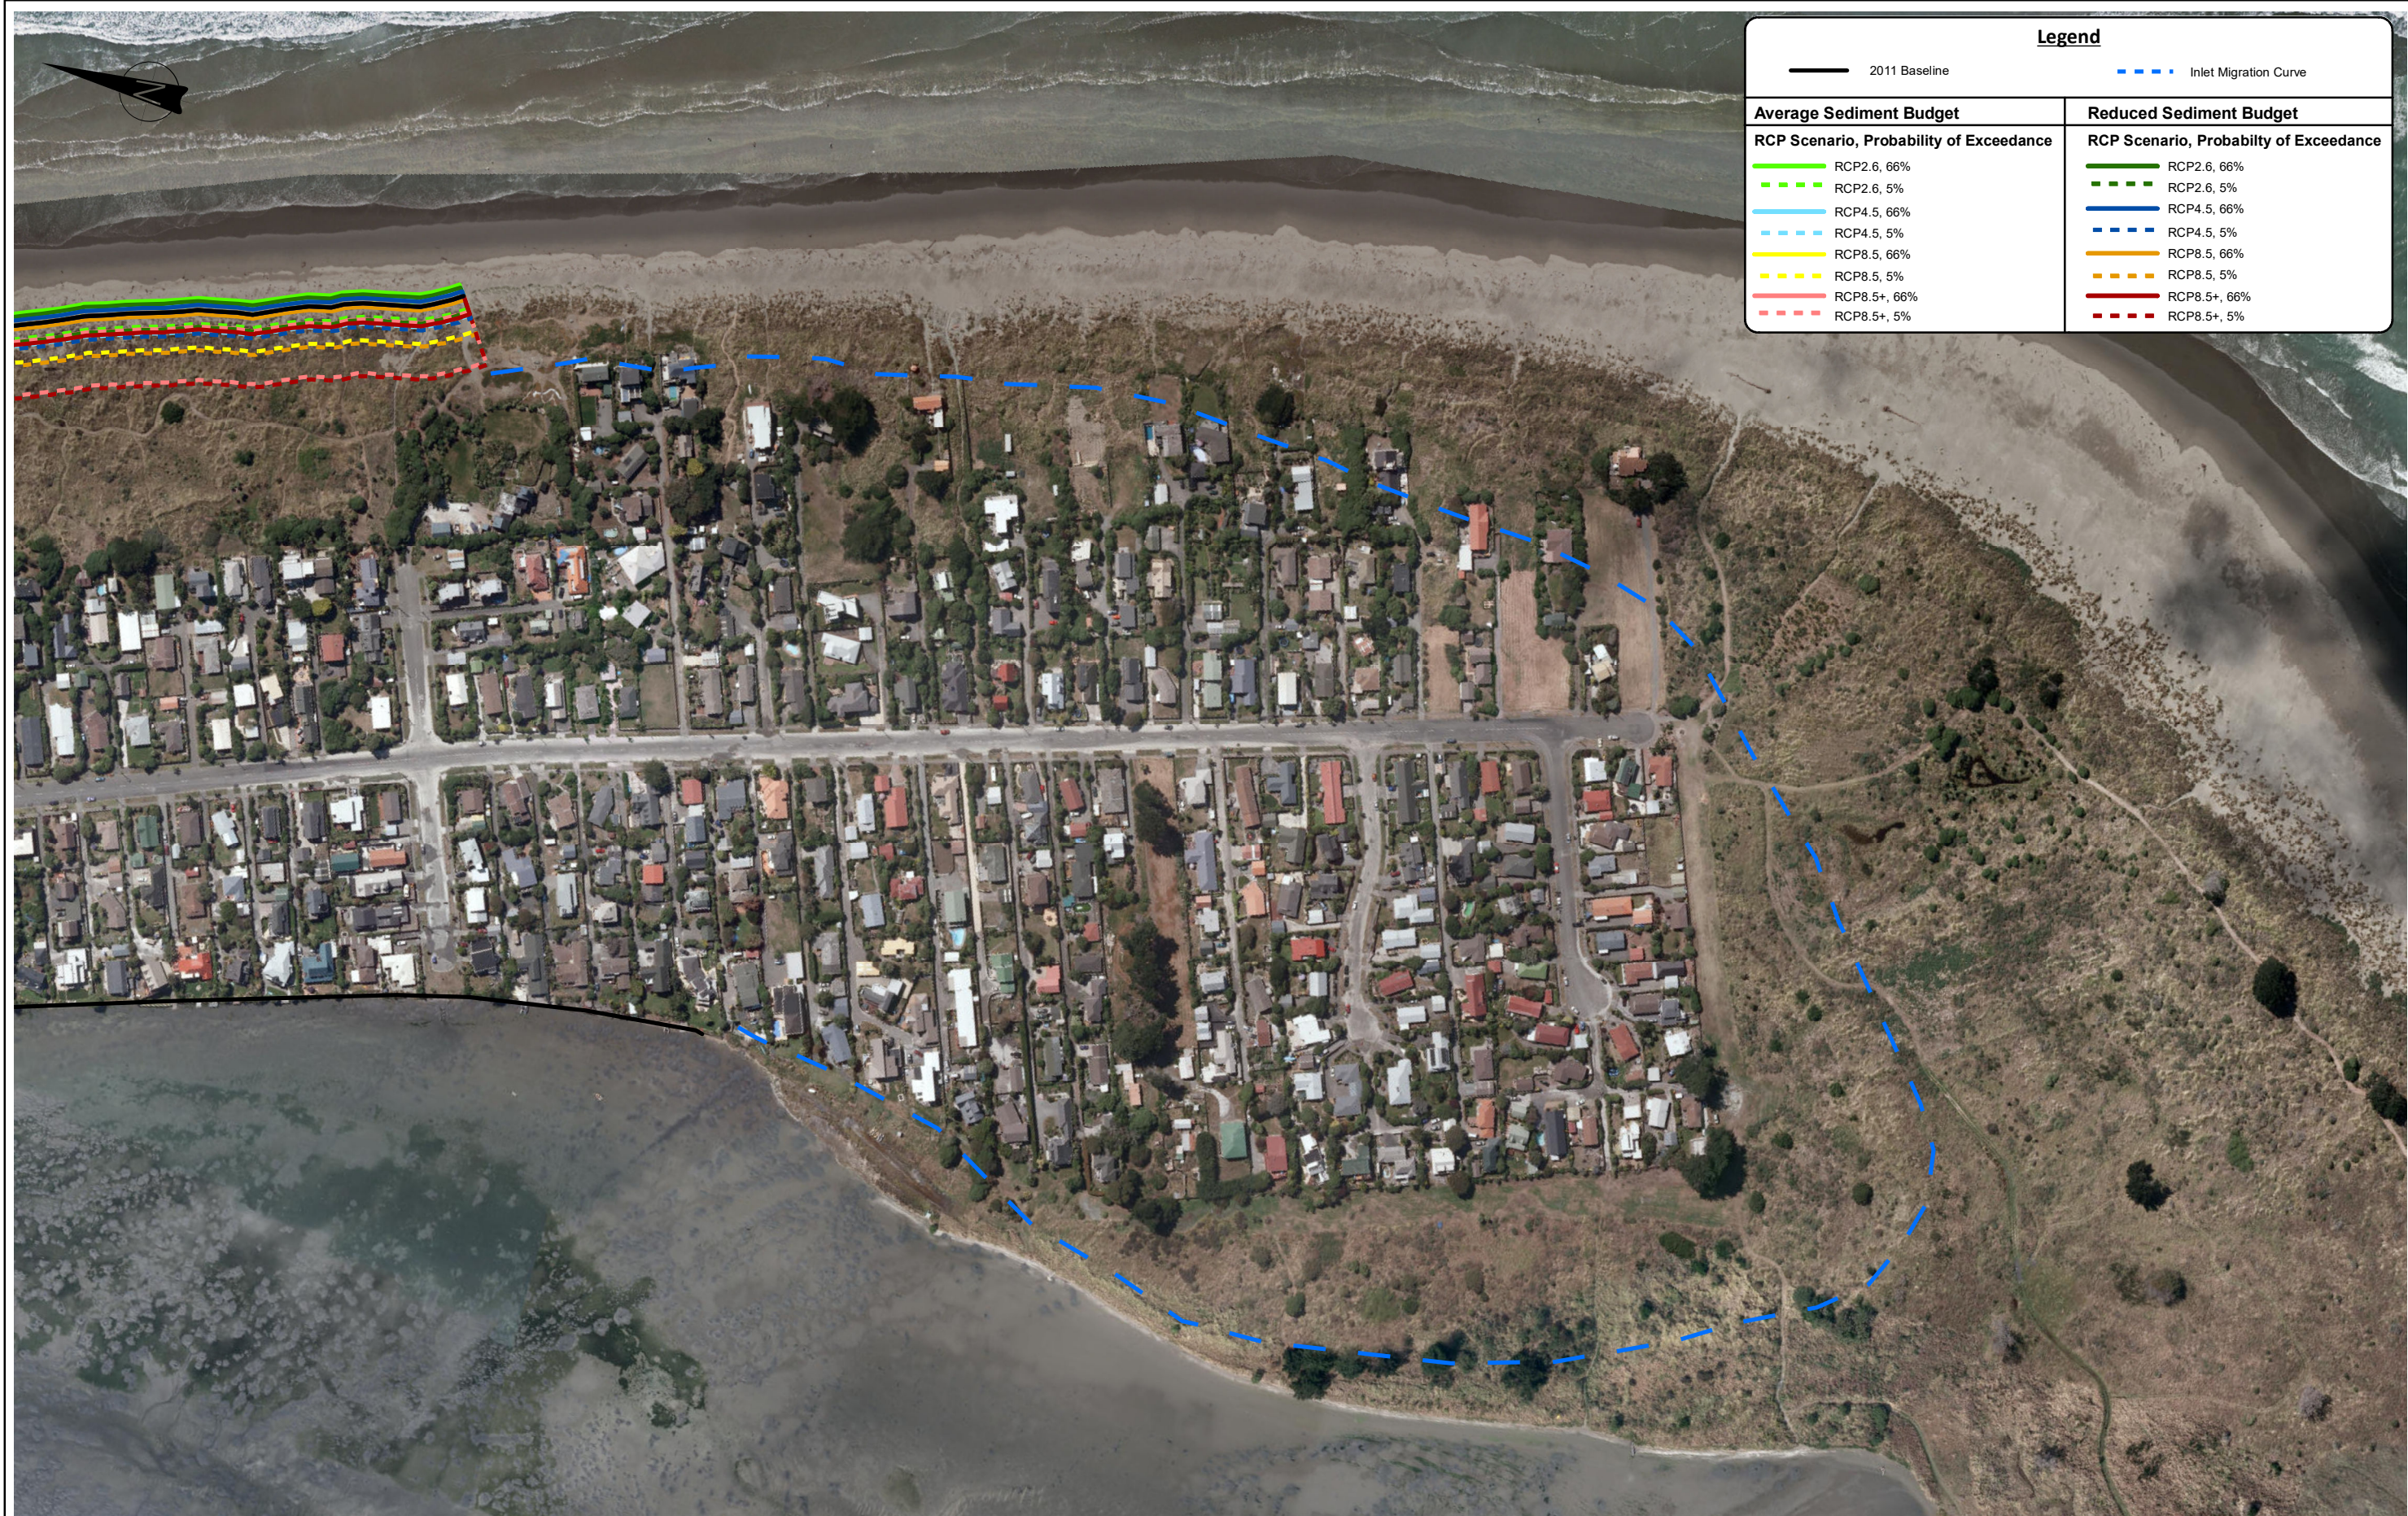
The CEHZs have been assessed by splitting up the shoreline in behaviour cells with the end/boundary of a coastal behaviour cell indicated with a shoreline-perpendicular CEHZ line. The CEHZs are only mapped for the study area (refer to report). The open coast CEHZs transition into the IMC along the South Brighton Spit where the shoreline has historically fluctuated and the morphology is relatively low-lying. Refer to note on map limitations on the front page of Appendix H.

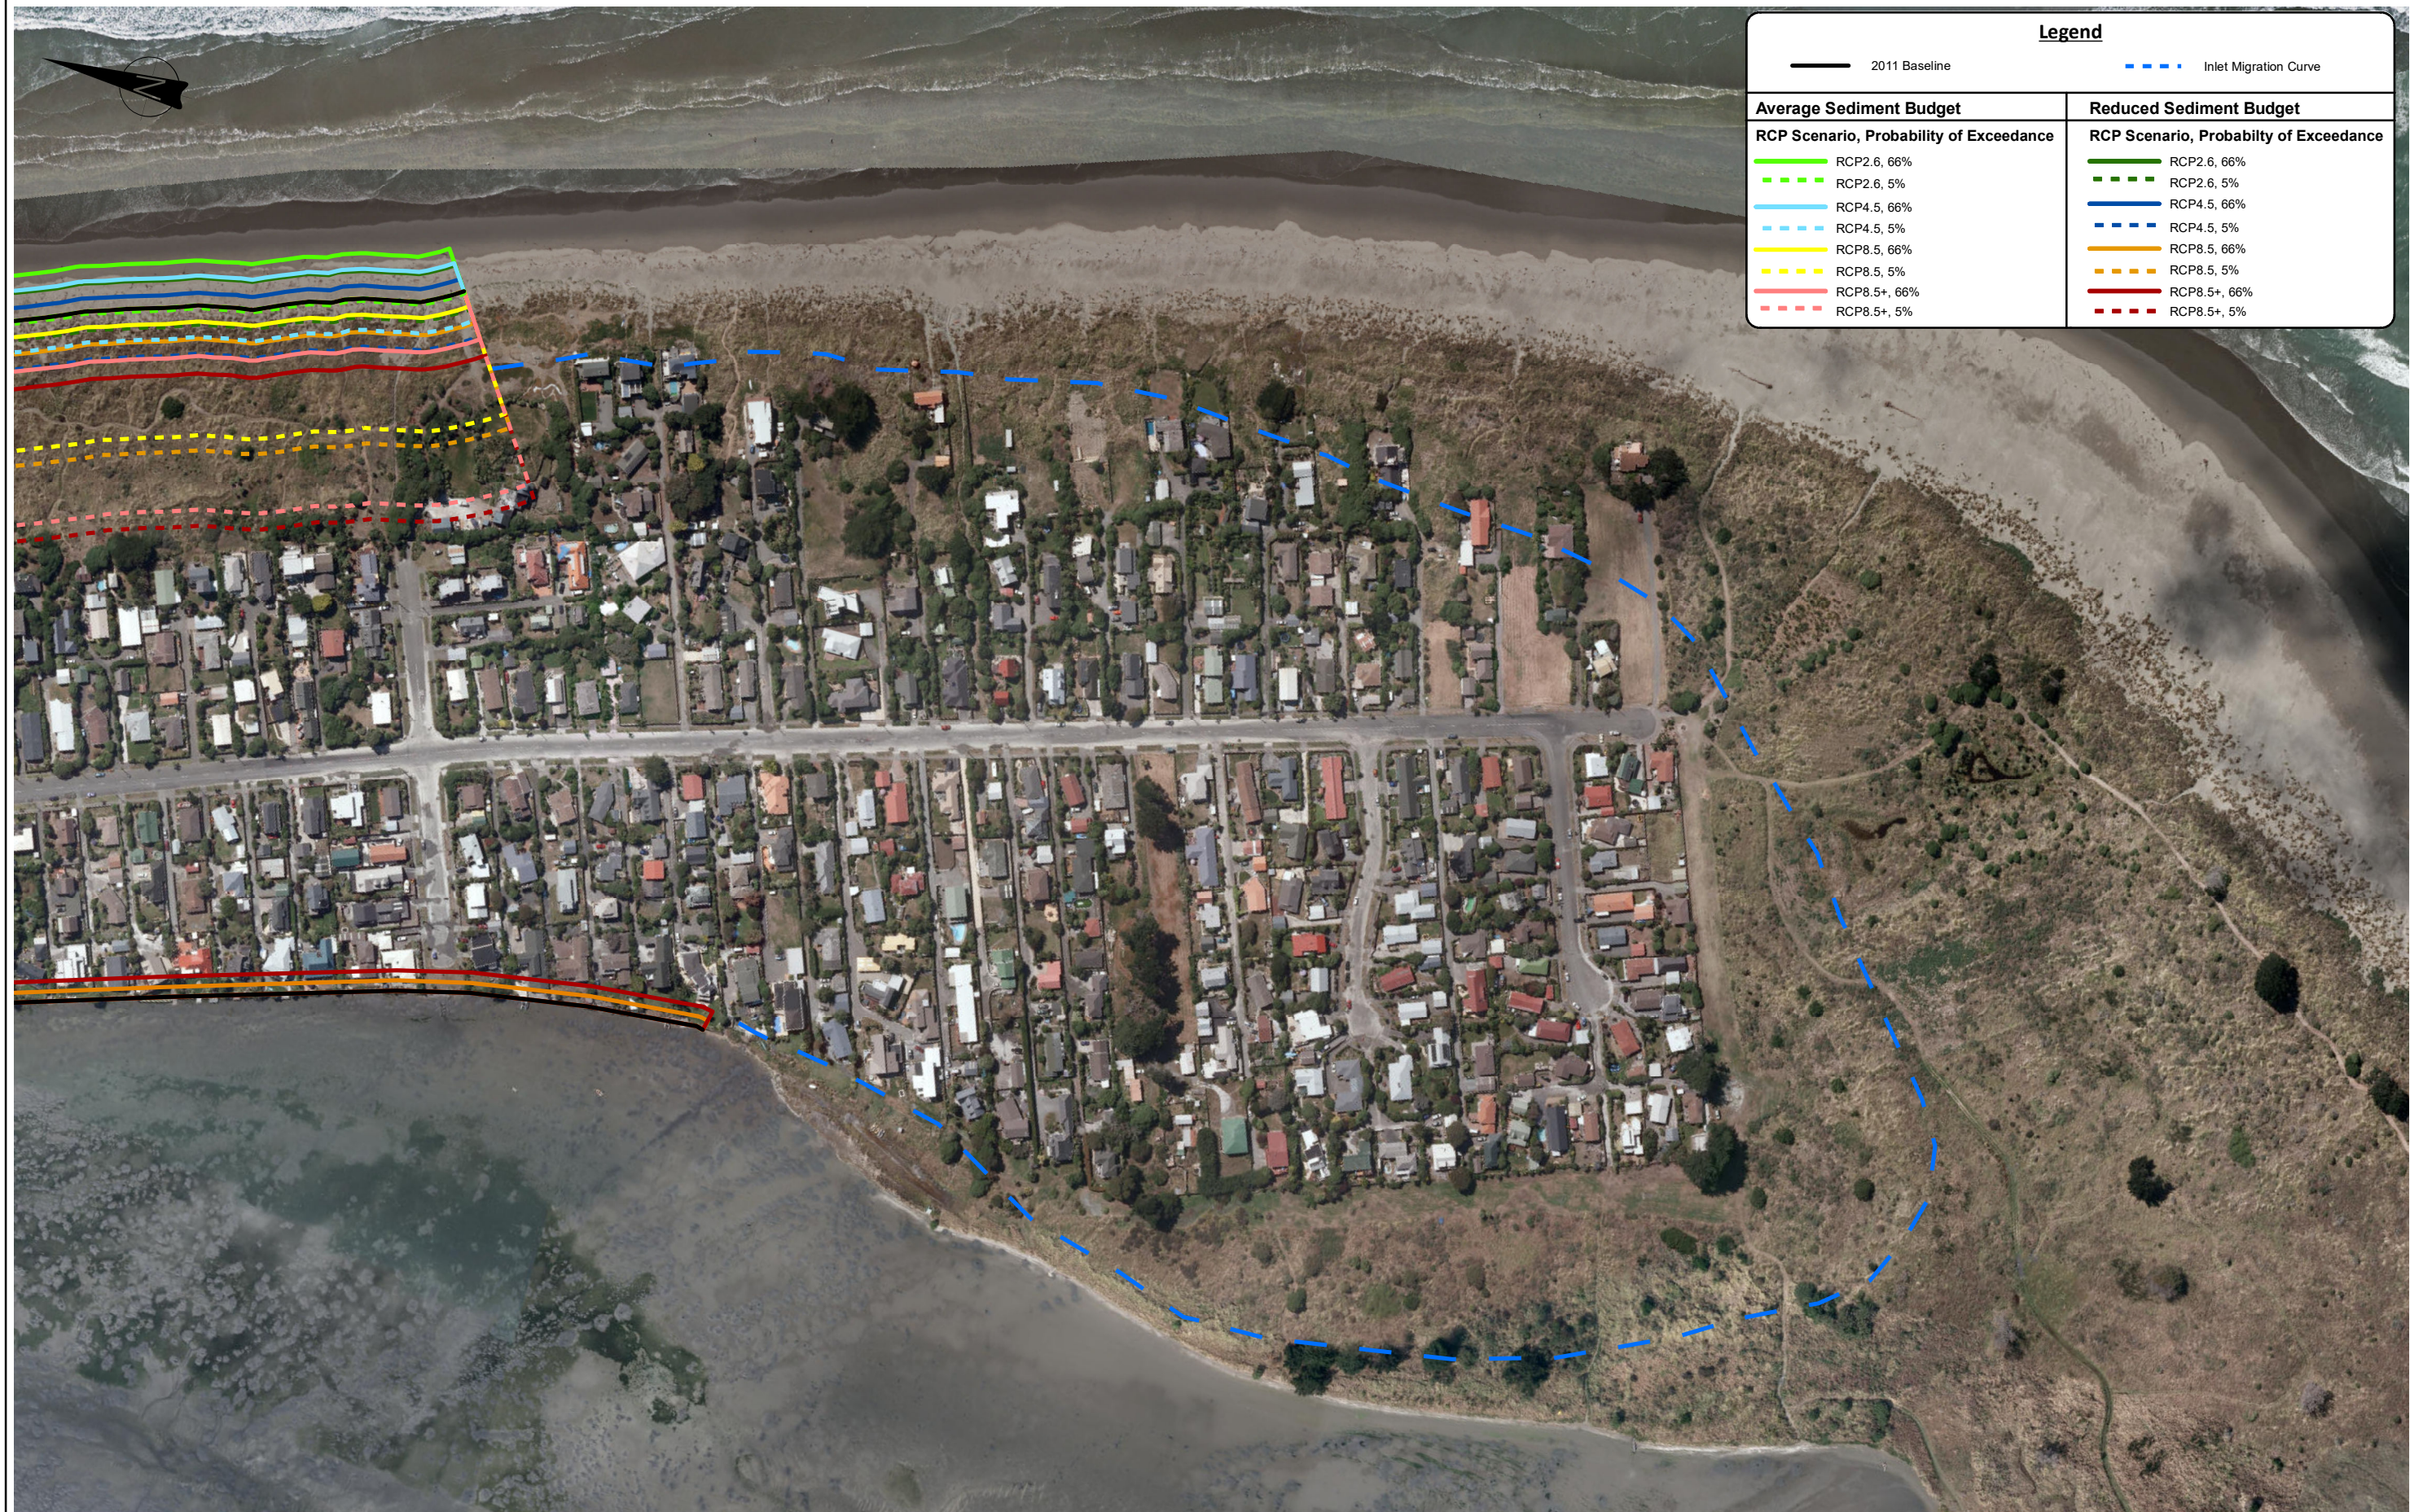
CHRISTCHURCH CITY COUNCIL		
COASTAL HAZARD ASSESSMENT		
Open Coast - 2120		
Erosion Hazard Zones		
FIGURE No.	Figure H -29(b)	Rev. 0

The CEHZs have been assessed by splitting up the shoreline in behaviour cells with the end/boundary of a coastal behaviour cell indicated with a shoreline-perpendicular CEHZ line. The CEHZs are only mapped for the study area (refer to report). The open coast CEHZs transition into the IMC along the South Brighton Spit where the shoreline has historically fluctuated and the morphology is relatively low-lying. Refer to note on map limitations on the front page of Appendix H.

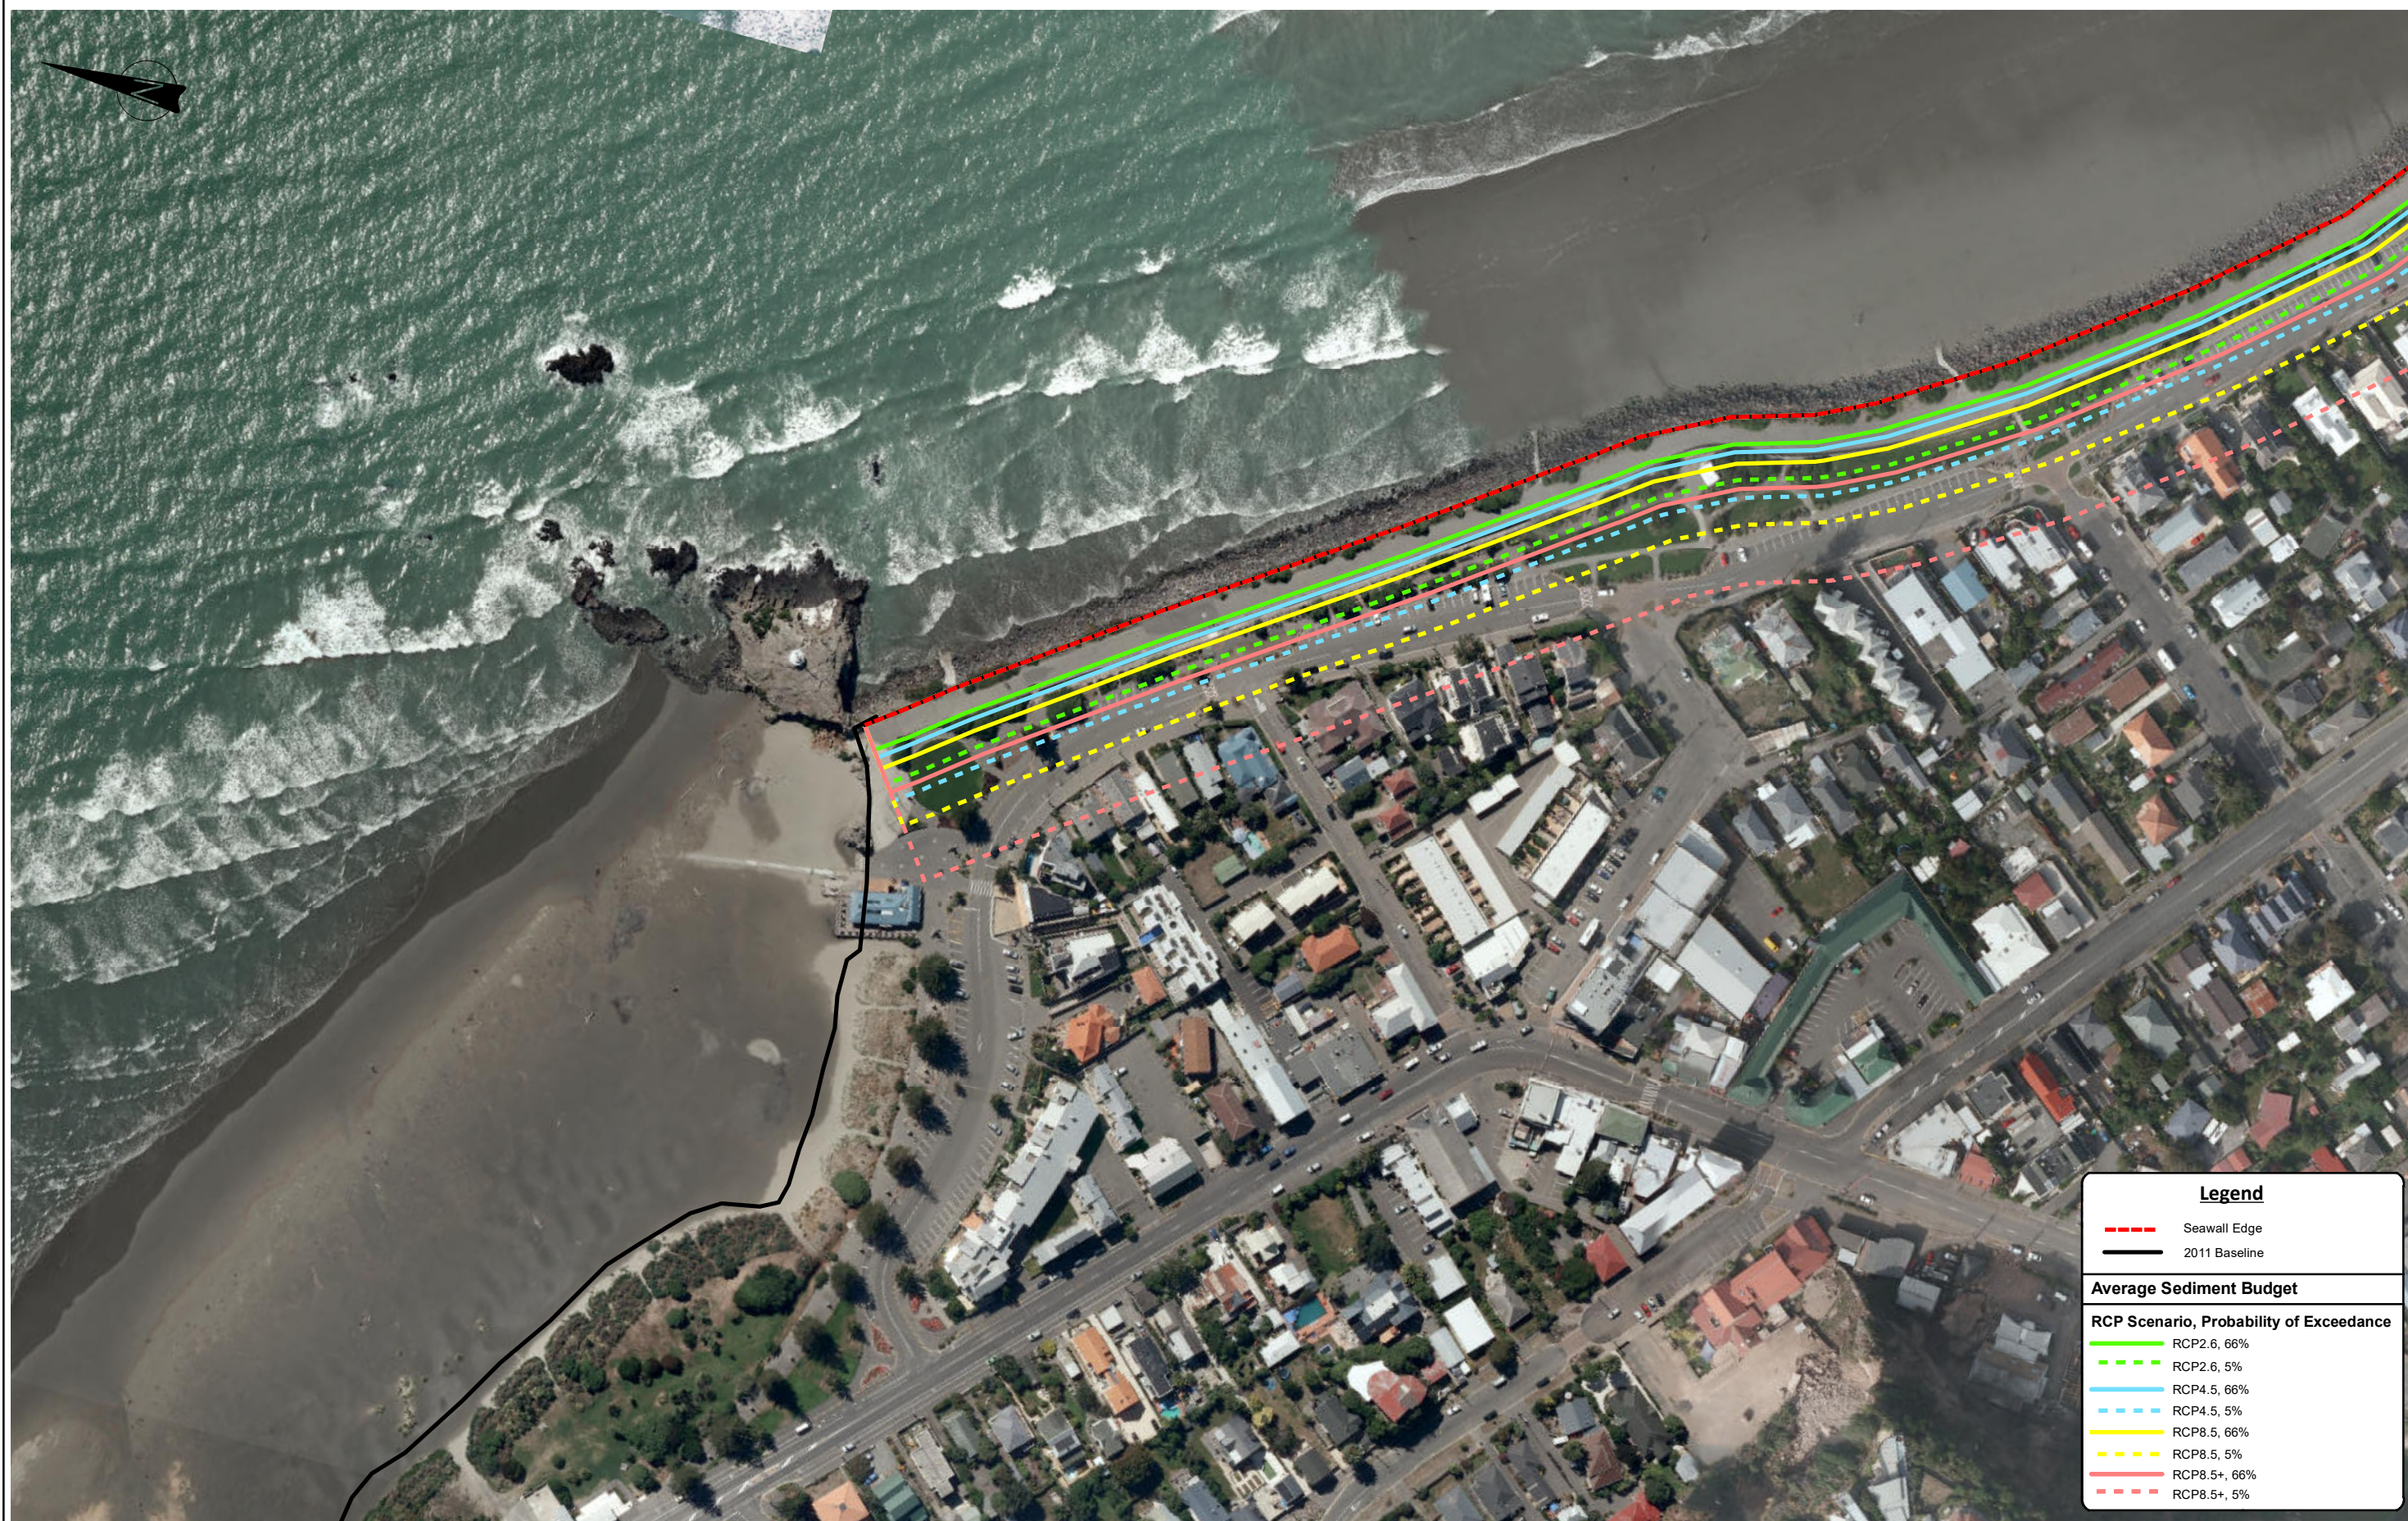
**CHRISTCHURCH CITY COUNCIL**  
**COASTAL HAZARD ASSESSMENT**  
Open Coast (Sumner) - 2065  
Erosion Hazard Zones

The CEHZs have been assessed by splitting up the shoreline in behaviour cells with the end/boundary of a coastal behaviour cell indicated with a shoreline-perpendicular CEHZ line. The CEHZs are only mapped for the study area (refer to report).  
Refer to note on map limitations on the front page of Appendix H.

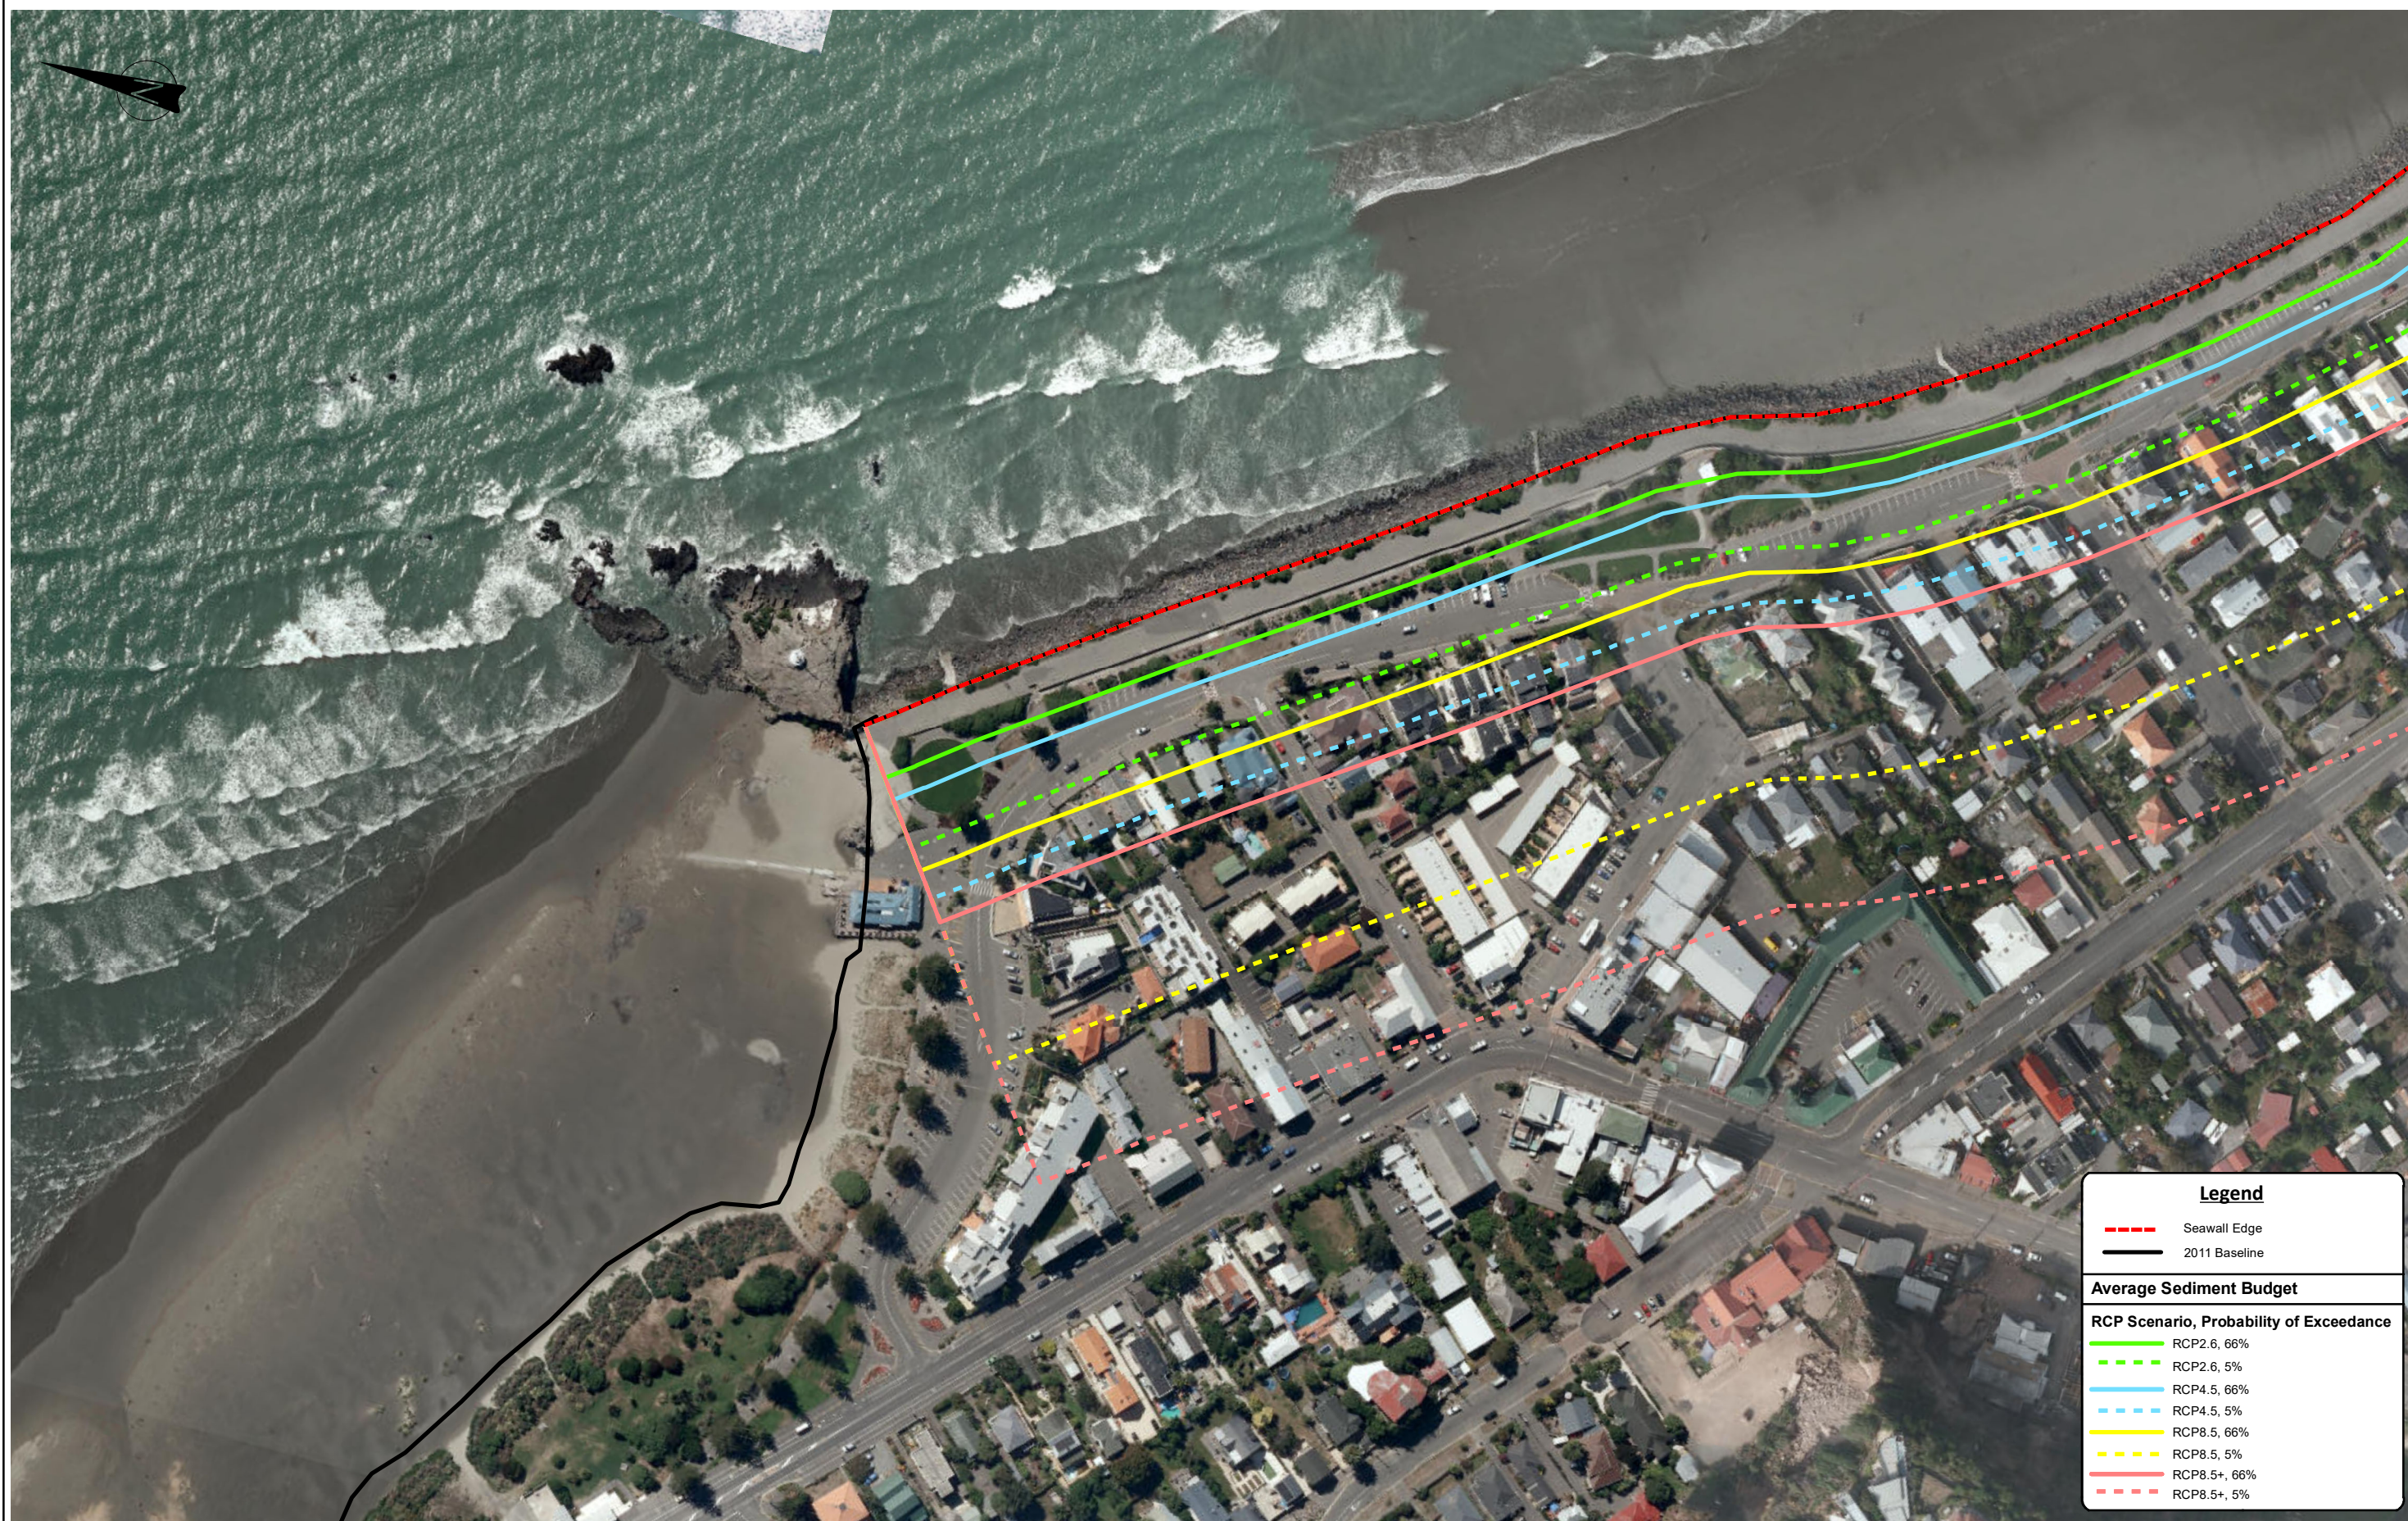
**CHRISTCHURCH CITY COUNCIL**  
**COASTAL HAZARD ASSESSMENT**  
Open Coast (Sumner) - 2120  
Erosion Hazard Zones

The CEHZs have been assessed by splitting up the shoreline in behaviour cells with the end/boundary of a coastal behaviour cell indicated with a shoreline-perpendicular CEHZ line. The CEHZs are only mapped for the study area (refer to report).  
Refer to note on map limitations on the front page of Appendix H.
