## Appendix H: CEHZ result maps

CHRISTCHURCH CITY COUNCIL		
COASTAL HAZARD ASSESSMENT		
Open Coast - 2065		
Erosion Hazard Zones		
FIGURE No.	Figure H - 1(a)	Rev. 0

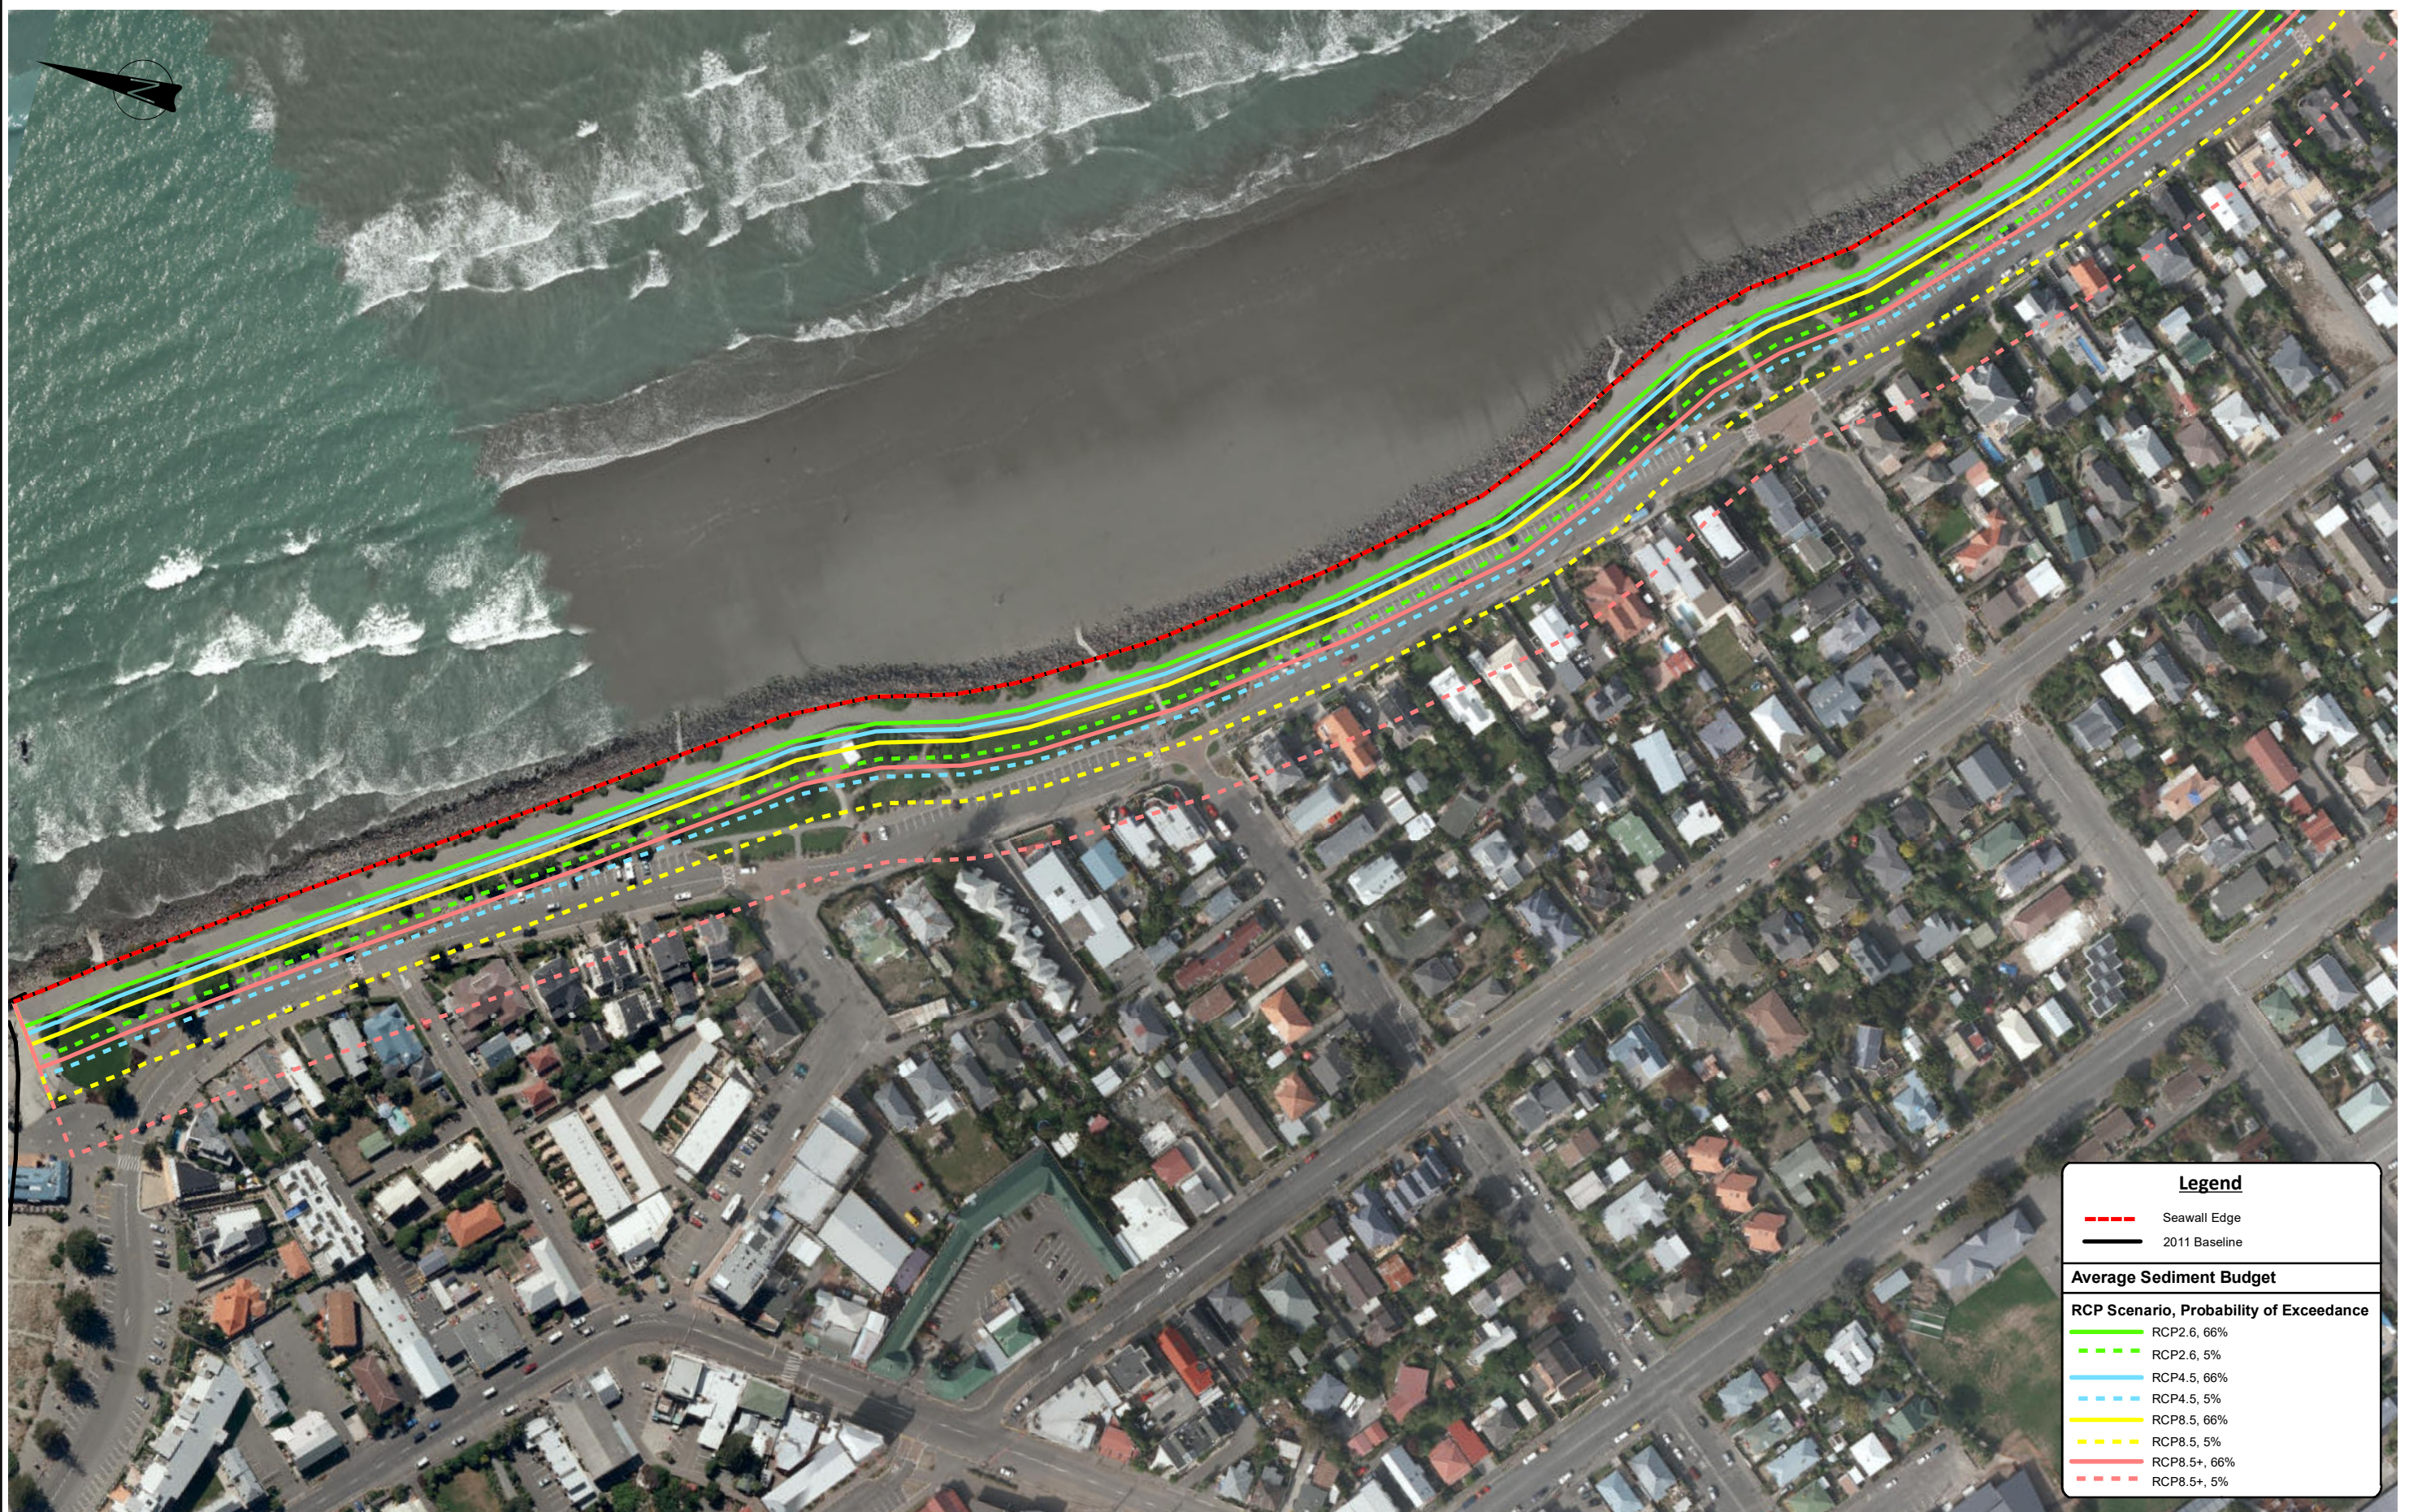
**CHRISTCHURCH CITY COUNCIL**  
**COASTAL HAZARD ASSESSMENT**  
Open Coast (Sumner) - 2065  
Erosion Hazard Zones

The CEHZs have been assessed by splitting up the shoreline in behaviour cells with the end/boundary of a coastal behaviour cell indicated with a shoreline-perpendicular CEHZ line. The CEHZs are only mapped for the study area (refer to report).  
Refer to note on map limitations on the front page of Appendix H.

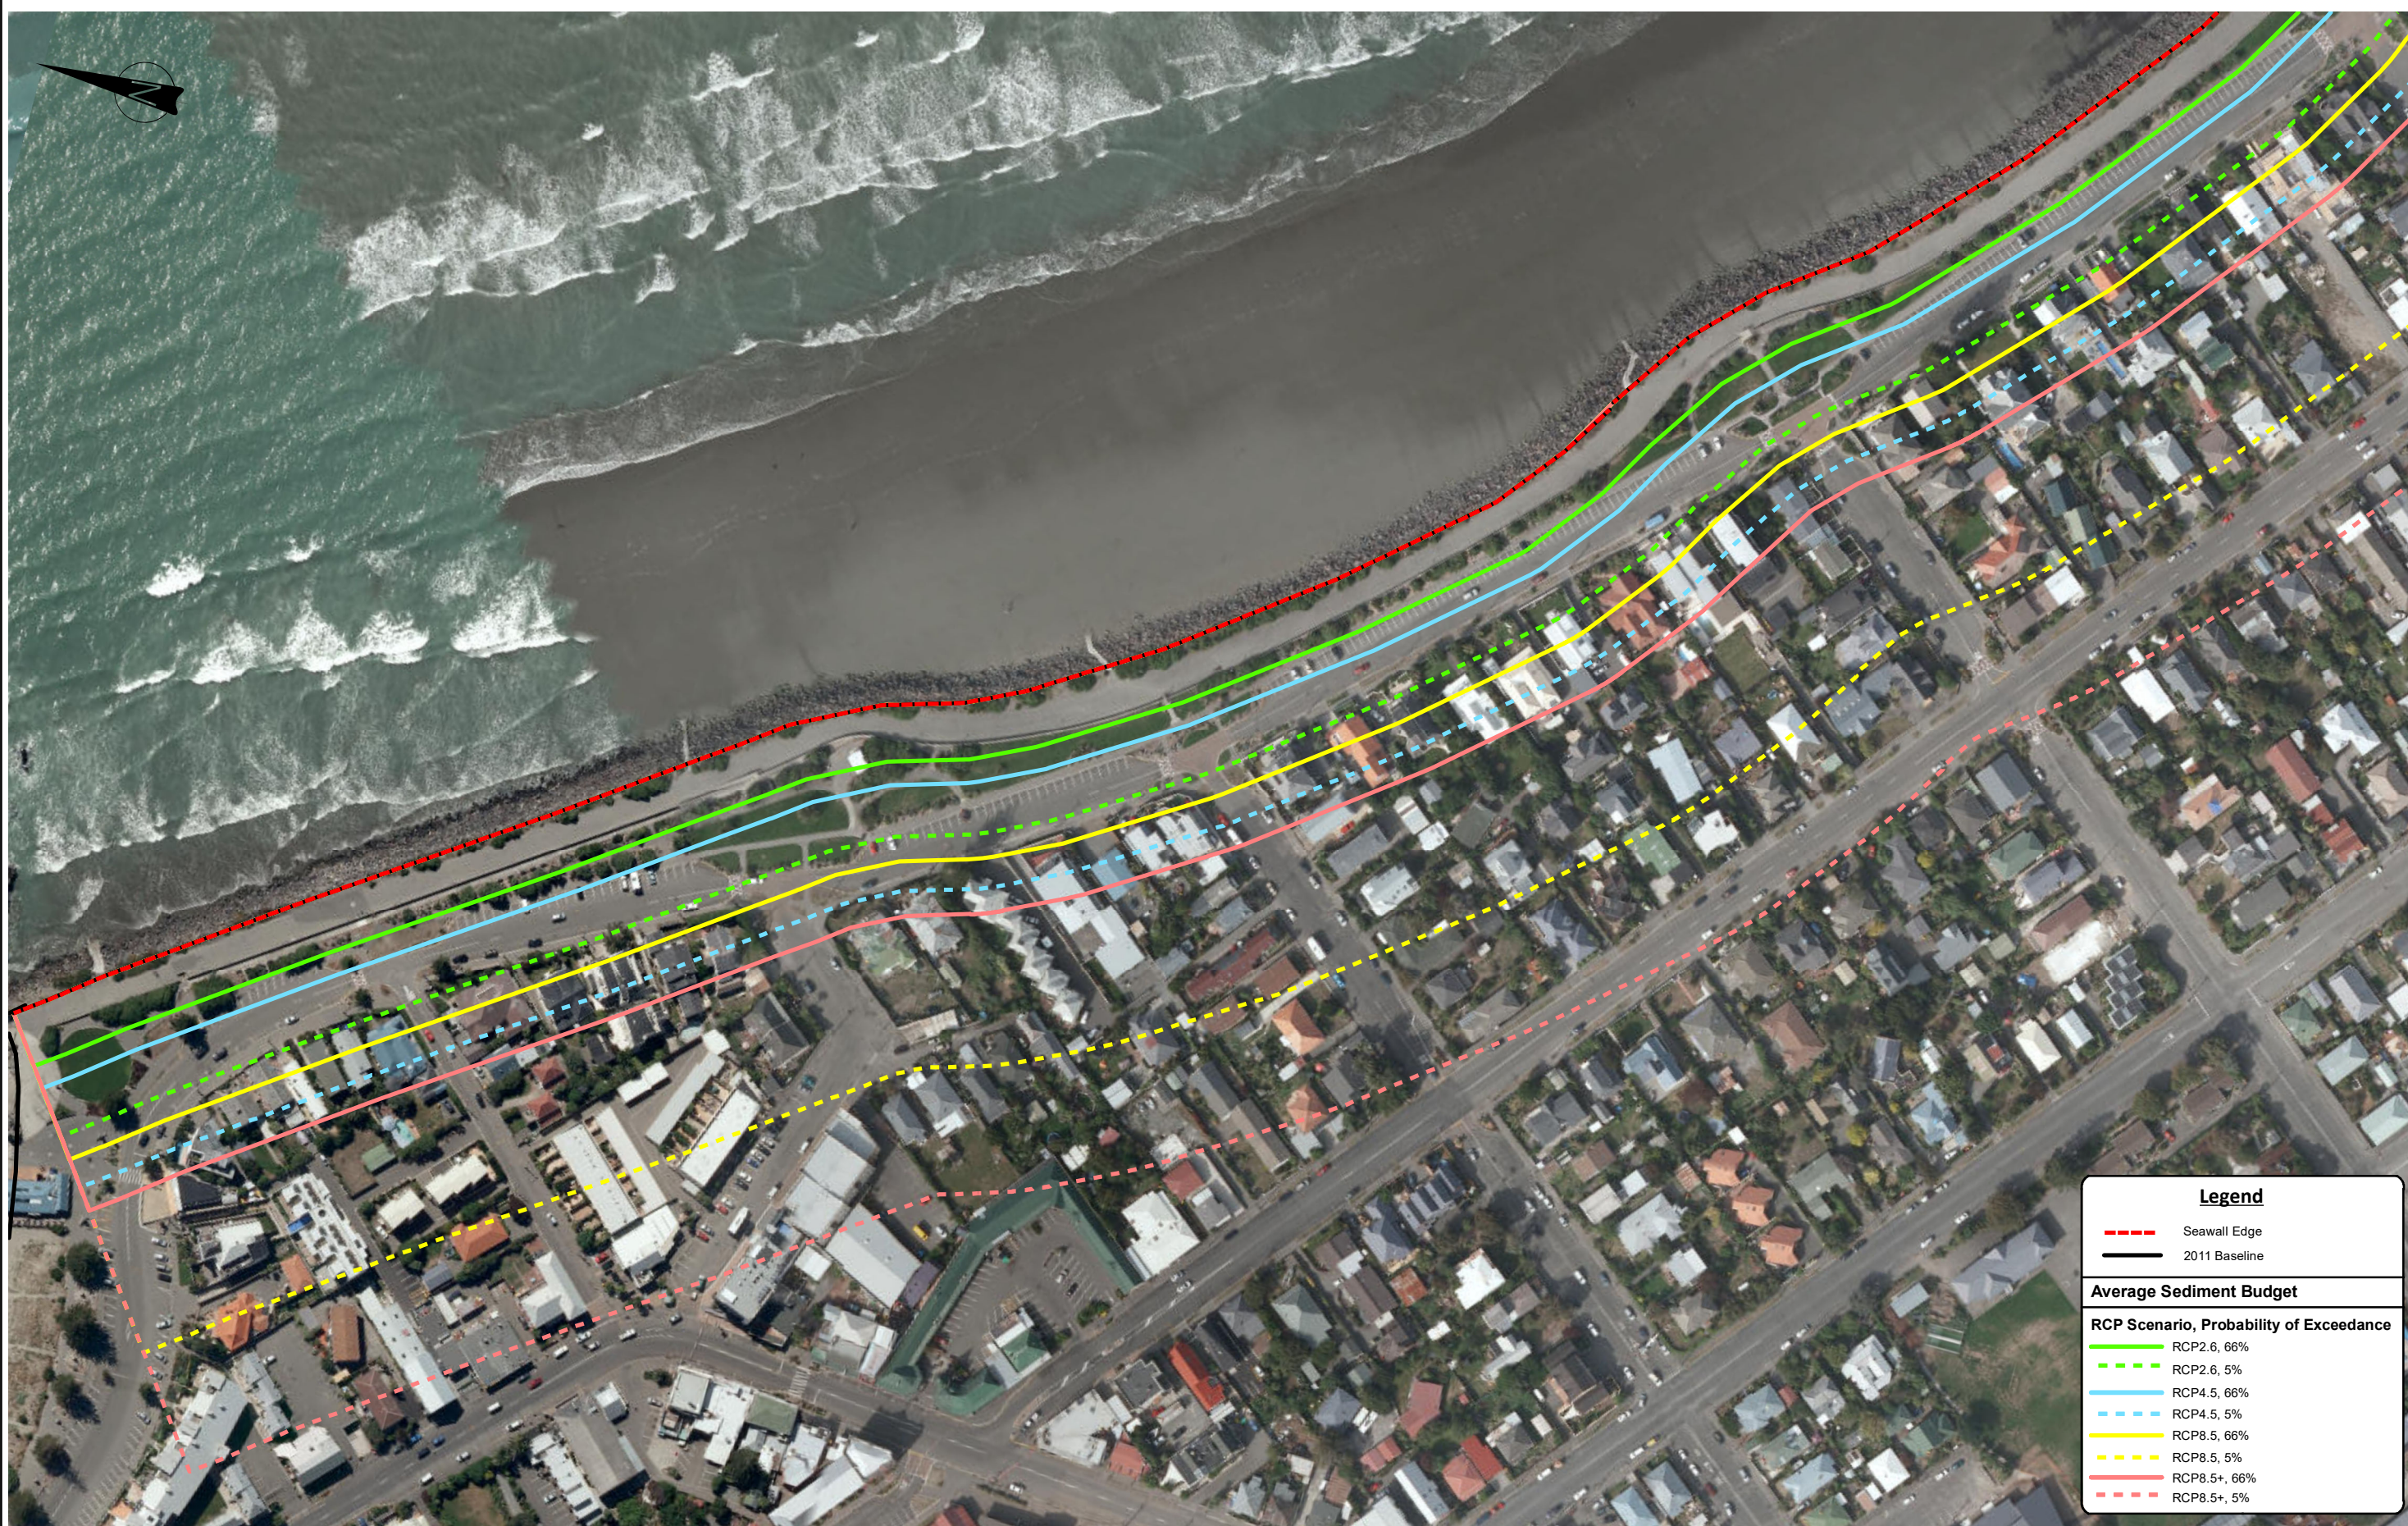
**CHRISTCHURCH CITY COUNCIL**  
**COASTAL HAZARD ASSESSMENT**  
Open Coast (Sumner) - 2120  
Erosion Hazard Zones

The CEHZs have been assessed by splitting up the shoreline in behaviour cells with the end/boundary of a coastal behaviour cell indicated with a shoreline-perpendicular CEHZ line. The CEHZs are only mapped for the study area (refer to report).  
Refer to note on map limitations on the front page of Appendix H.

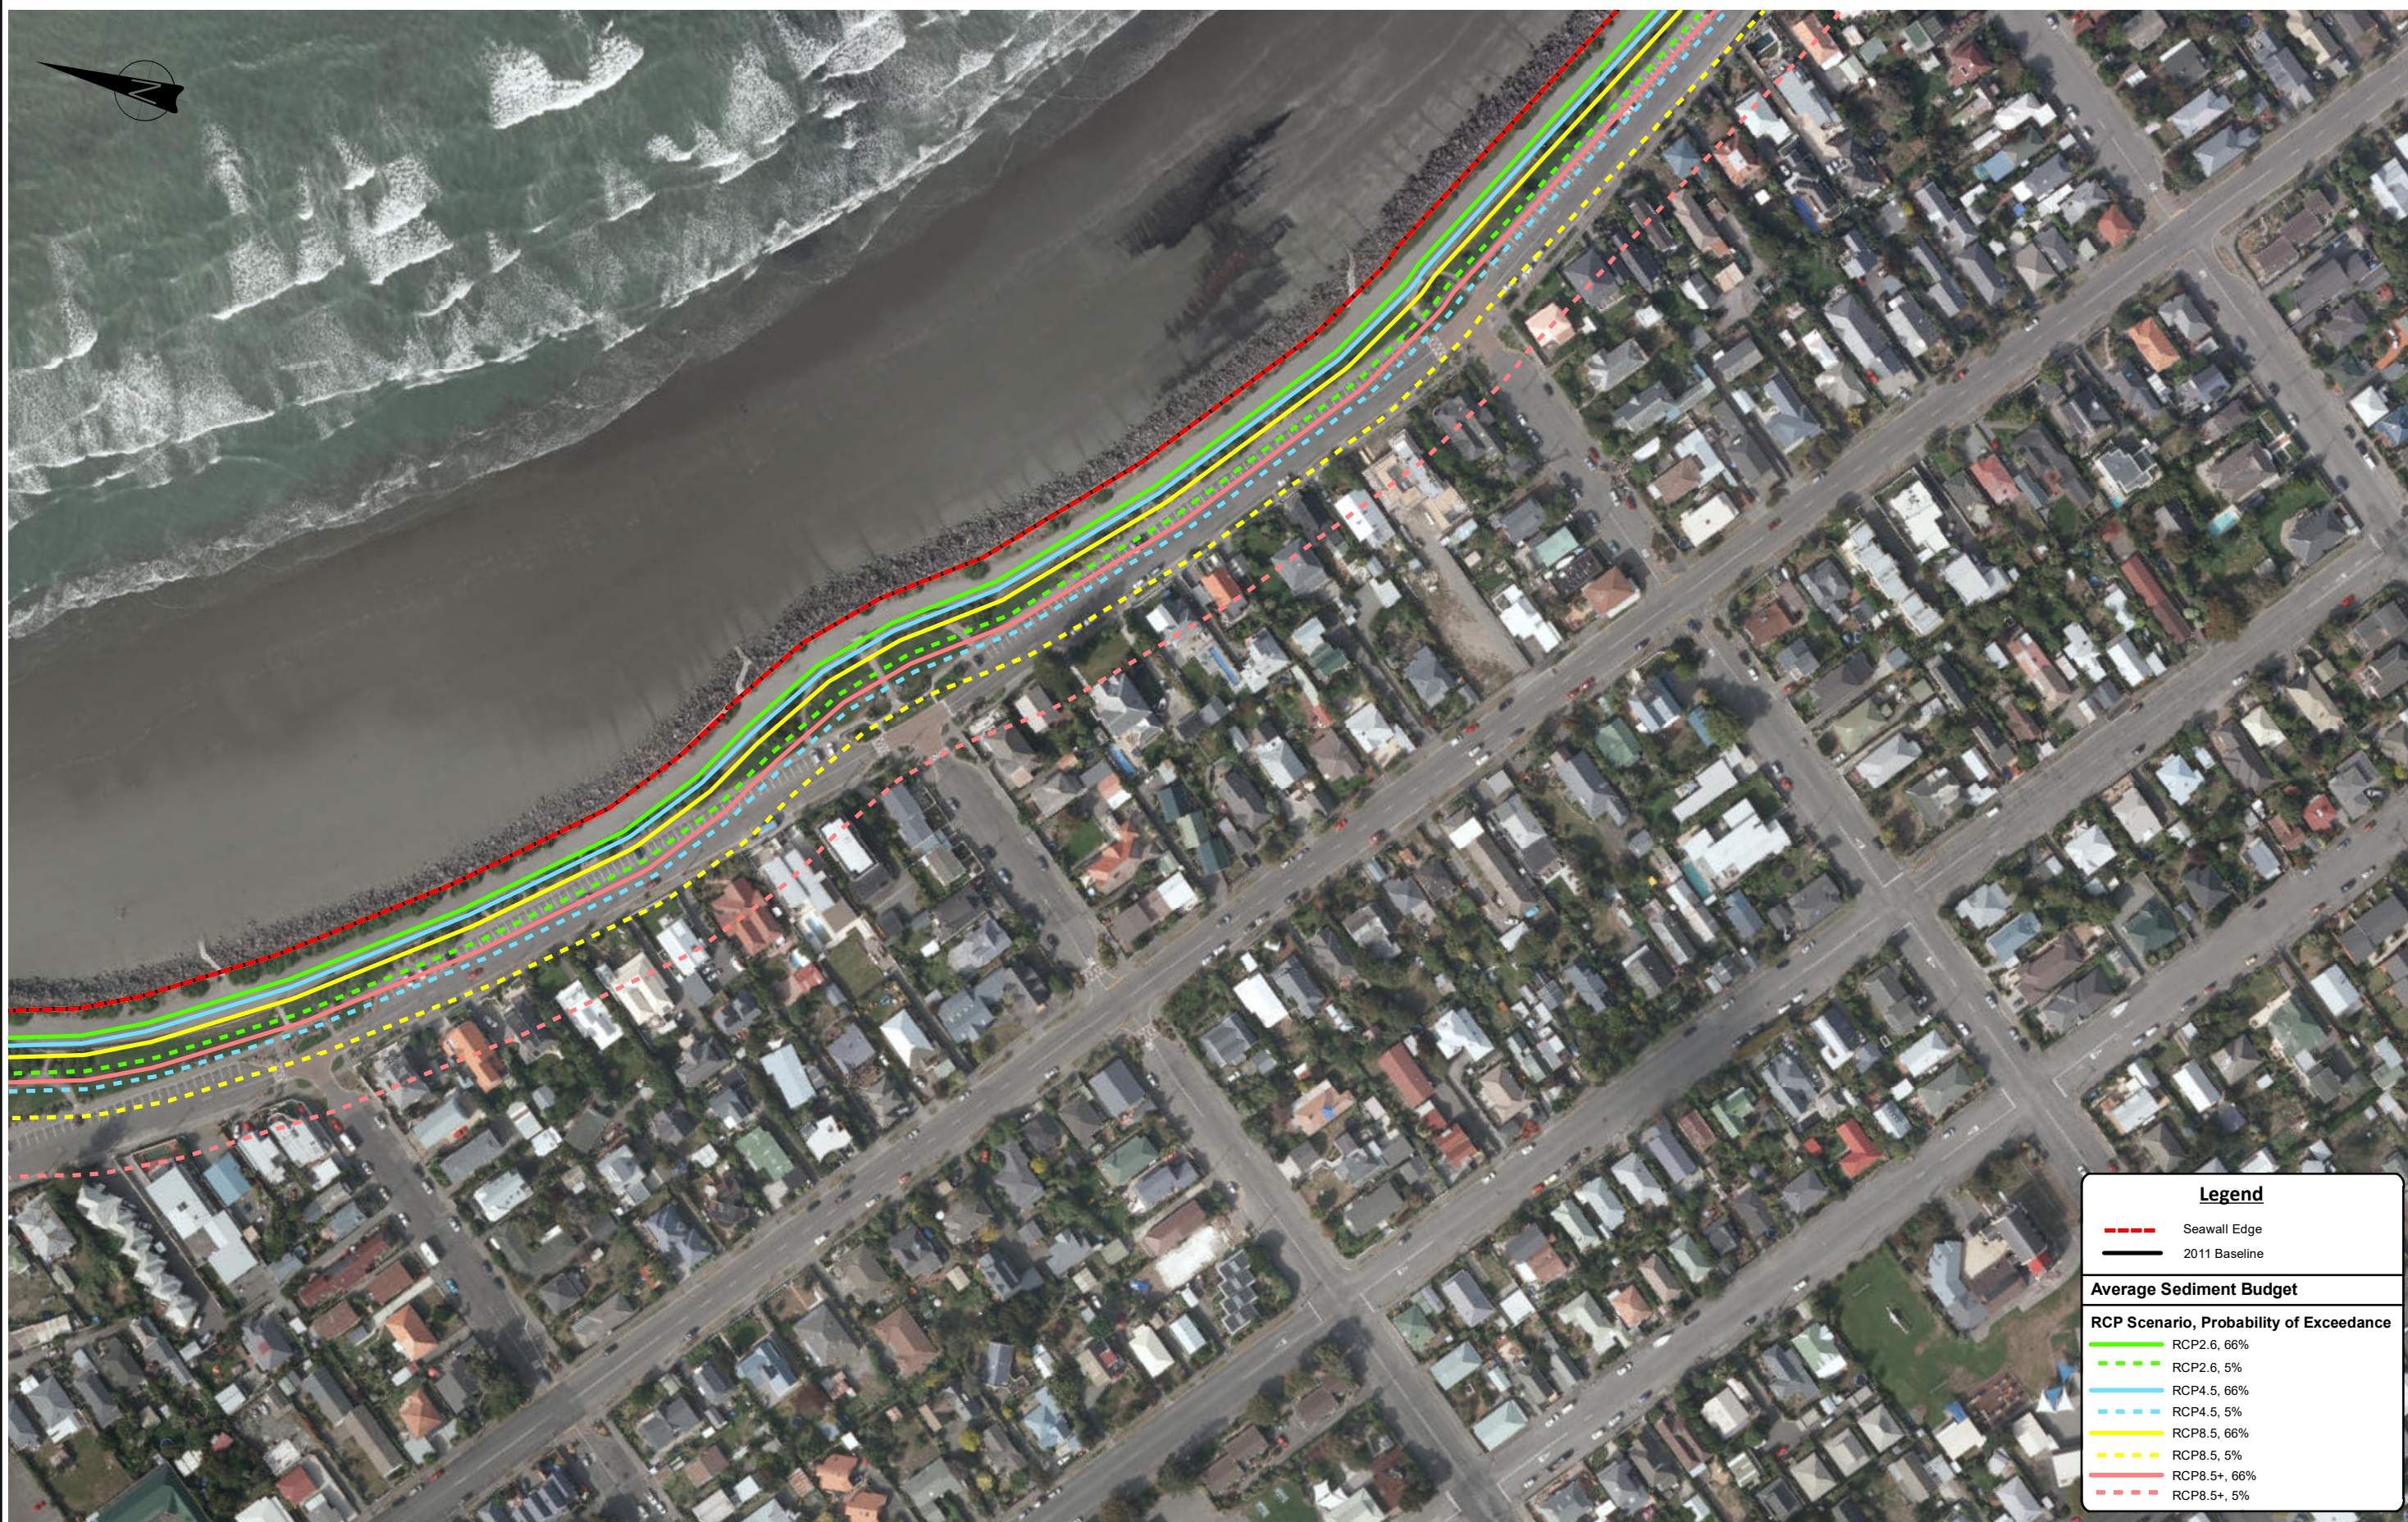
**CHRISTCHURCH CITY COUNCIL**  
**COASTAL HAZARD ASSESSMENT**  
Open Coast (Sumner) - 2065  
Erosion Hazard Zones

The CEHZs have been assessed by splitting up the shoreline in behaviour cells with the end/boundary of a coastal behaviour cell indicated with a shoreline-perpendicular CEHZ line. The CEHZs are only mapped for the study area (refer to report).  
Refer to note on map limitations on the front page of Appendix H.

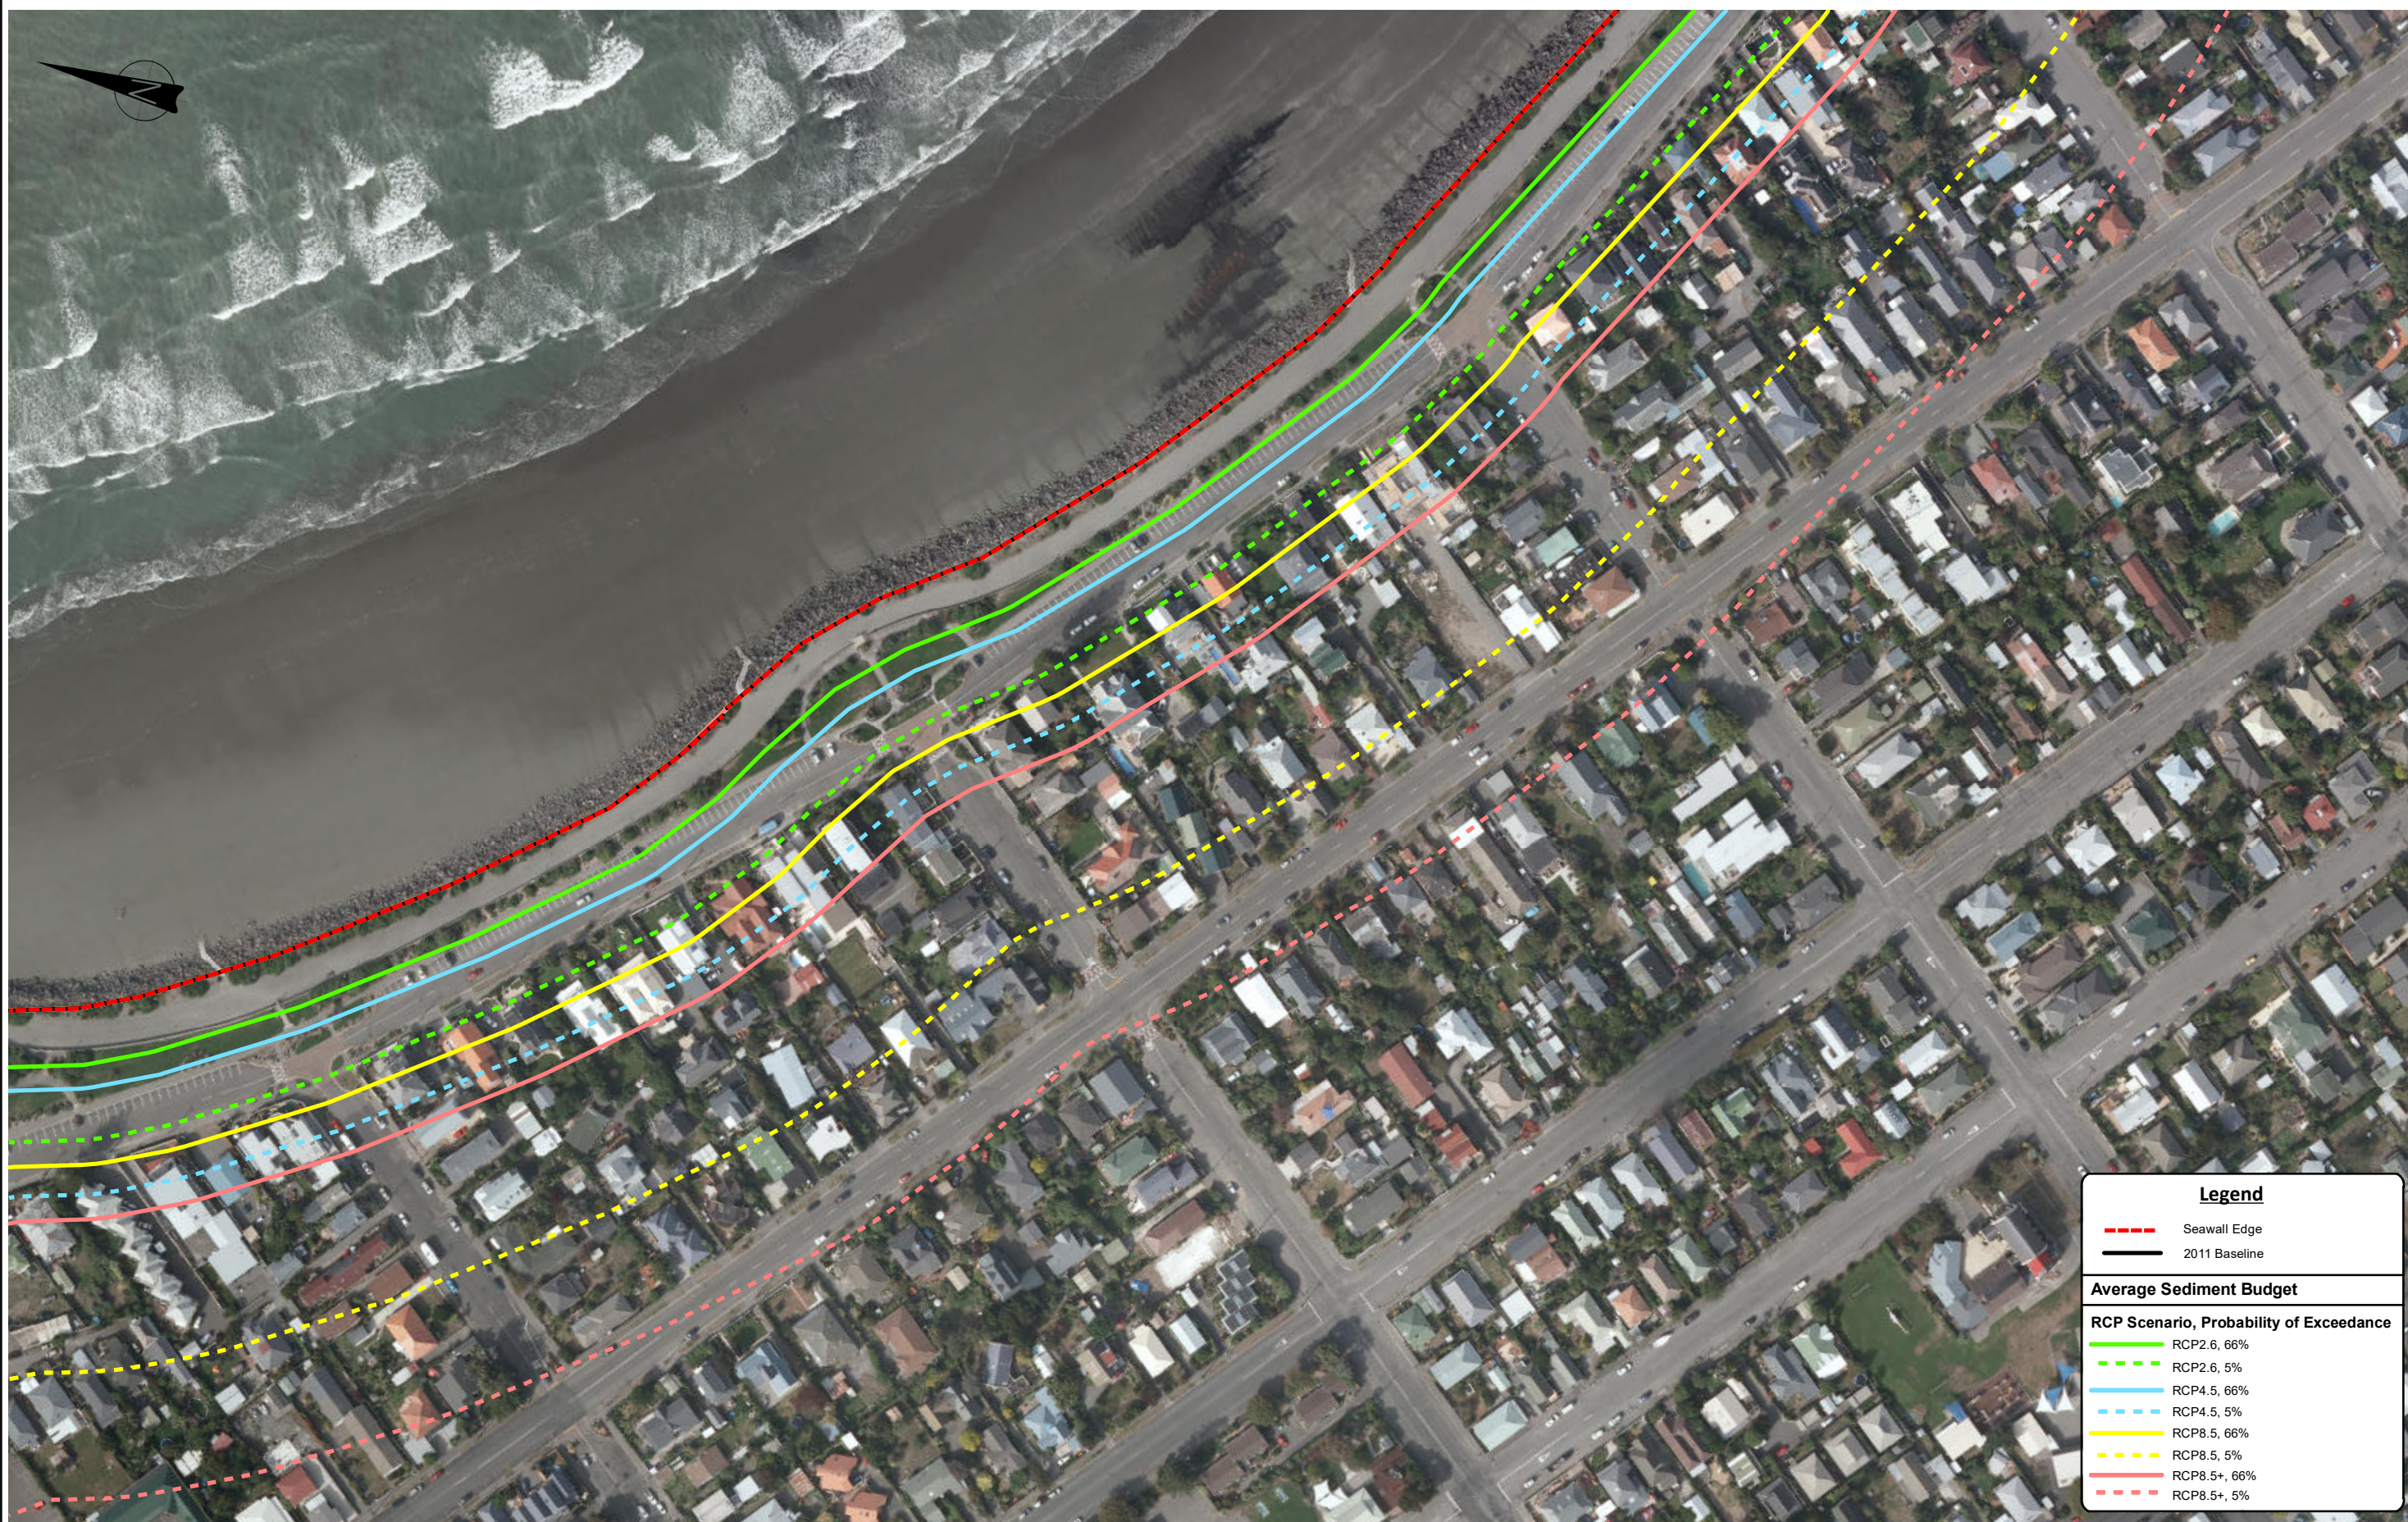
**CHRISTCHURCH CITY COUNCIL**  
**COASTAL HAZARD ASSESSMENT**  
Open Coast (Sumner) - 2120  
Erosion Hazard Zones

The CEHZs have been assessed by splitting up the shoreline in behaviour cells with the end/boundary of a coastal behaviour cell indicated with a shoreline-perpendicular CEHZ line. The CEHZs are only mapped for the study area (refer to report).  
Refer to note on map limitations on the front page of Appendix H.

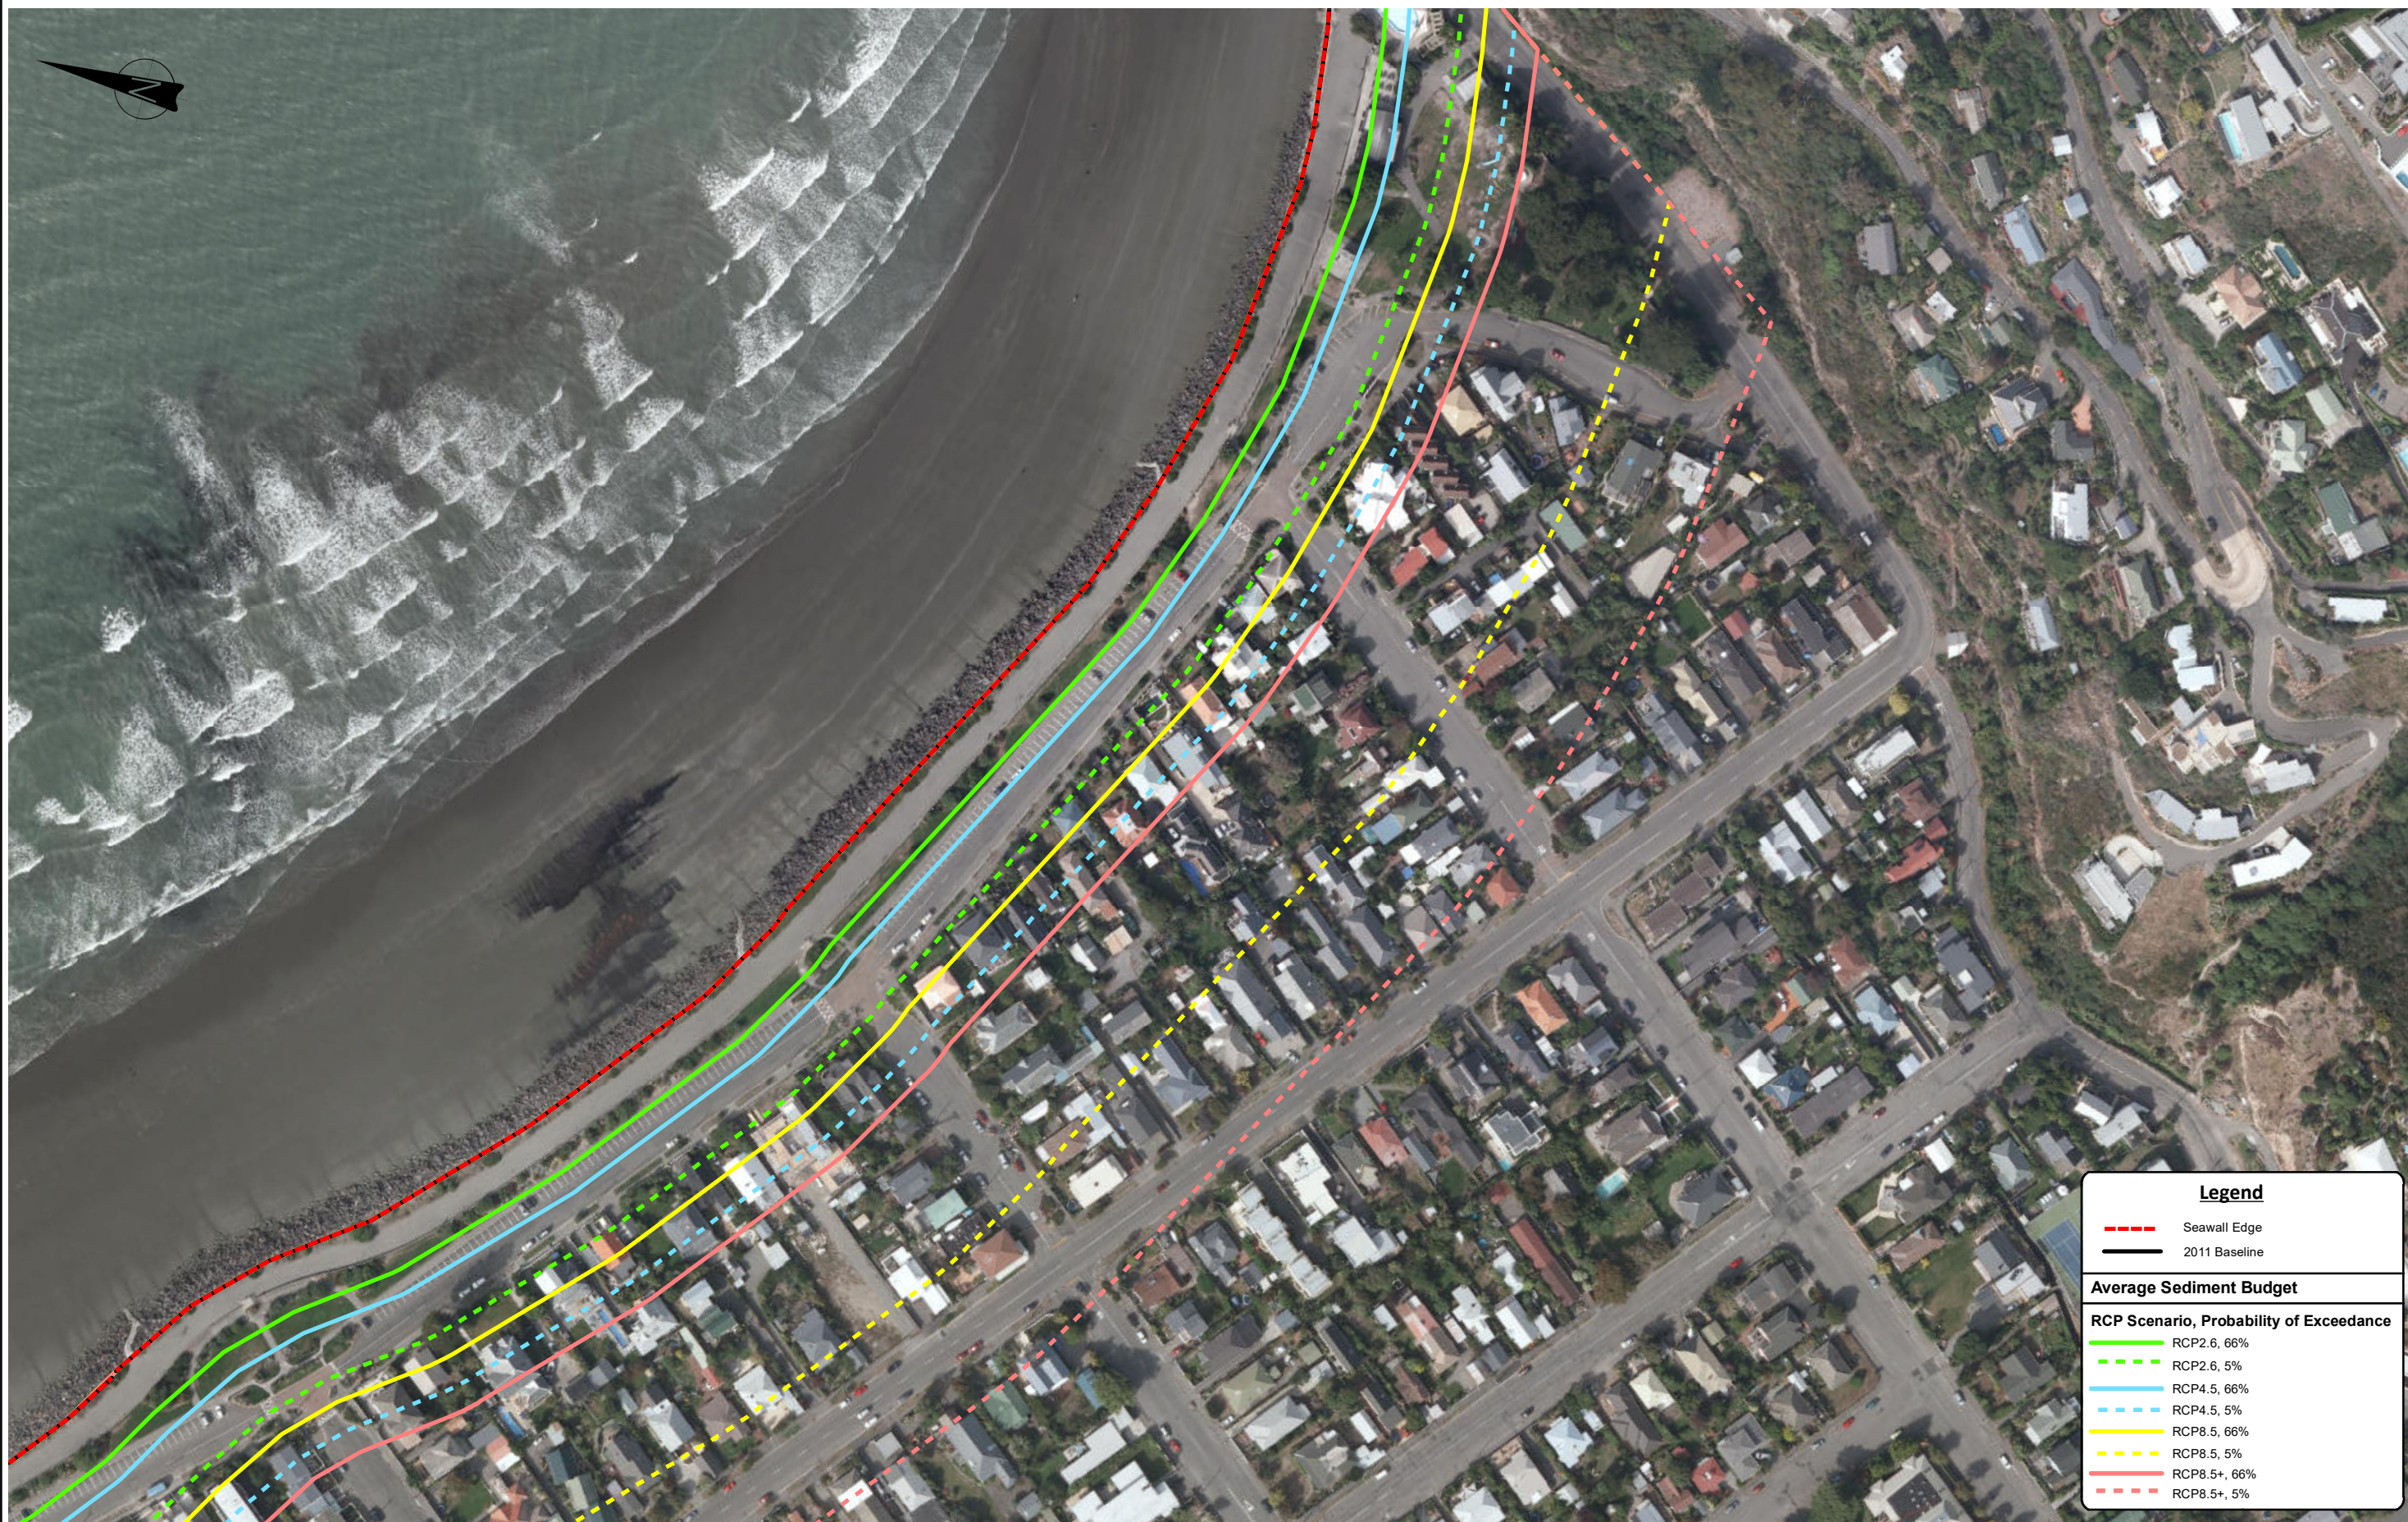
**CHRISTCHURCH CITY COUNCIL**  
**COASTAL HAZARD ASSESSMENT**  
Open Coast (Sumner) - 2120  
Erosion Hazard Zones

The CEHZs have been assessed by splitting up the shoreline in behaviour cells with the end/boundary of a coastal behaviour cell indicated with a shoreline-perpendicular CEHZ line. The CEHZs are only mapped for the study area (refer to report).  
Refer to note on map limitations on the front page of Appendix H.

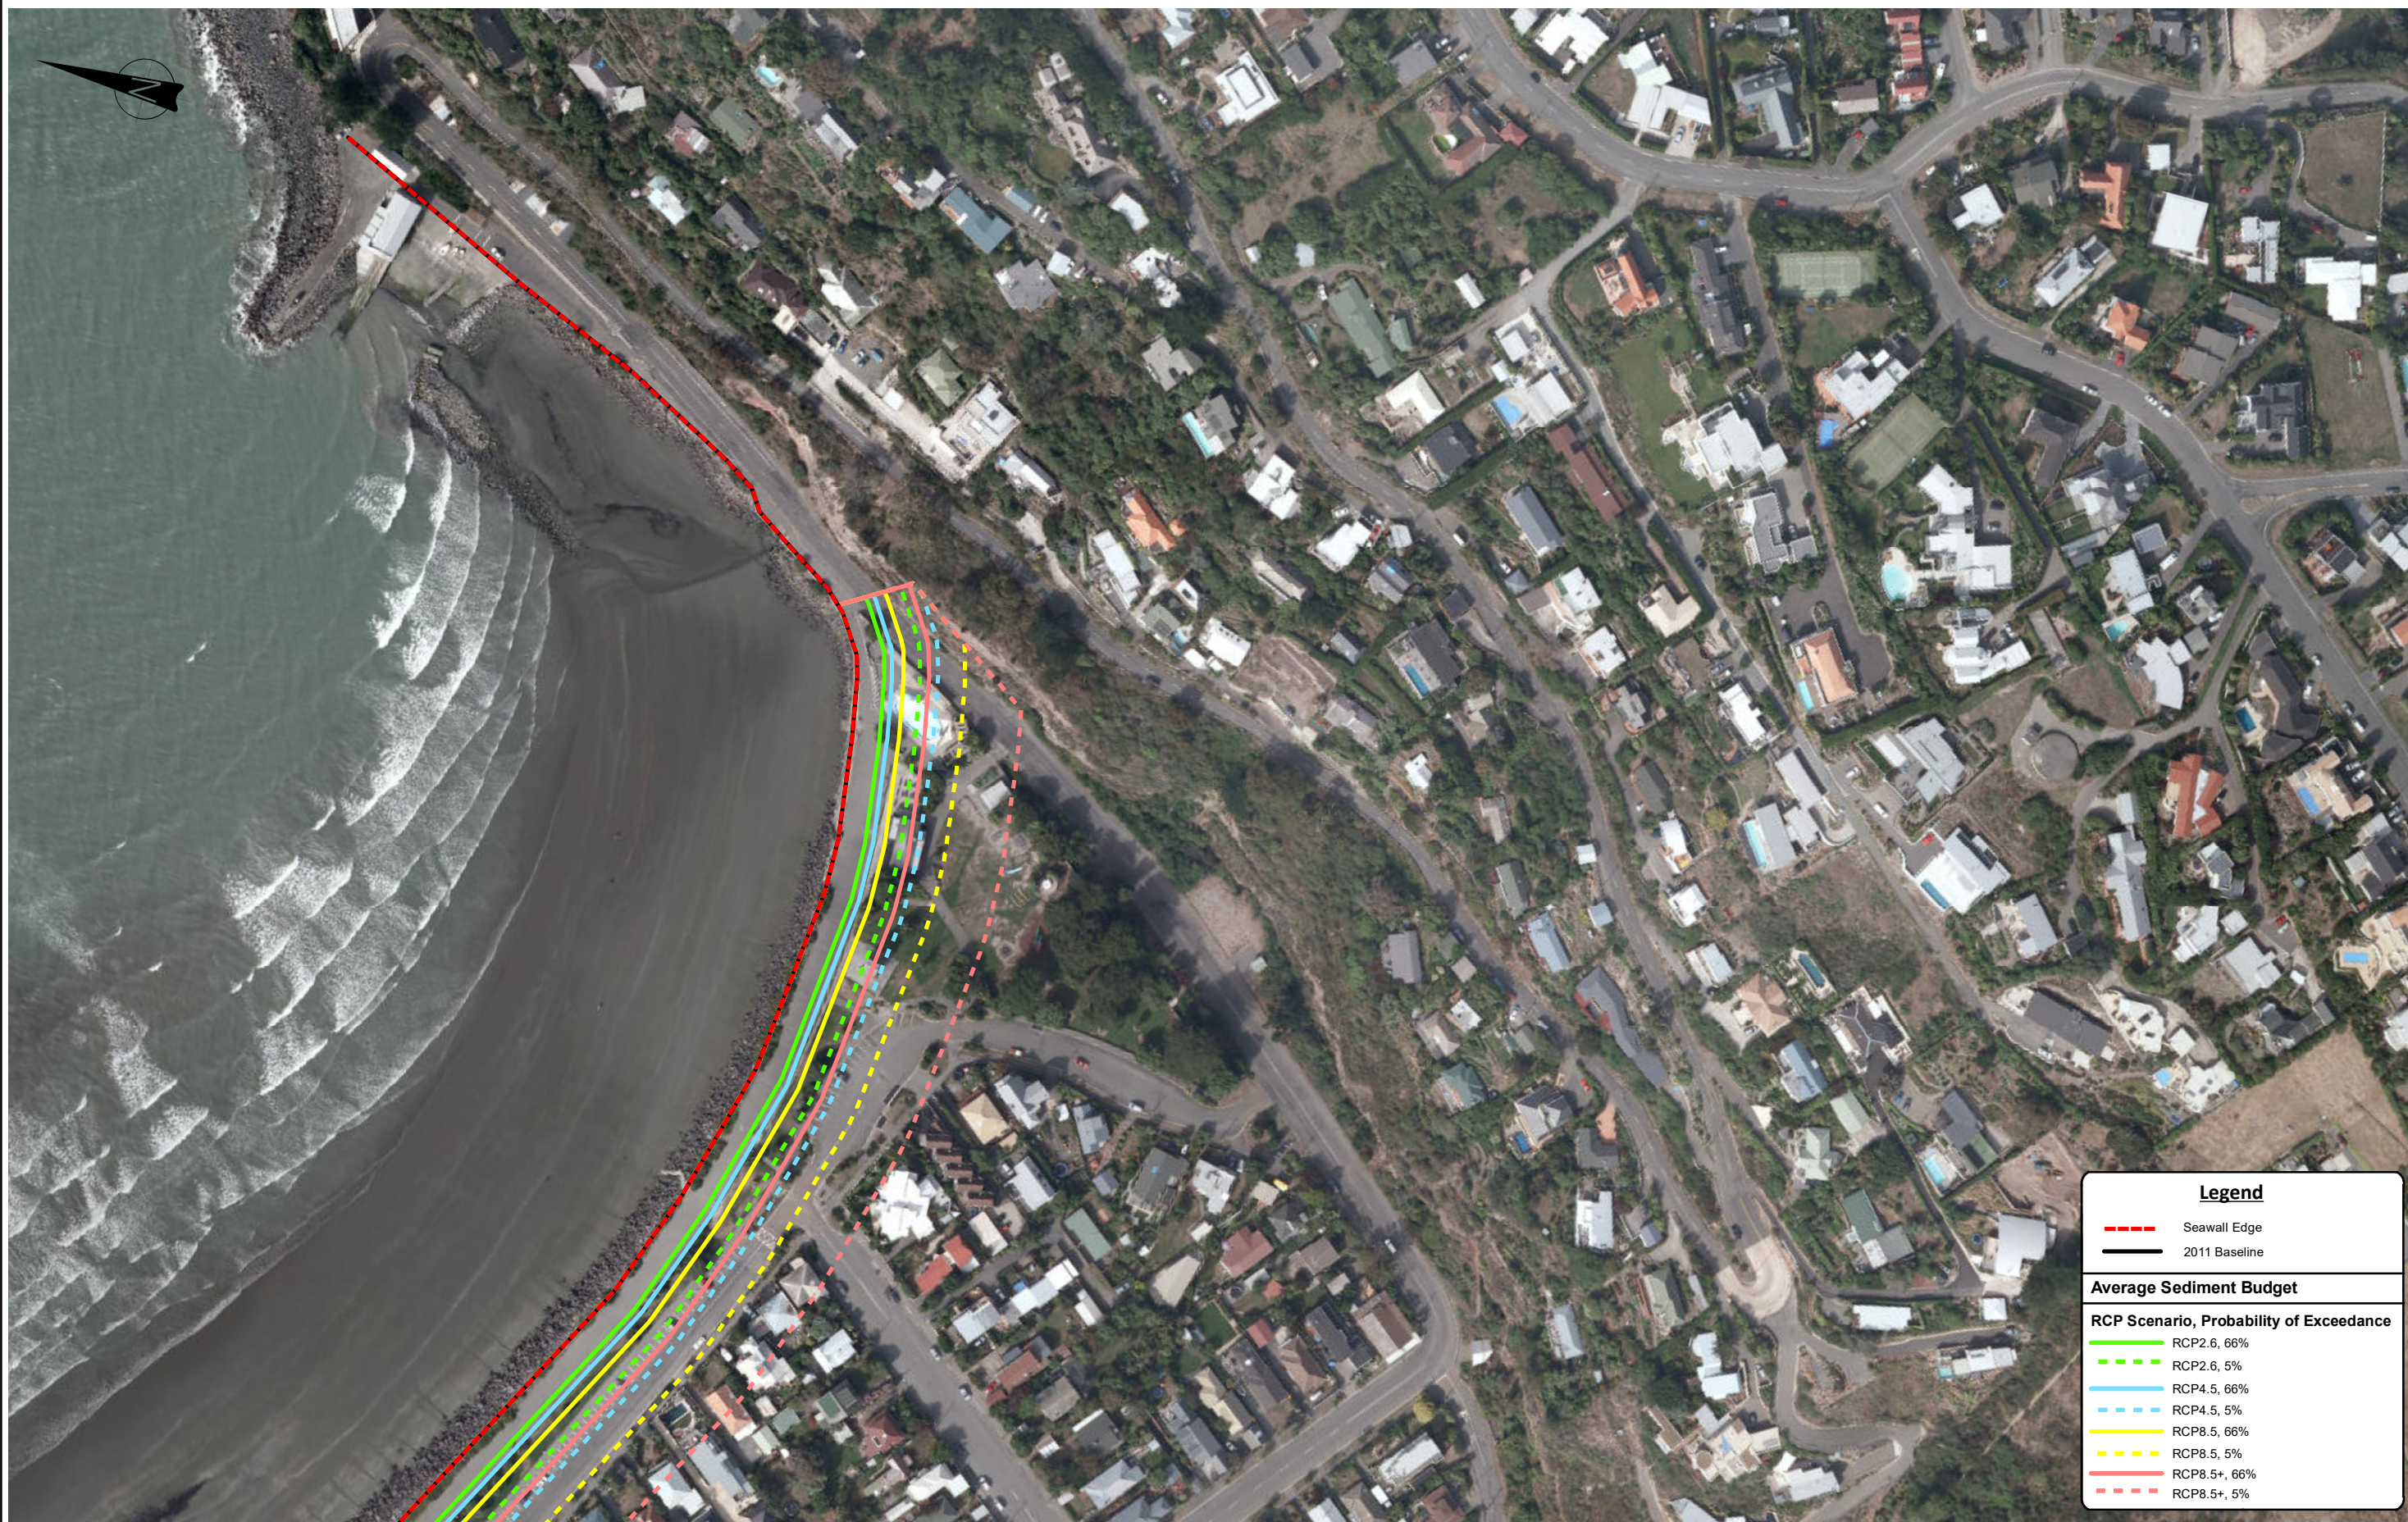
**CHRISTCHURCH CITY COUNCIL**  
**COASTAL HAZARD ASSESSMENT**  
Open Coast (Sumner) - 2065  
Erosion Hazard Zones

The CEHZs have been assessed by splitting up the shoreline in behaviour cells with the end/boundary of a coastal behaviour cell indicated with a shoreline-perpendicular CEHZ line. The CEHZs are only mapped for the study area (refer to report).  
Refer to note on map limitations on the front page of Appendix H.
