## Appendix H: CEHZ result maps

CHRISTCHURCH CITY COUNCIL		
COASTAL HAZARD ASSESSMENT		
Open Coast - 2065		
Erosion Hazard Zones		
FIGURE No.	Figure H - 1(a)	Rev. 0

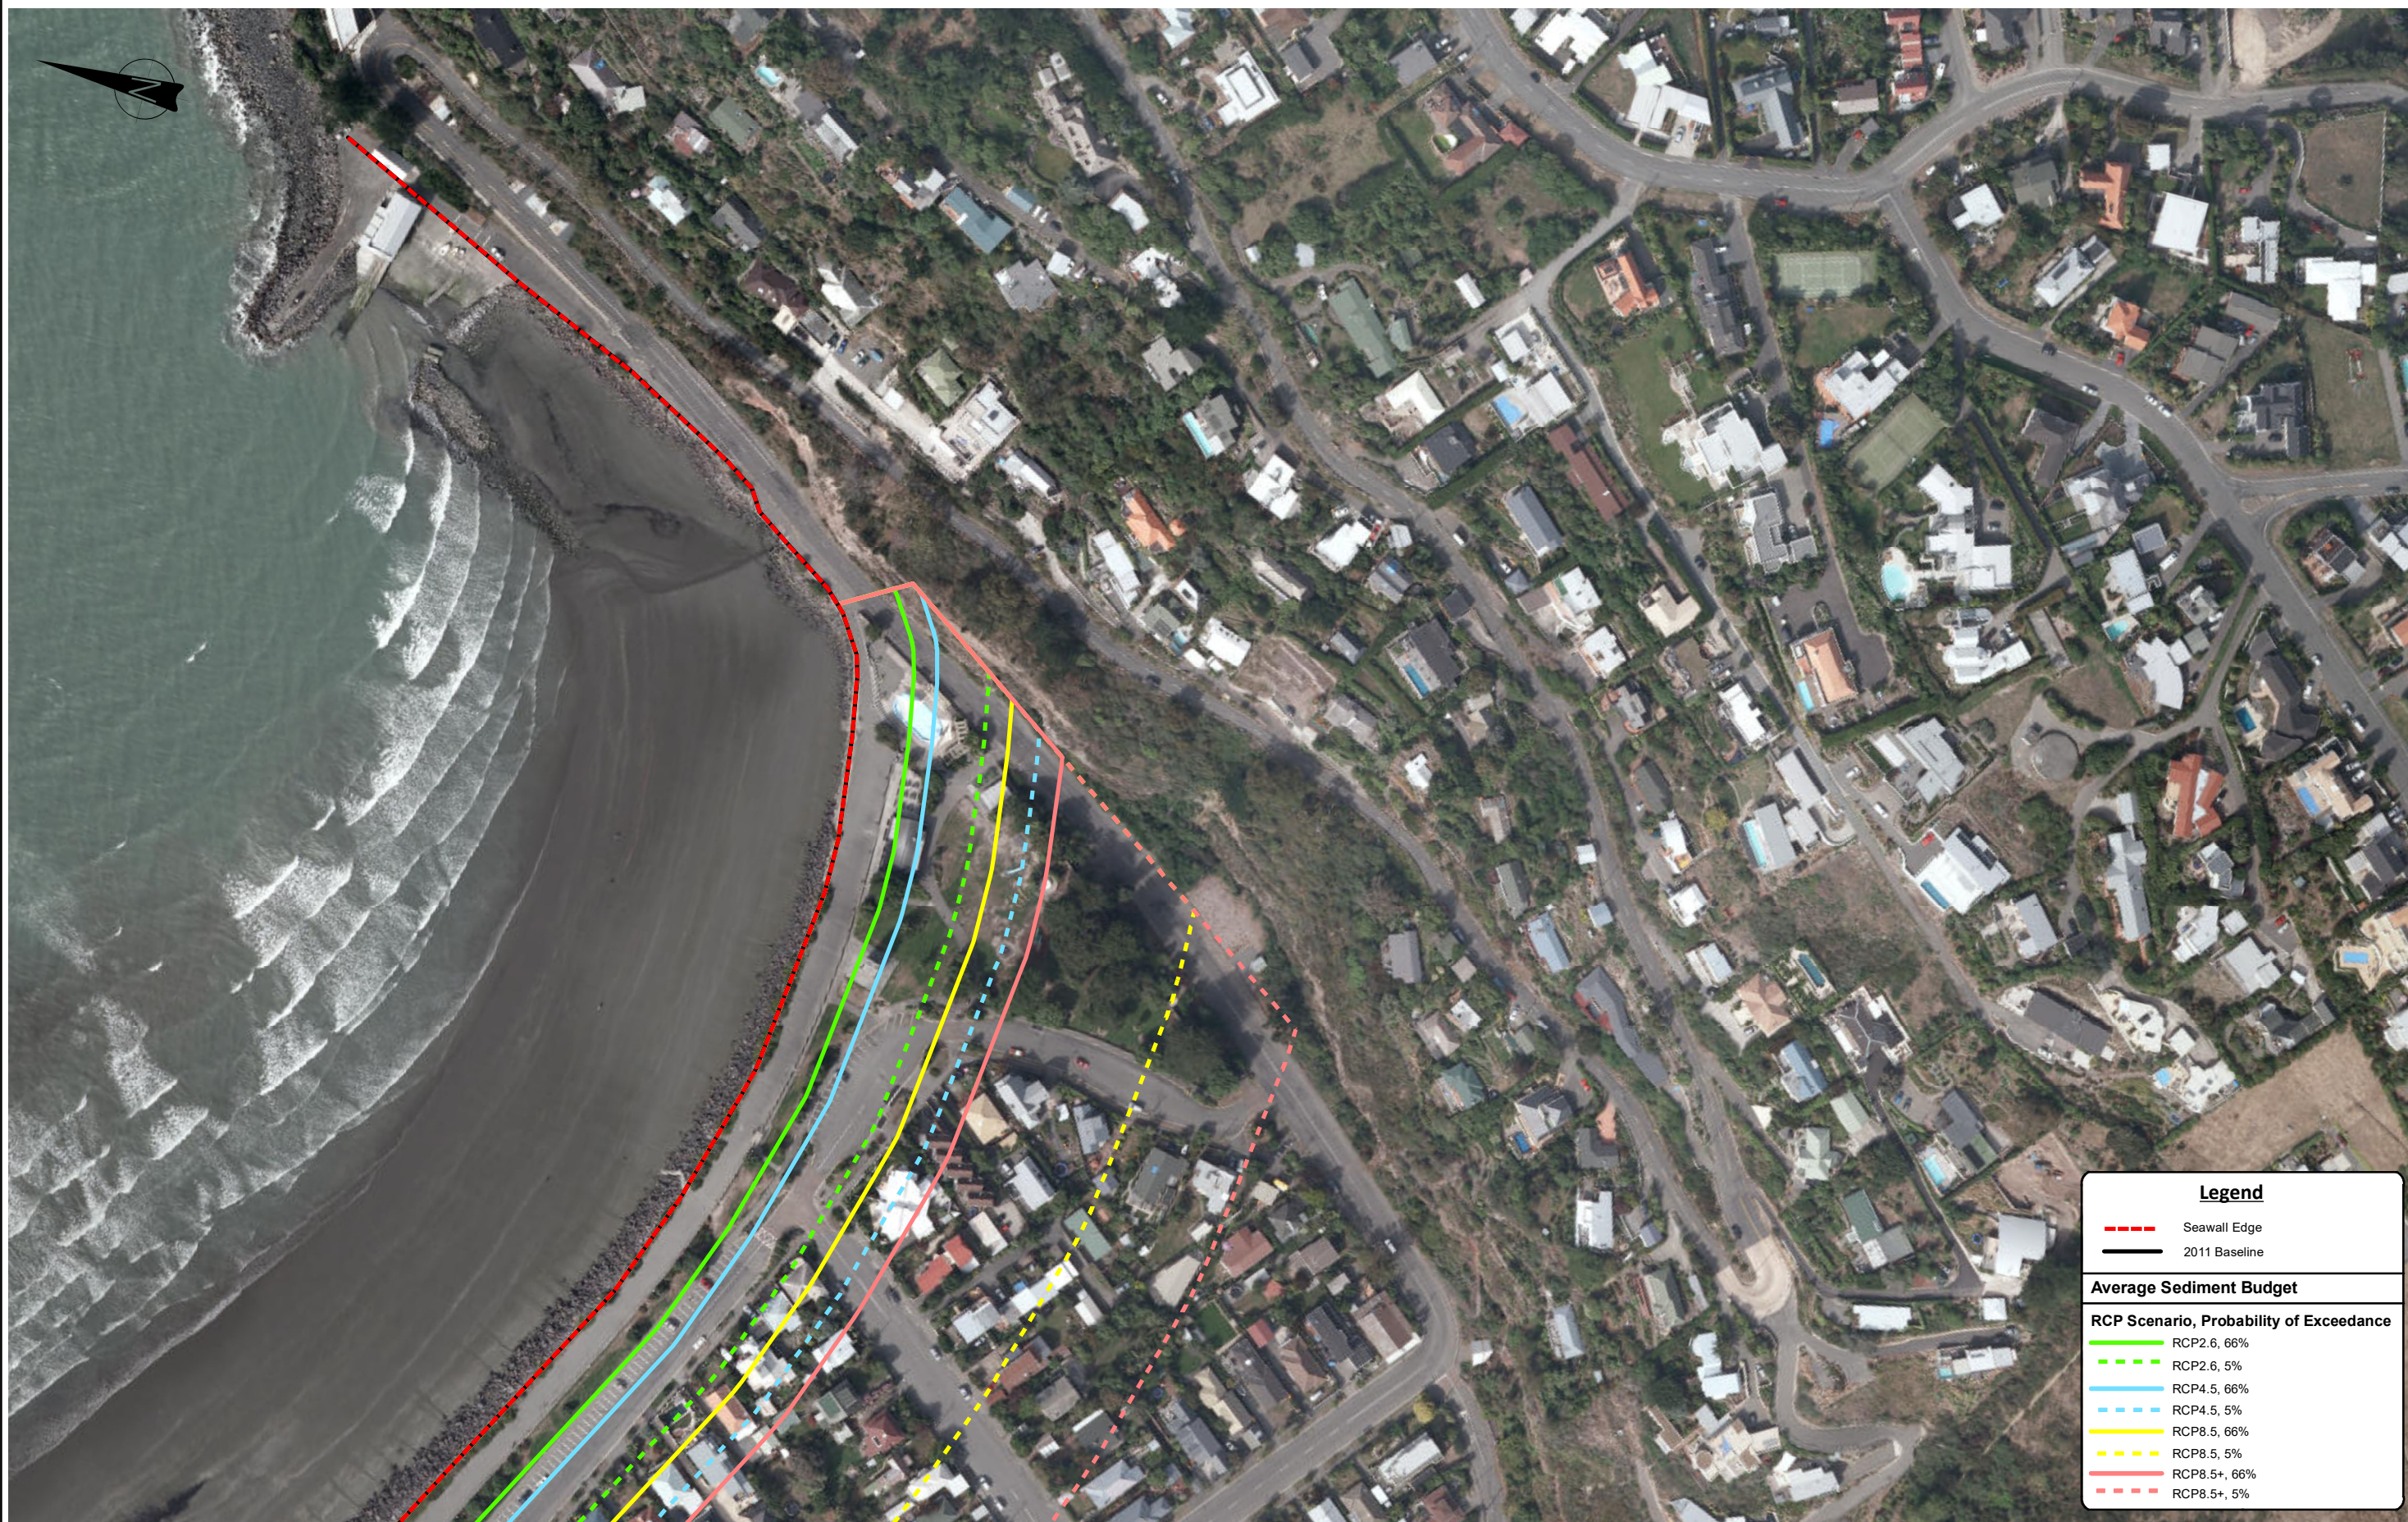
**CHRISTCHURCH CITY COUNCIL**  
**COASTAL HAZARD ASSESSMENT**  
Open Coast (Sumner) - 2120  
Erosion Hazard Zones

The CEHZs have been assessed by splitting up the shoreline in behaviour cells with the end/boundary of a coastal behaviour cell indicated with a shoreline-perpendicular CEHZ line. The CEHZs are only mapped for the study area (refer to report).  
Refer to note on map limitations on the front page of Appendix H.

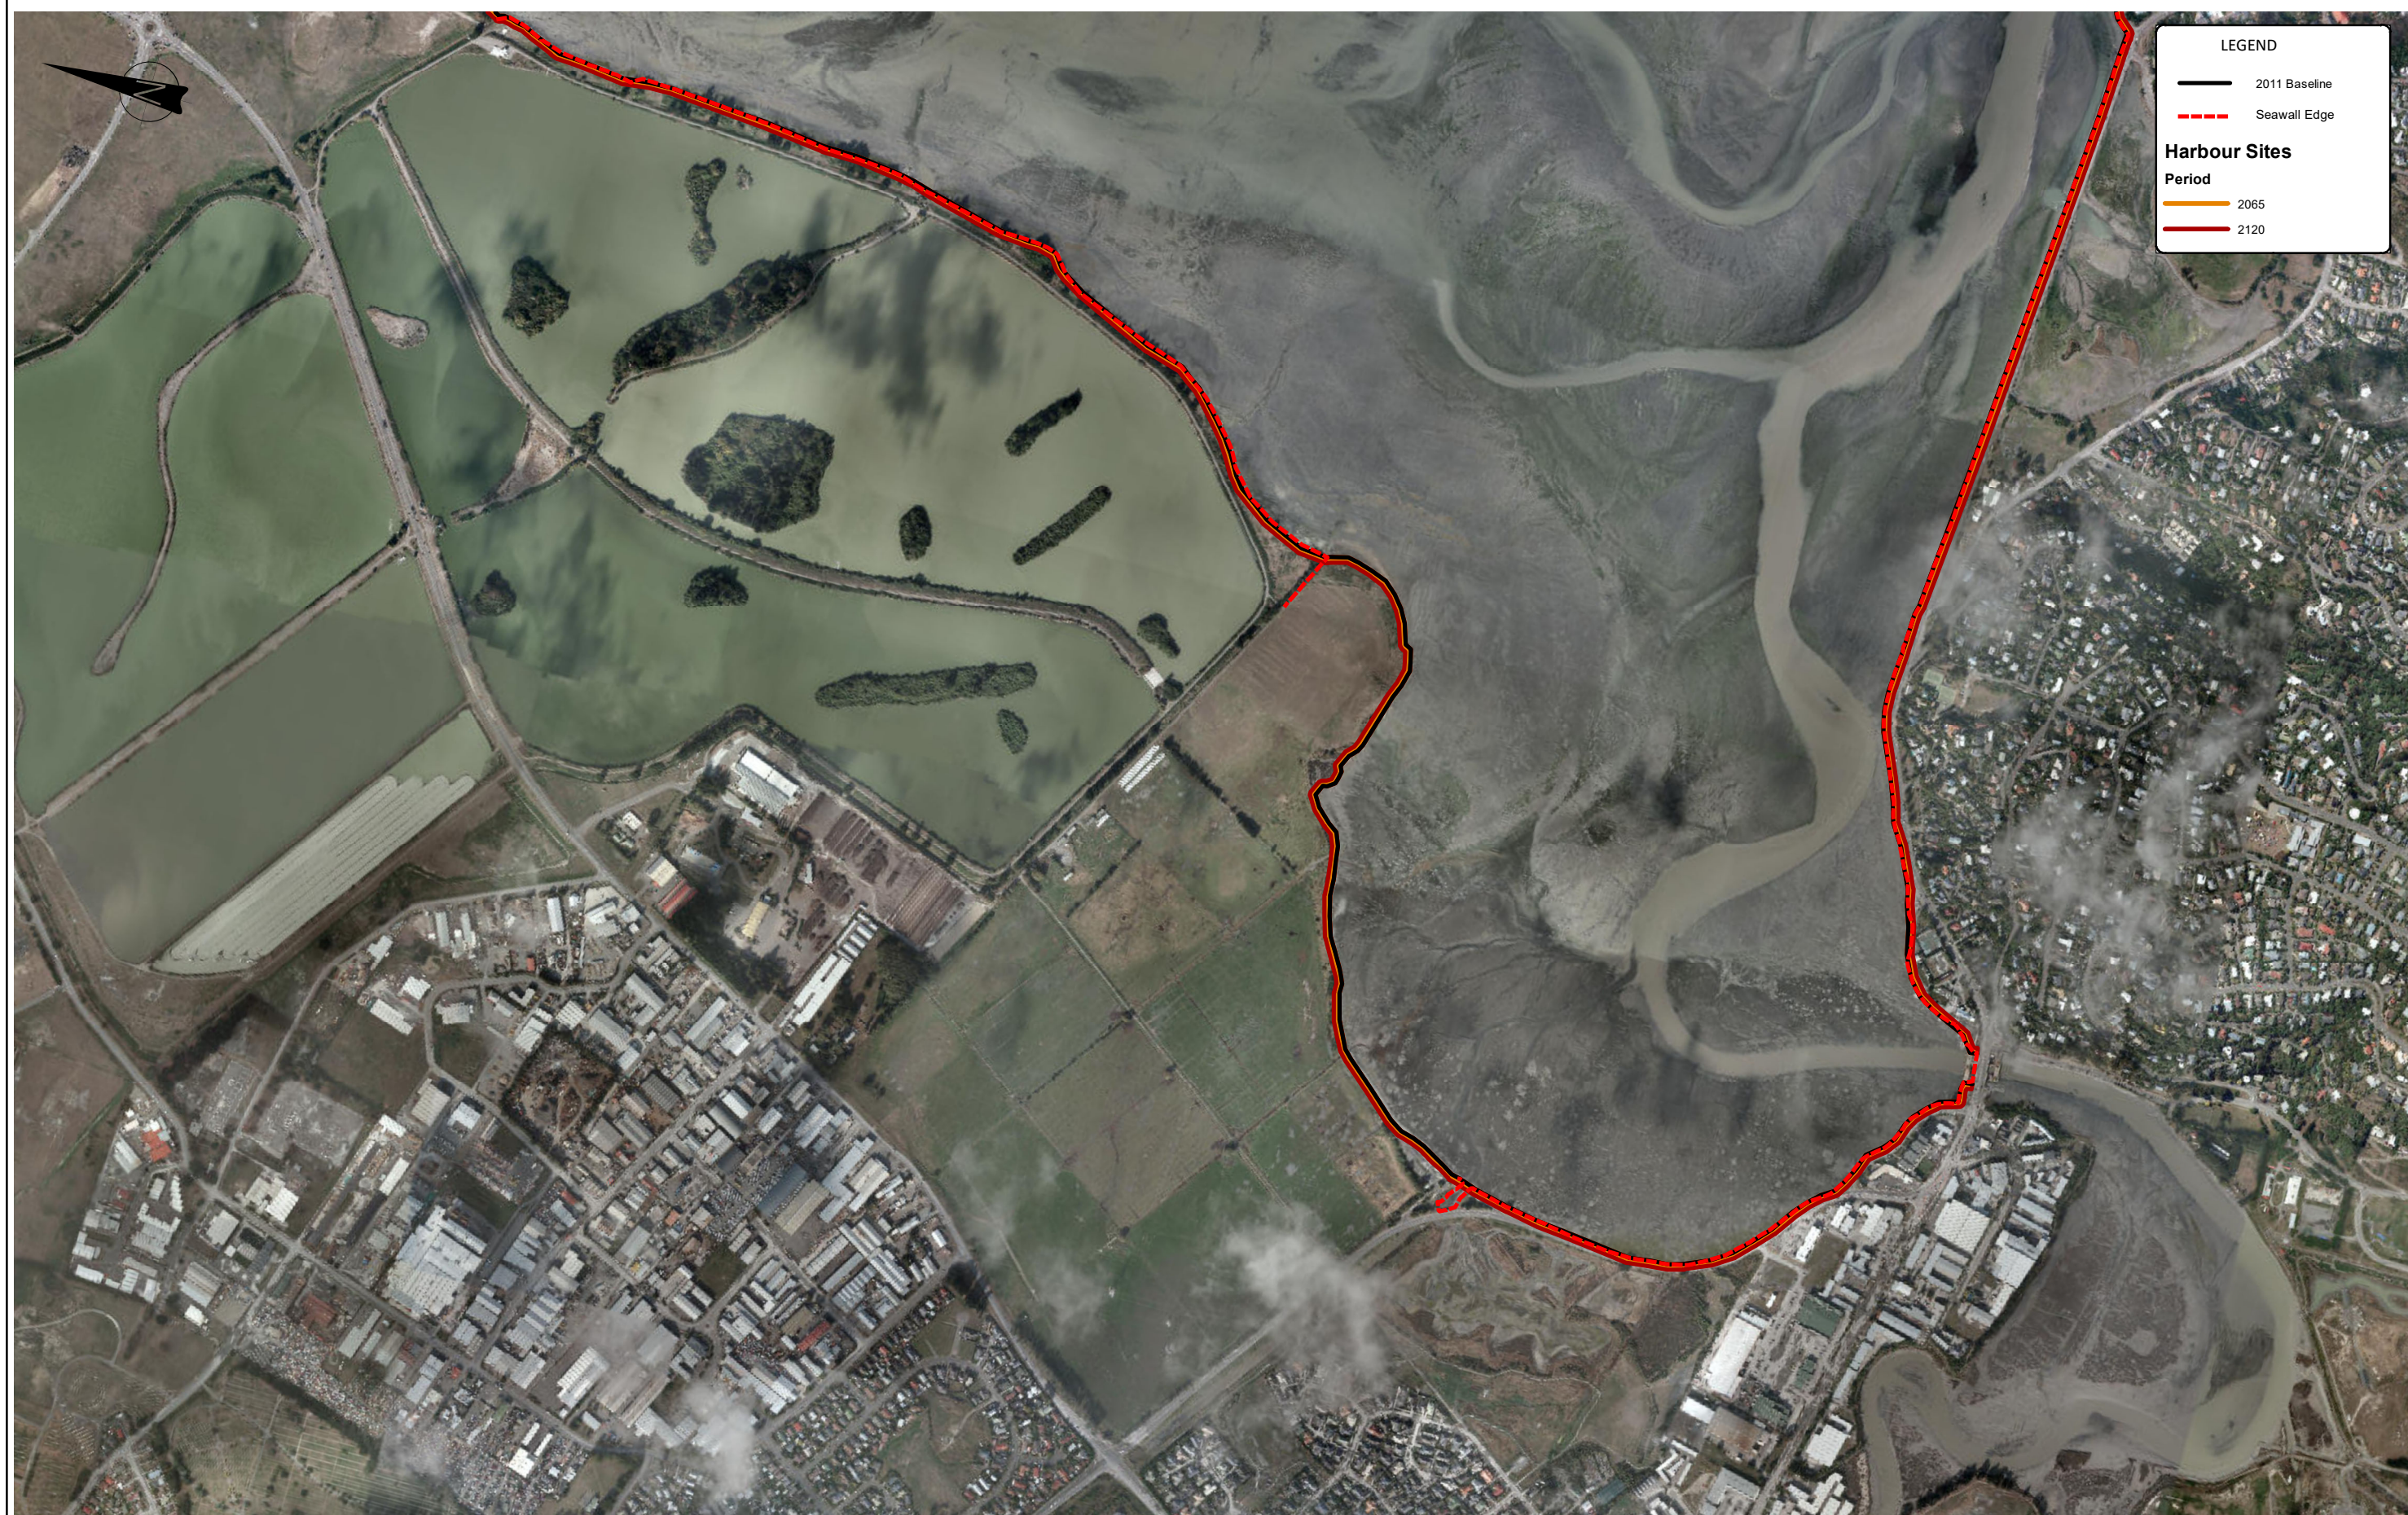
**CHRISTCHURCH CITY COUNCIL**  
**COASTAL HAZARD ASSESSMENT**  
Avon-Heathcote Section 2  
Erosion Hazard Zones

The CEHZs have been assessed by splitting up the shoreline in behaviour cells with the end/boundary of a coastal behaviour cell indicated with a shoreline-perpendicular CEHZ line. The CEHZs are only mapped for the study area (refer to report).  
Refer to note on map limitations on the front page of Appendix H.

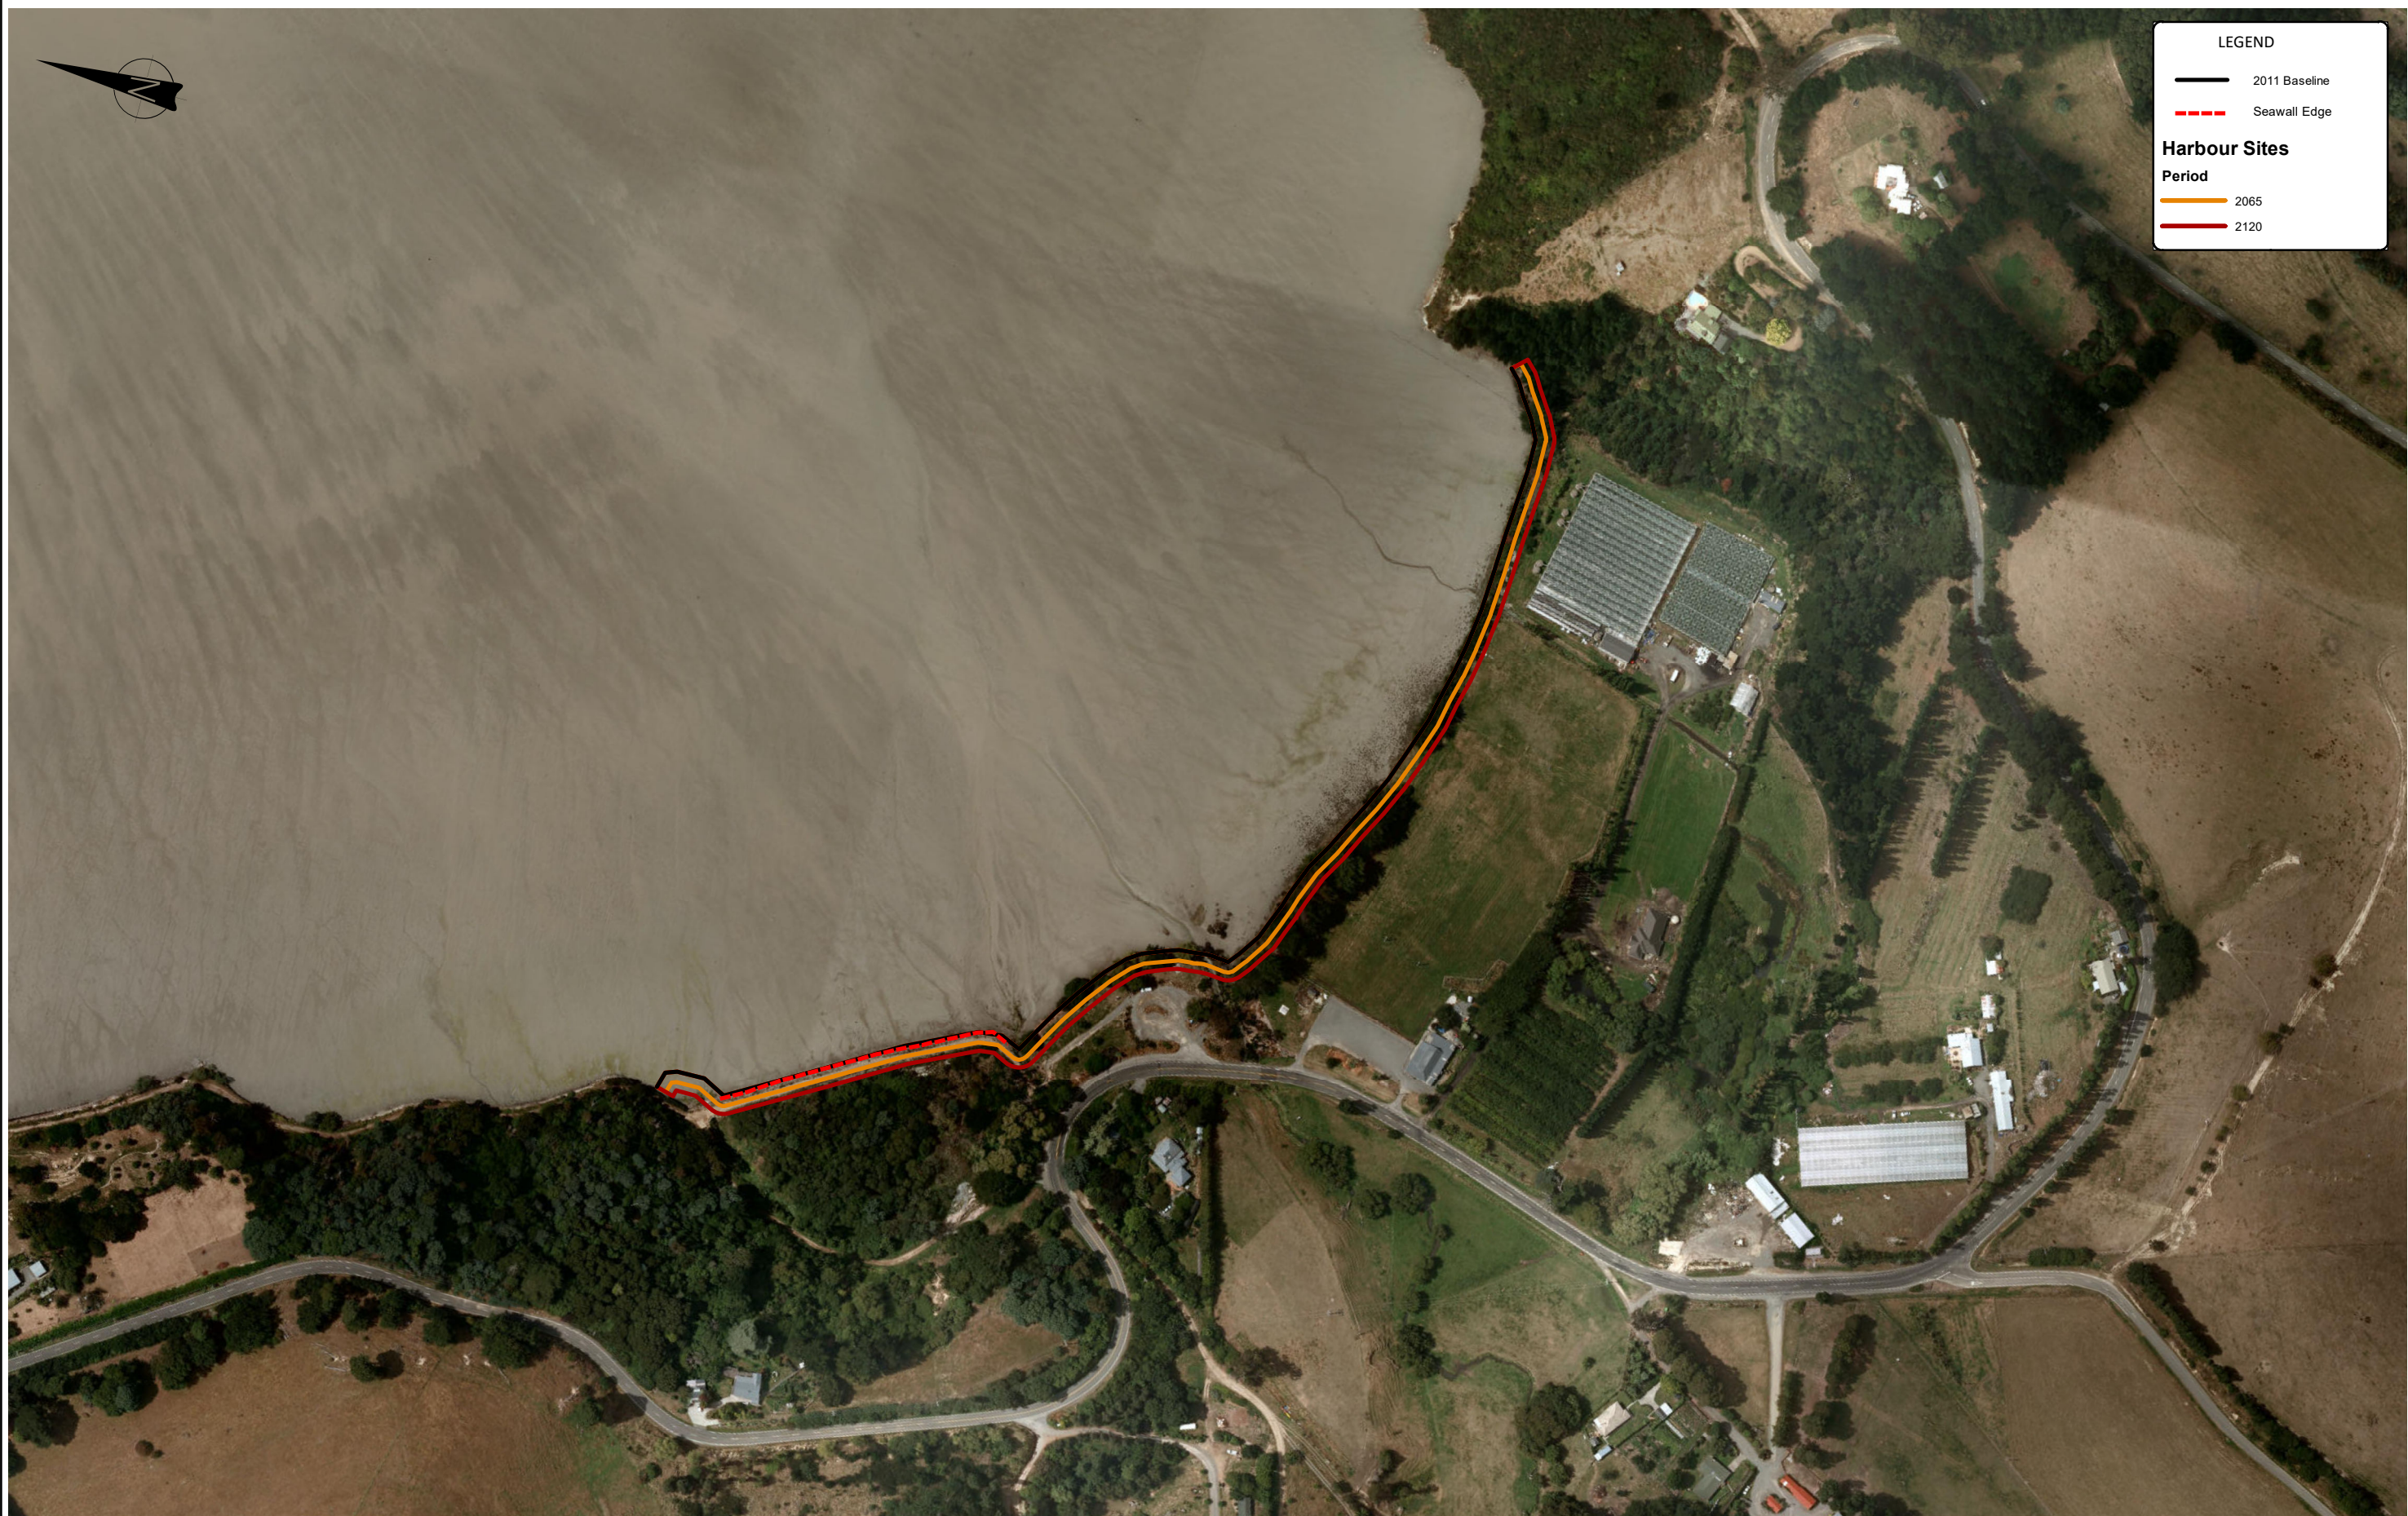
**CHRISTCHURCH CITY COUNCIL**  
**COASTAL HAZARD ASSESSMENT**  
Alandale  
Erosion Hazard Zones

The CEHZs have been assessed by splitting up the shoreline in behaviour cells with the end/boundary of a coastal behaviour cell indicated with a shoreline-perpendicular CEHZ line. The CEHZs are only mapped for the study area (refer to report).  
Refer to note on map limitations on the front page of Appendix H.

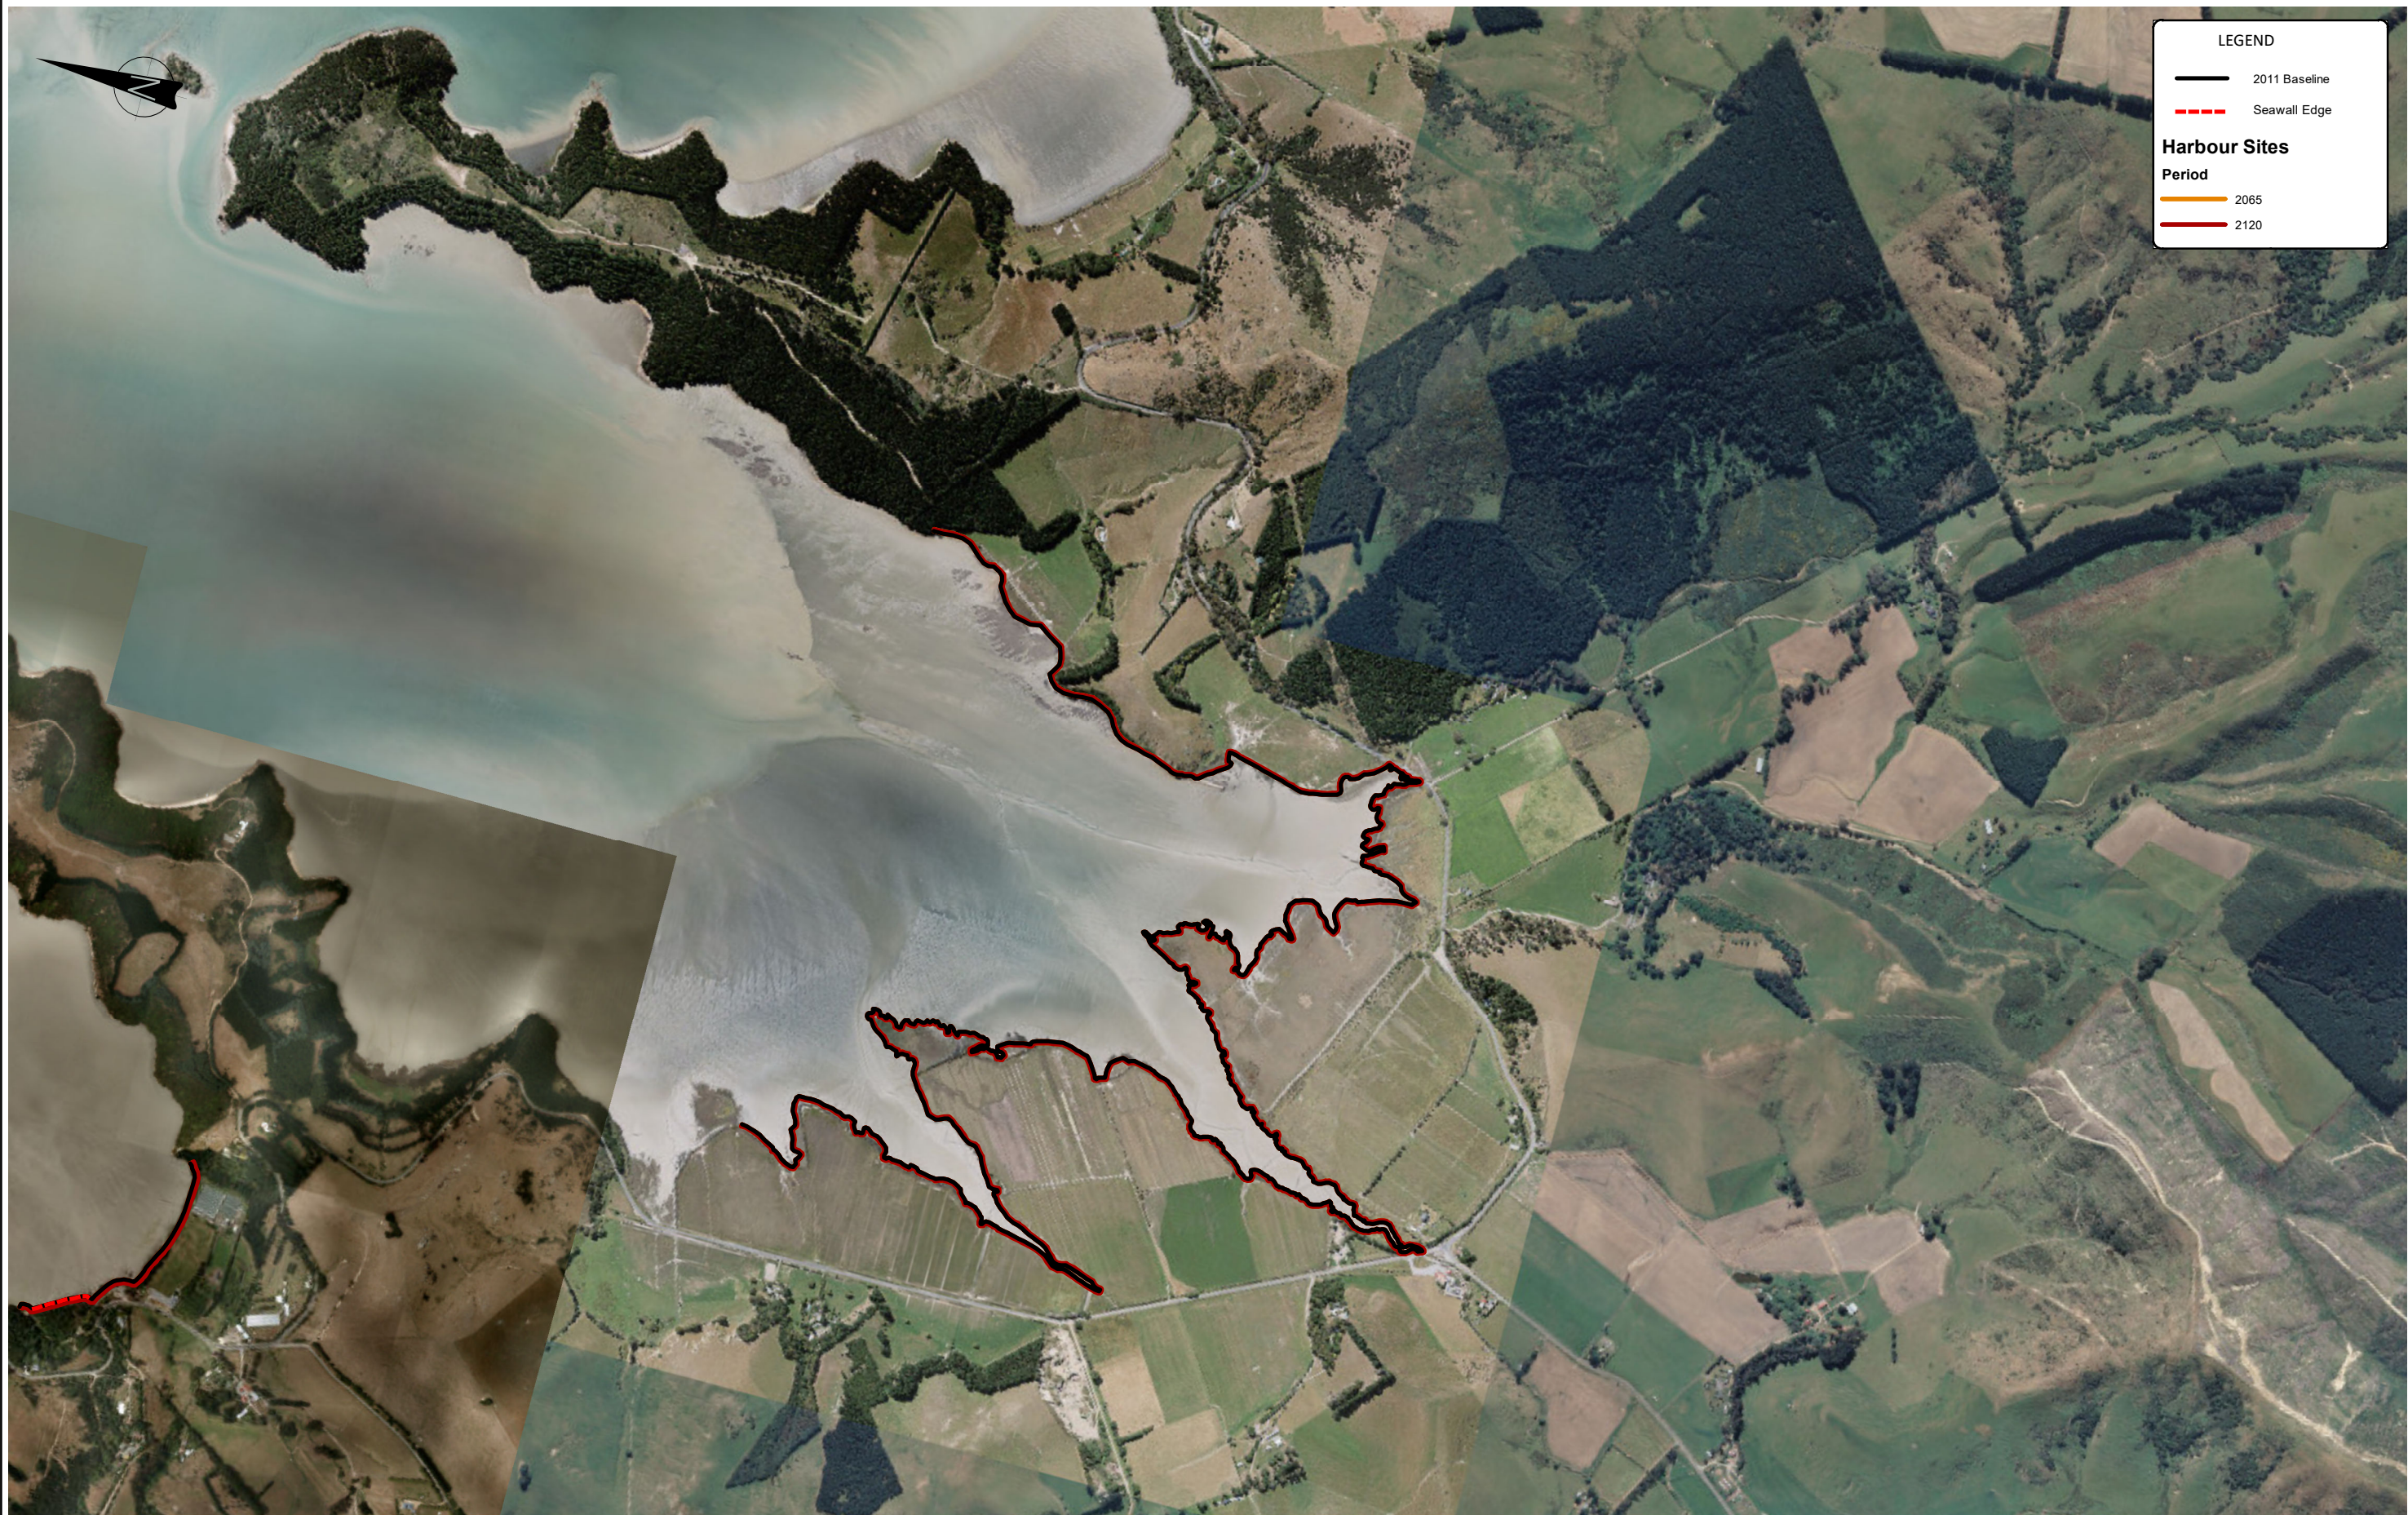
**CHRISTCHURCH CITY COUNCIL**  
**COASTAL HAZARD ASSESSMENT**  
Teddington  
Erosion Hazard Zones

The CEHZs have been assessed by splitting up the shoreline in behaviour cells with the end/boundary of a coastal behaviour cell indicated with a shoreline-perpendicular CEHZ line. The CEHZs are only mapped for the study area (refer to report).  
Refer to note on map limitations on the front page of Appendix H.

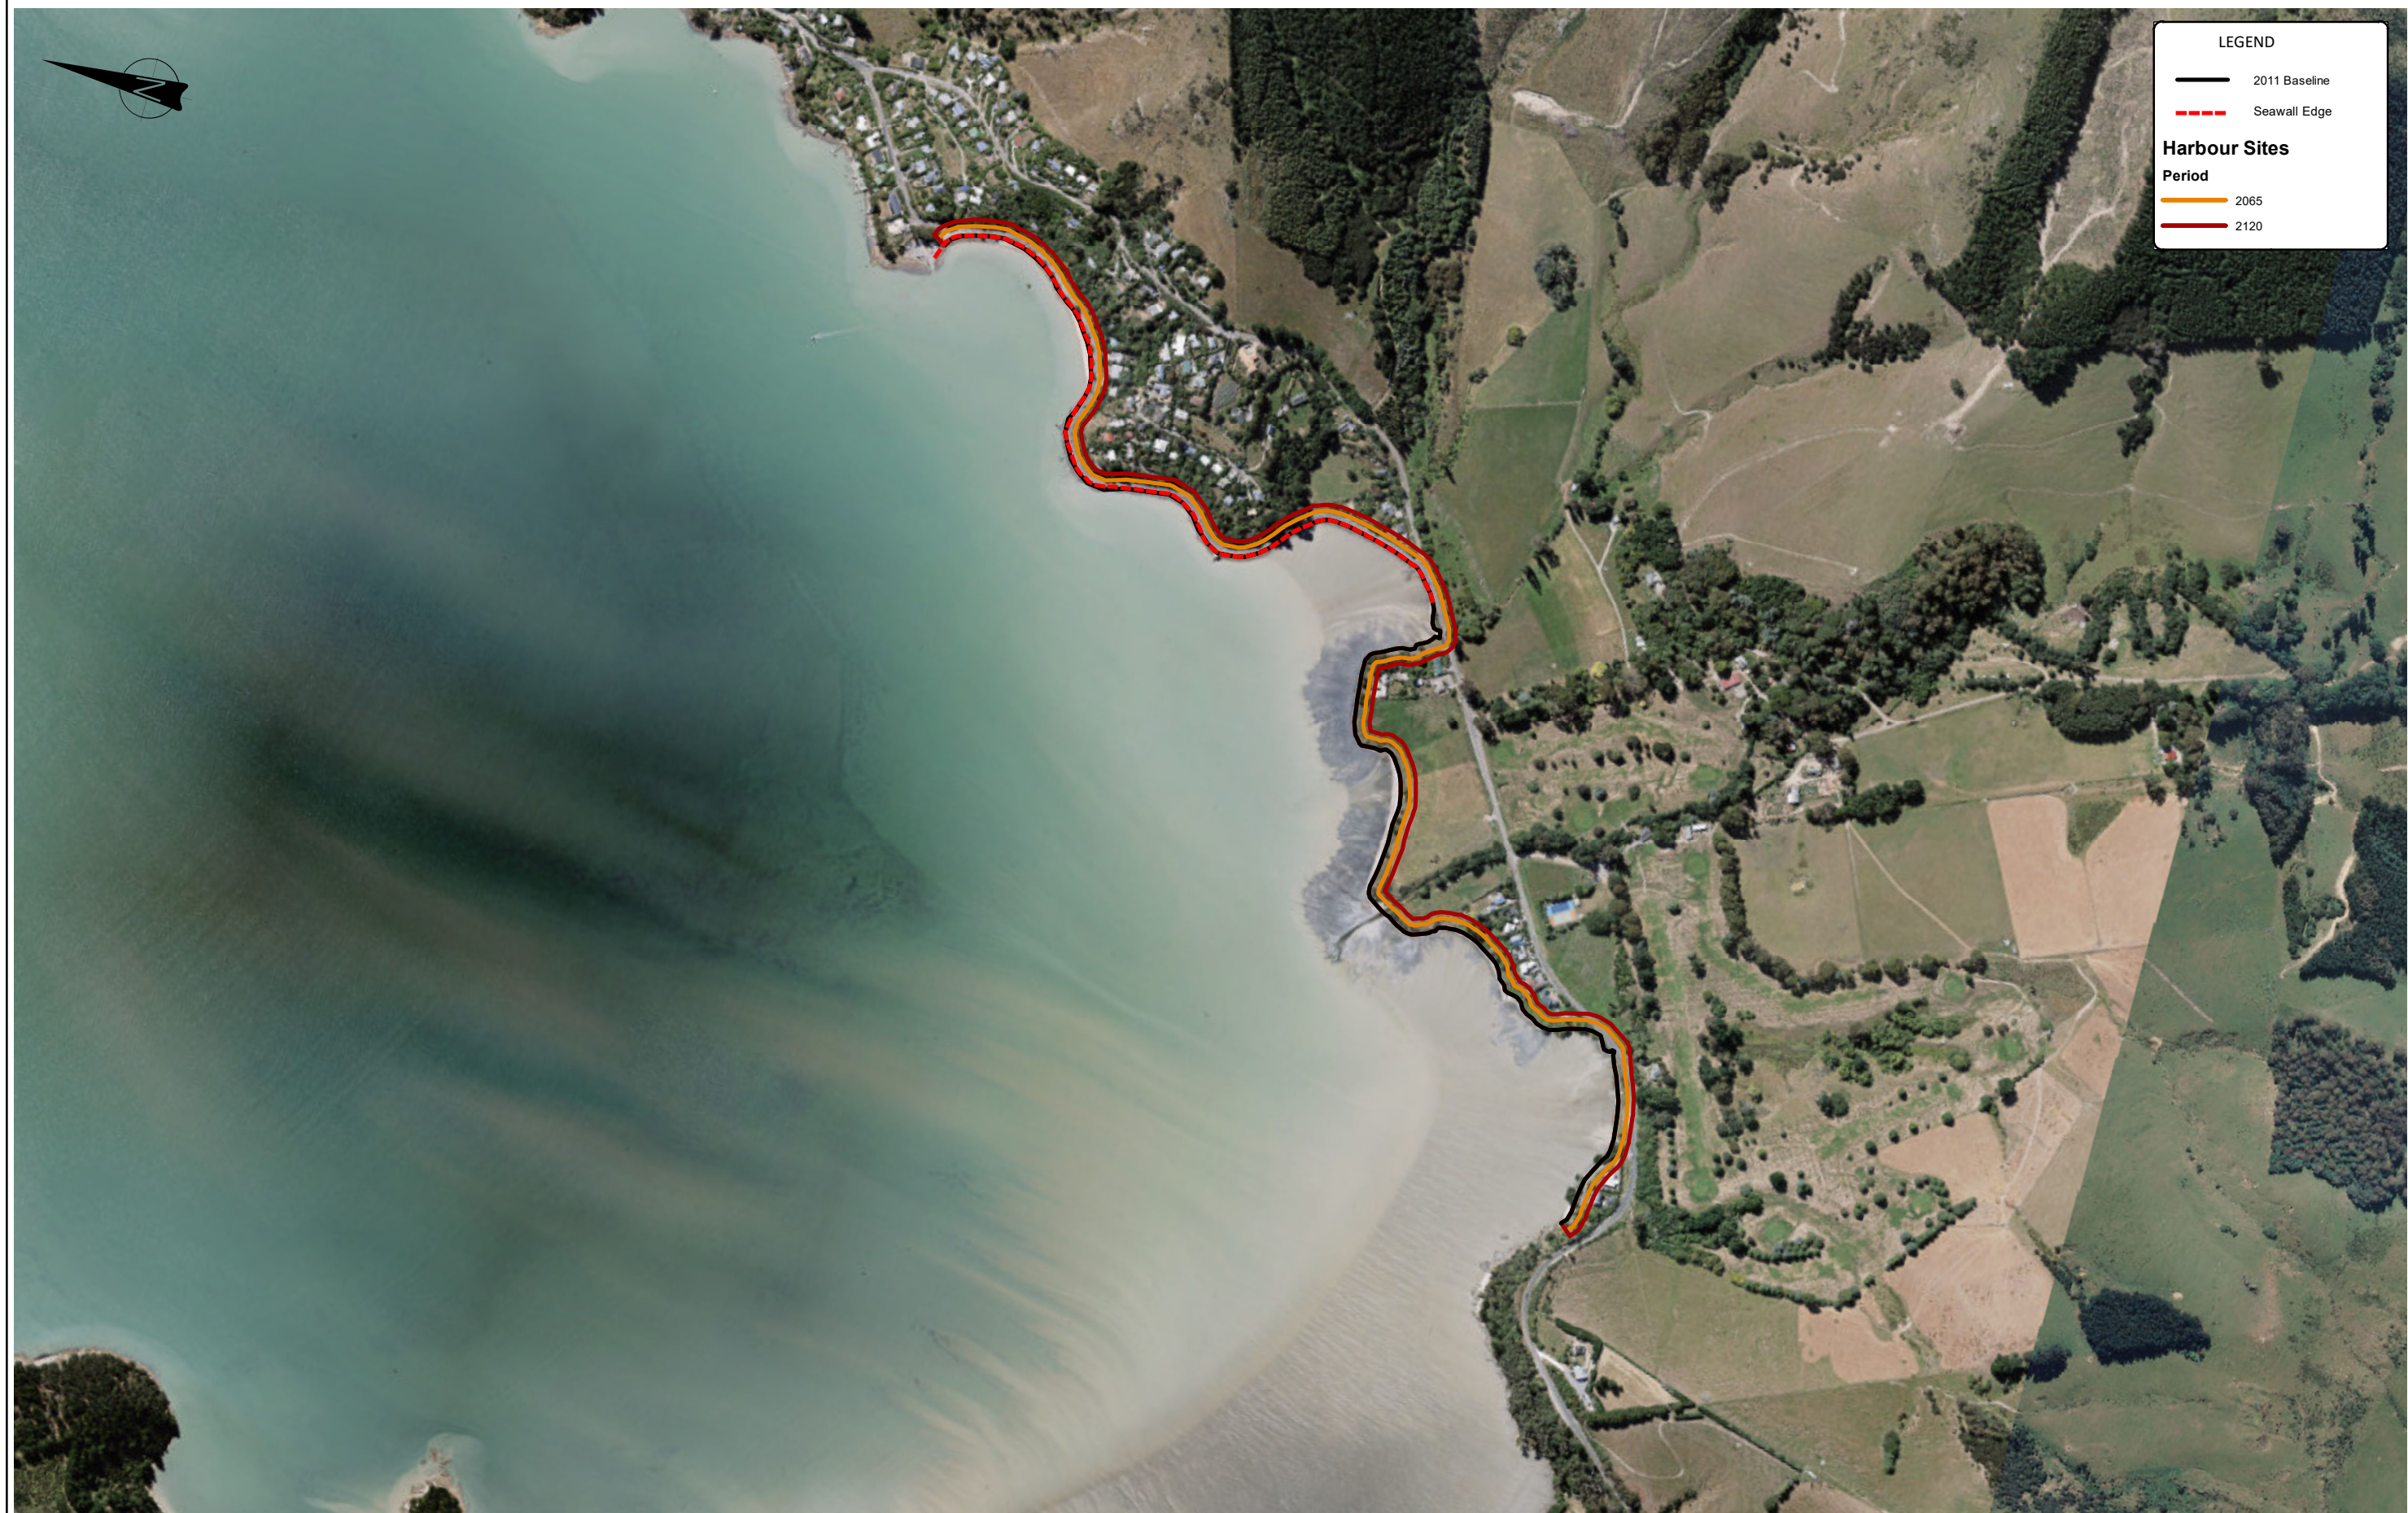
CHRISTCHURCH CITY COUNCIL COASTAL HAZARD ASSESSMENT Charteris Bay Erosion Hazard Zones		
FIGURE No.	Figure H -43	Rev. 0

The CEHZs have been assessed by splitting up the shoreline in behaviour cells with the end/boundary of a coastal behaviour cell indicated with a shoreline-perpendicular CEHZ line. The CEHZs are only mapped for the study area (refer to report).  
Refer to note on map limitations on the front page of Appendix H.

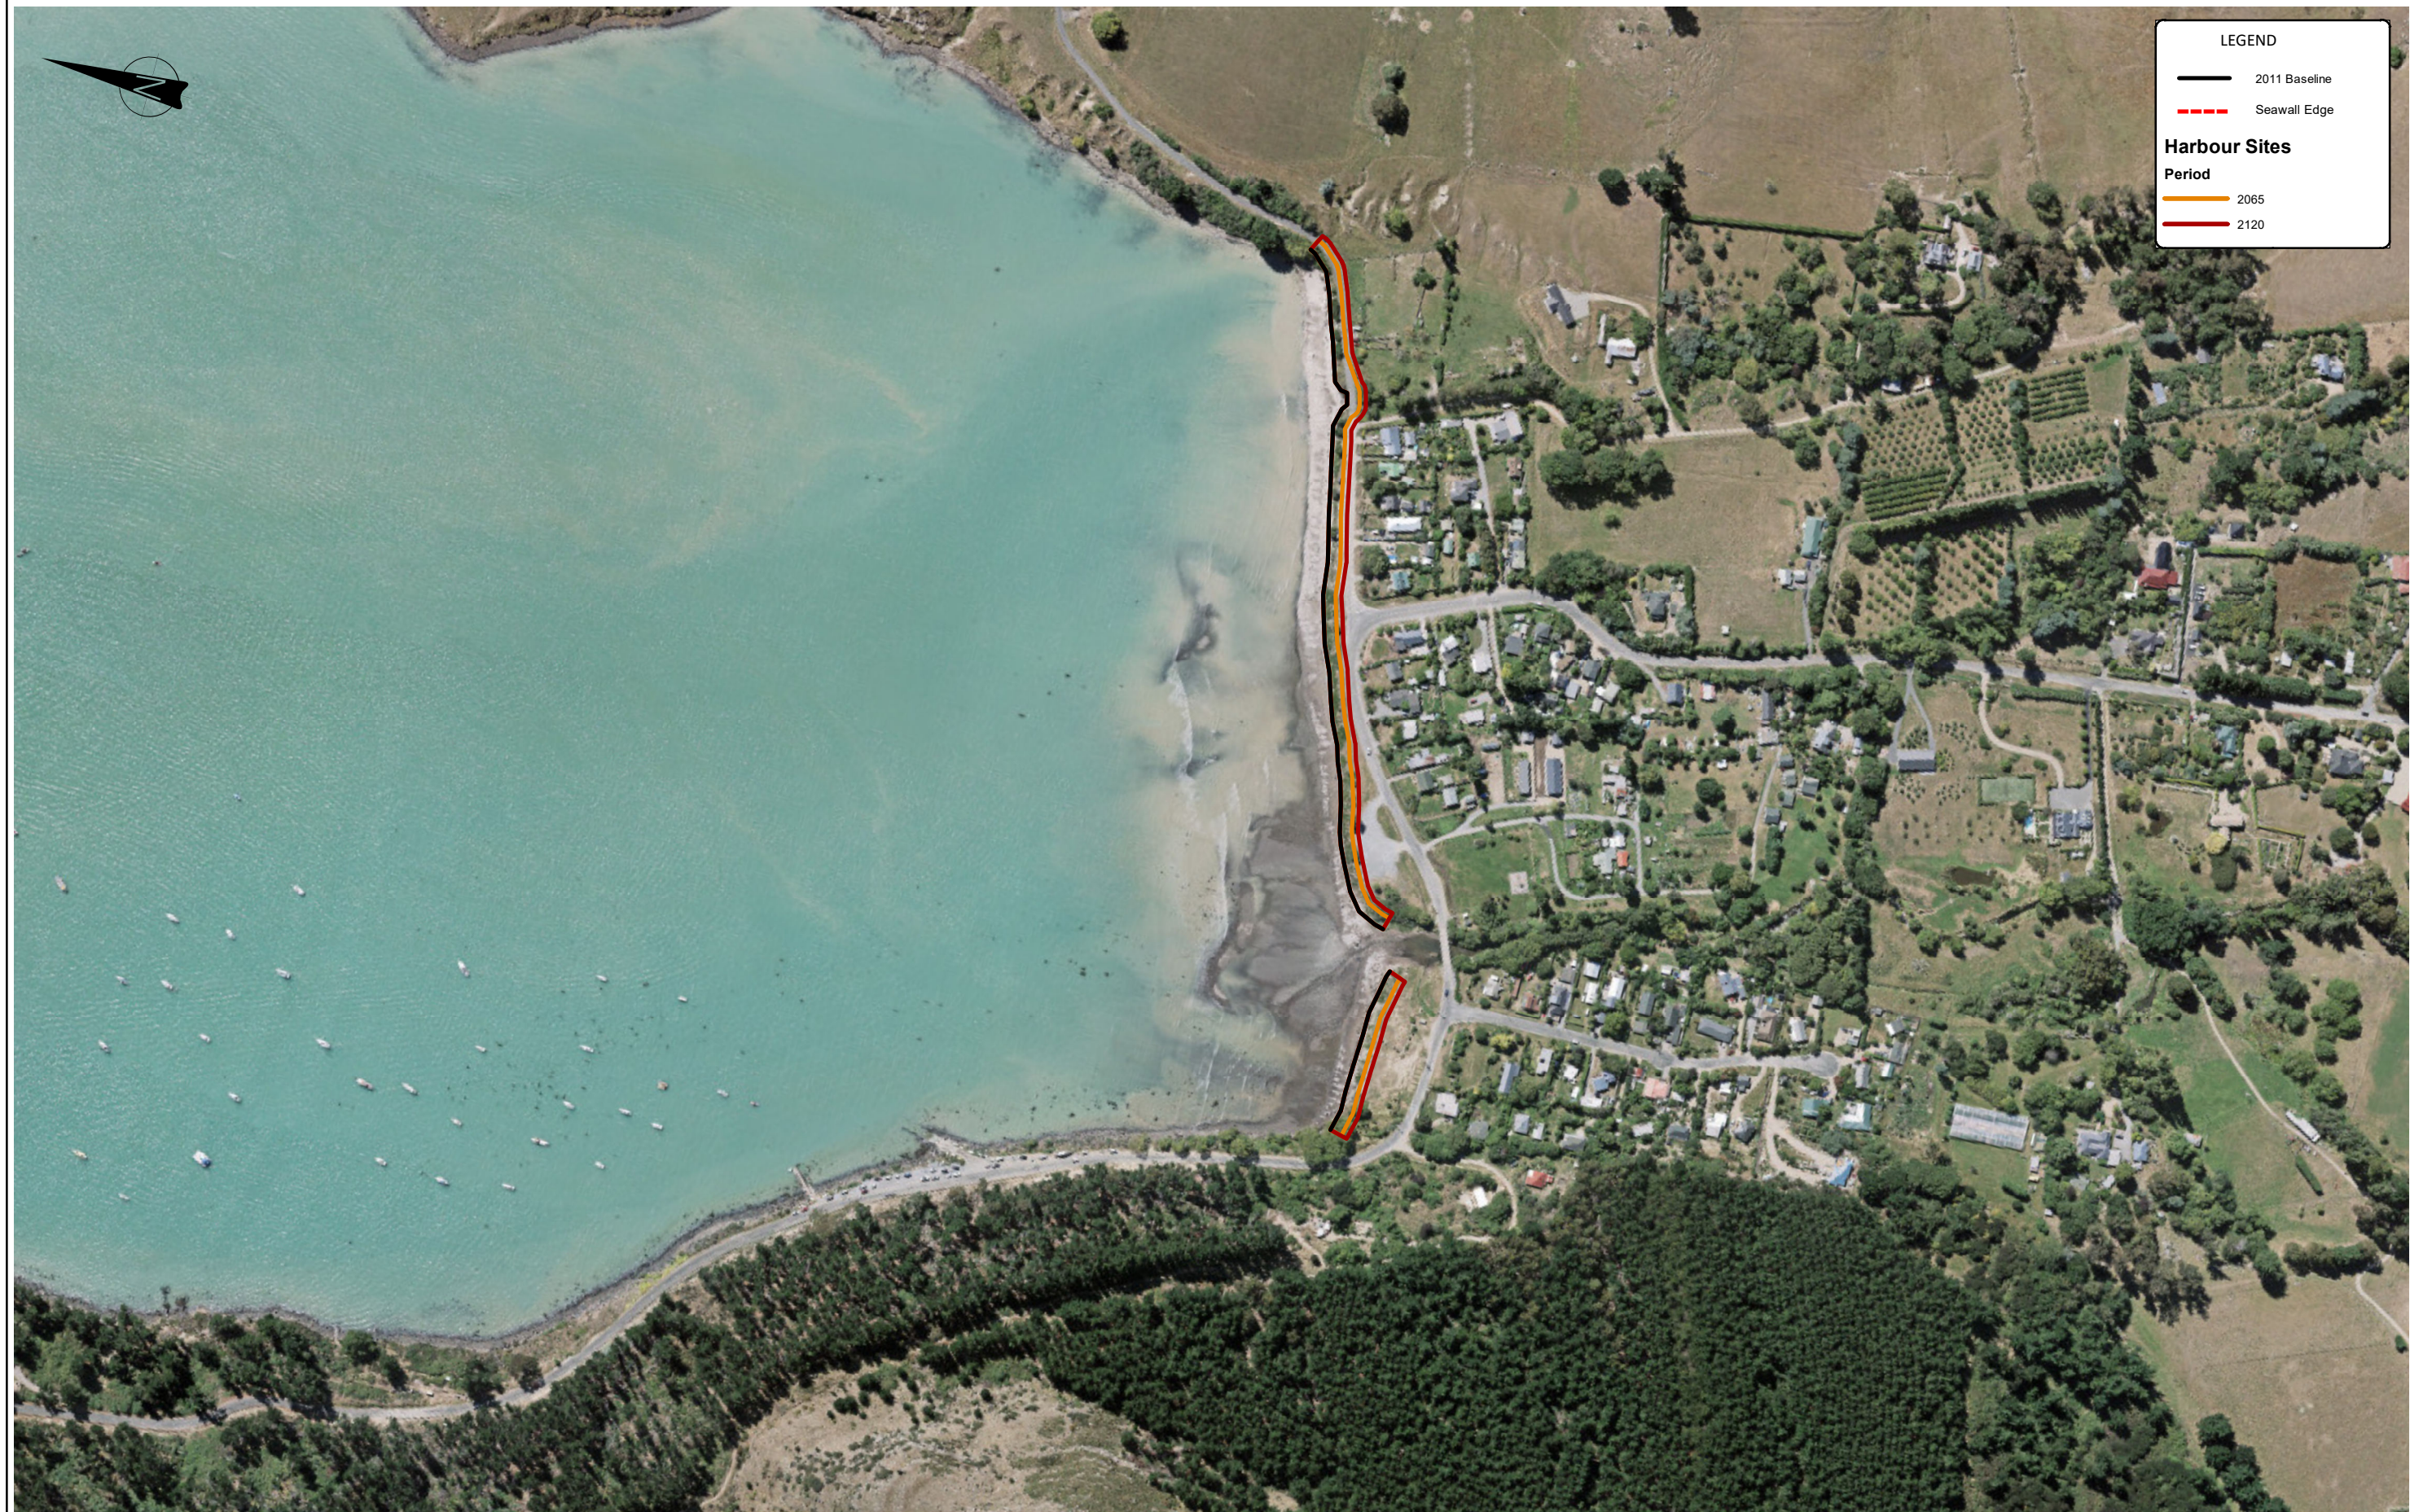
**CHRISTCHURCH CITY COUNCIL**  
**COASTAL HAZARD ASSESSMENT**  
Purau  
Erosion Hazard Zones

The CEHZs have been assessed by splitting up the shoreline in behaviour cells with the end/boundary of a coastal behaviour cell indicated with a shoreline-perpendicular CEHZ line. The CEHZs are only mapped for the study area (refer to report).  
Refer to note on map limitations on the front page of Appendix H.
