## Appendix H: CEHZ result maps

CHRISTCHURCH CITY COUNCIL		
COASTAL HAZARD ASSESSMENT		
Open Coast - 2065		
Erosion Hazard Zones		
FIGURE No.	Figure H - 1(a)	Rev. 0

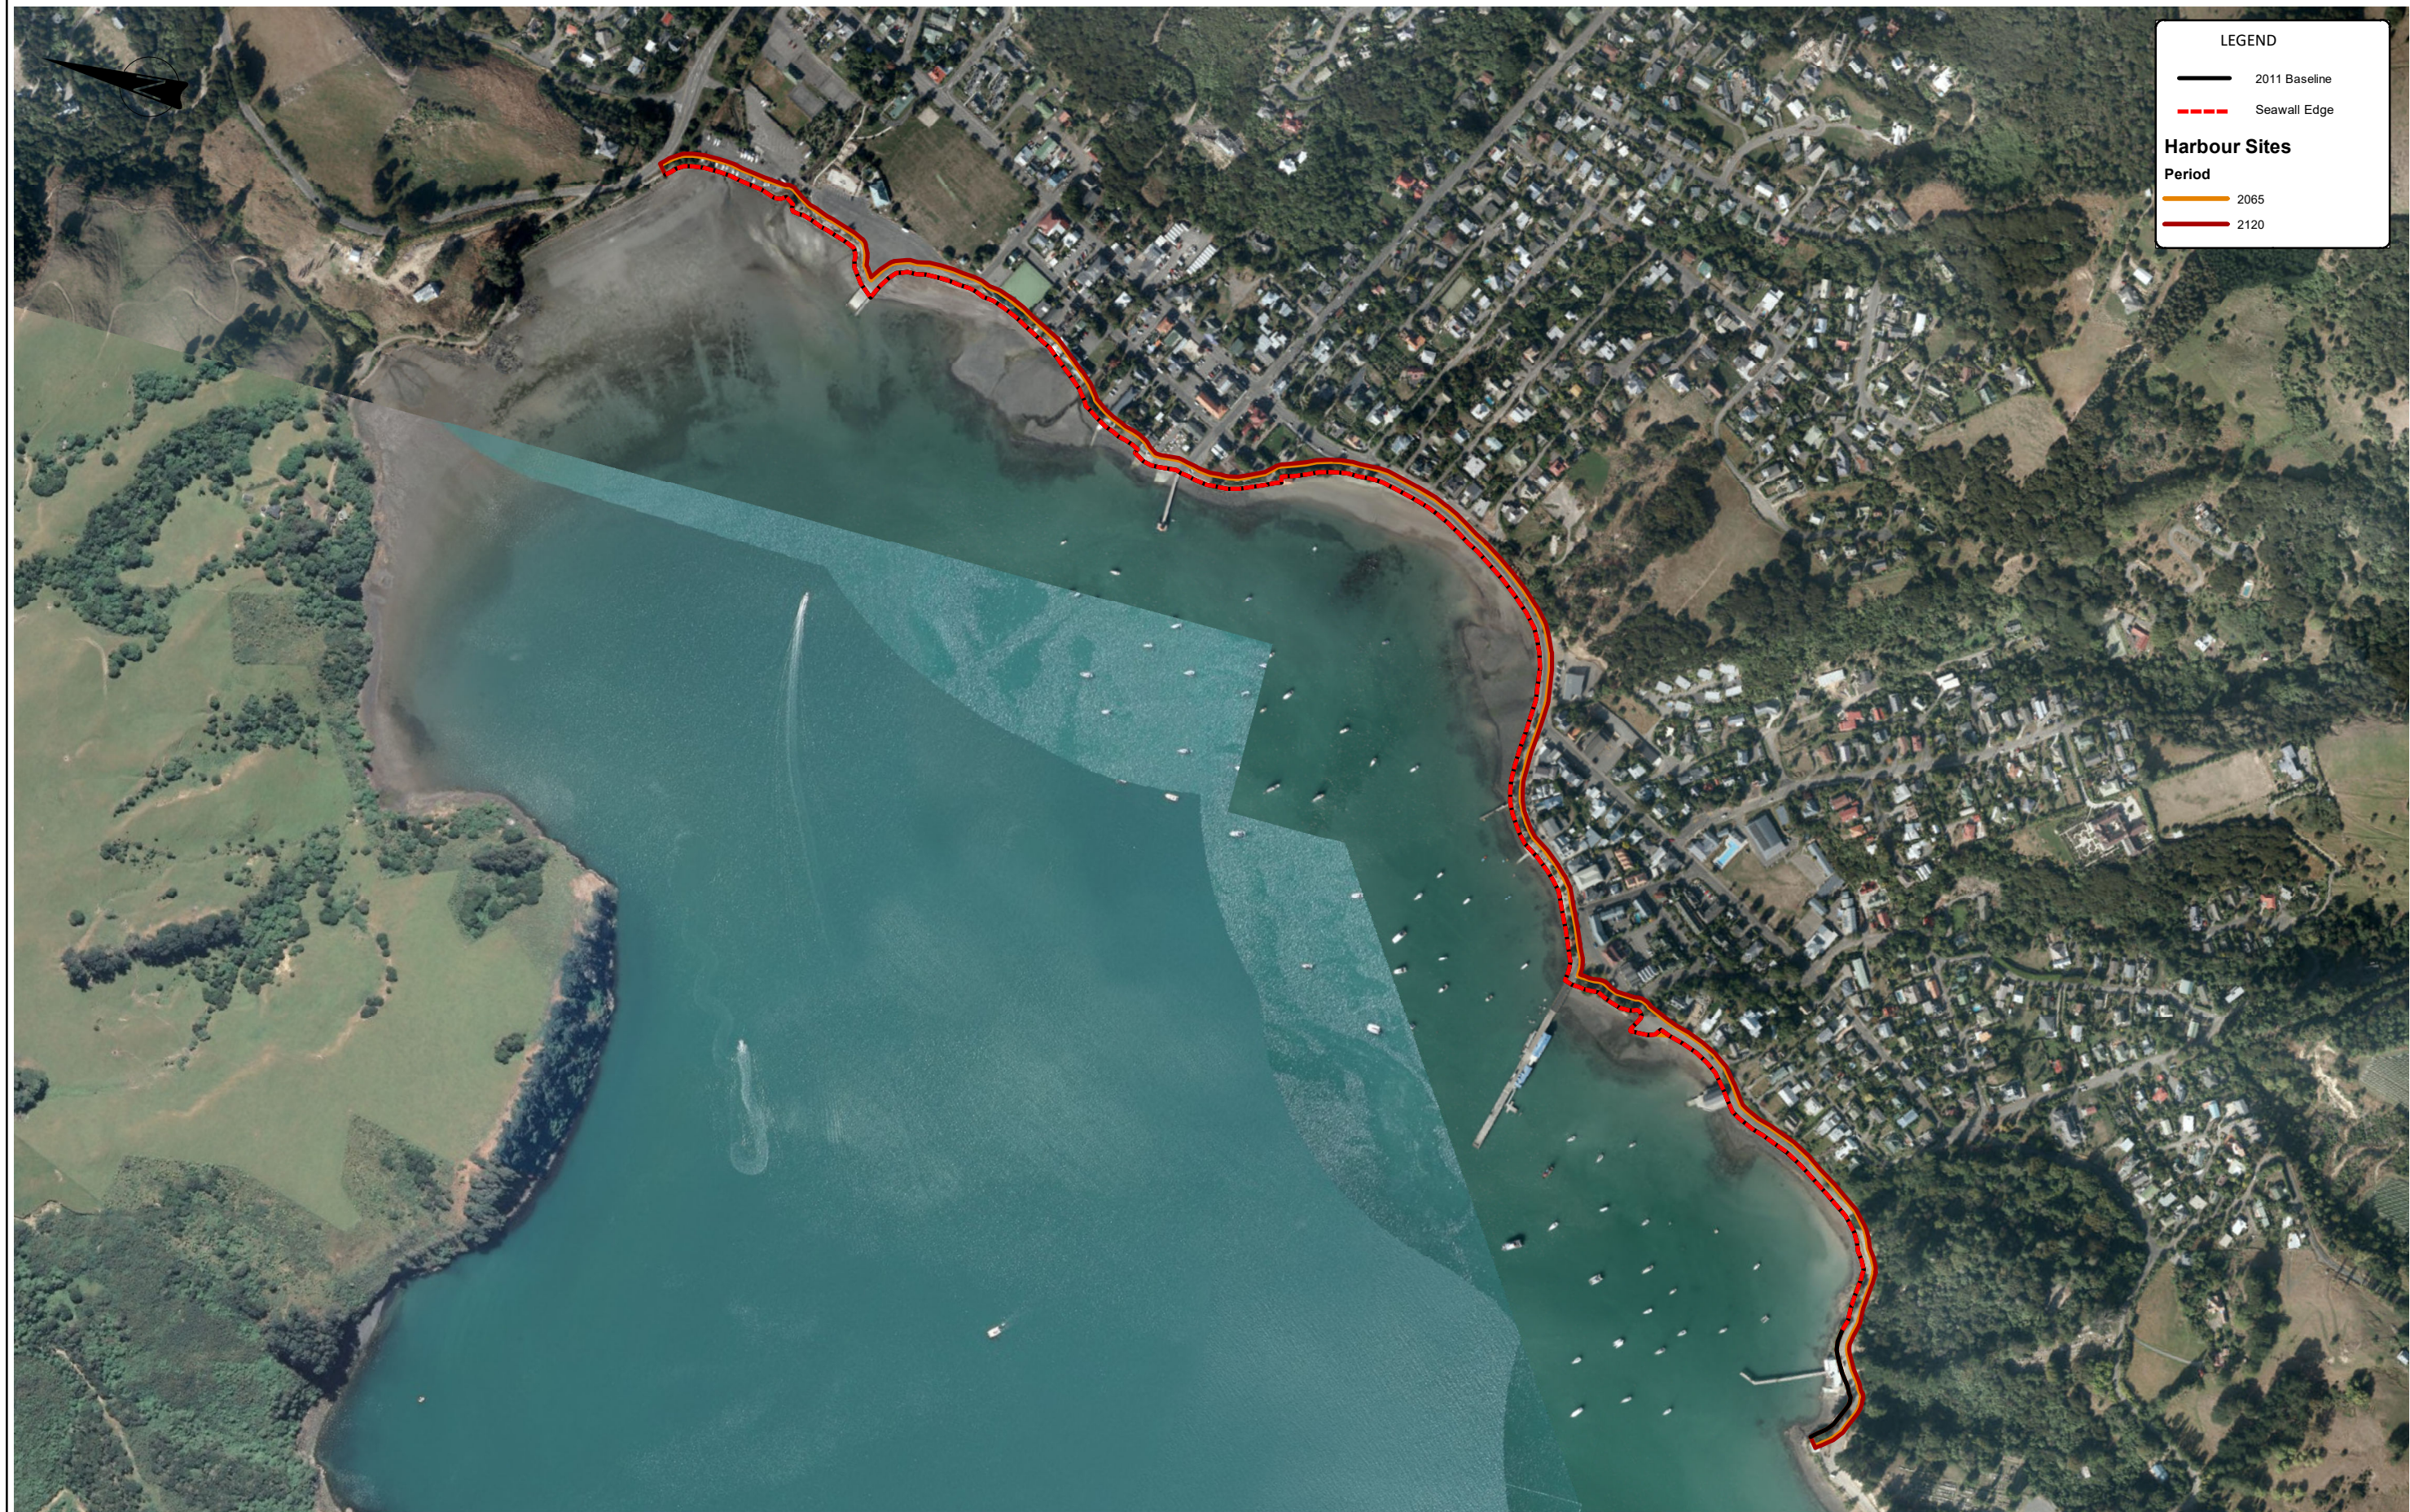
**CHRISTCHURCH CITY COUNCIL**  
**COASTAL HAZARD ASSESSMENT**  
Akaroa North  
Erosion Hazard Zones

The CEHZs have been assessed by splitting up the shoreline in behaviour cells with the end/boundary of a coastal behaviour cell indicated with a shoreline-perpendicular CEHZ line. The CEHZs are only mapped for the study area (refer to report).  
Refer to note on map limitations on the front page of Appendix H.

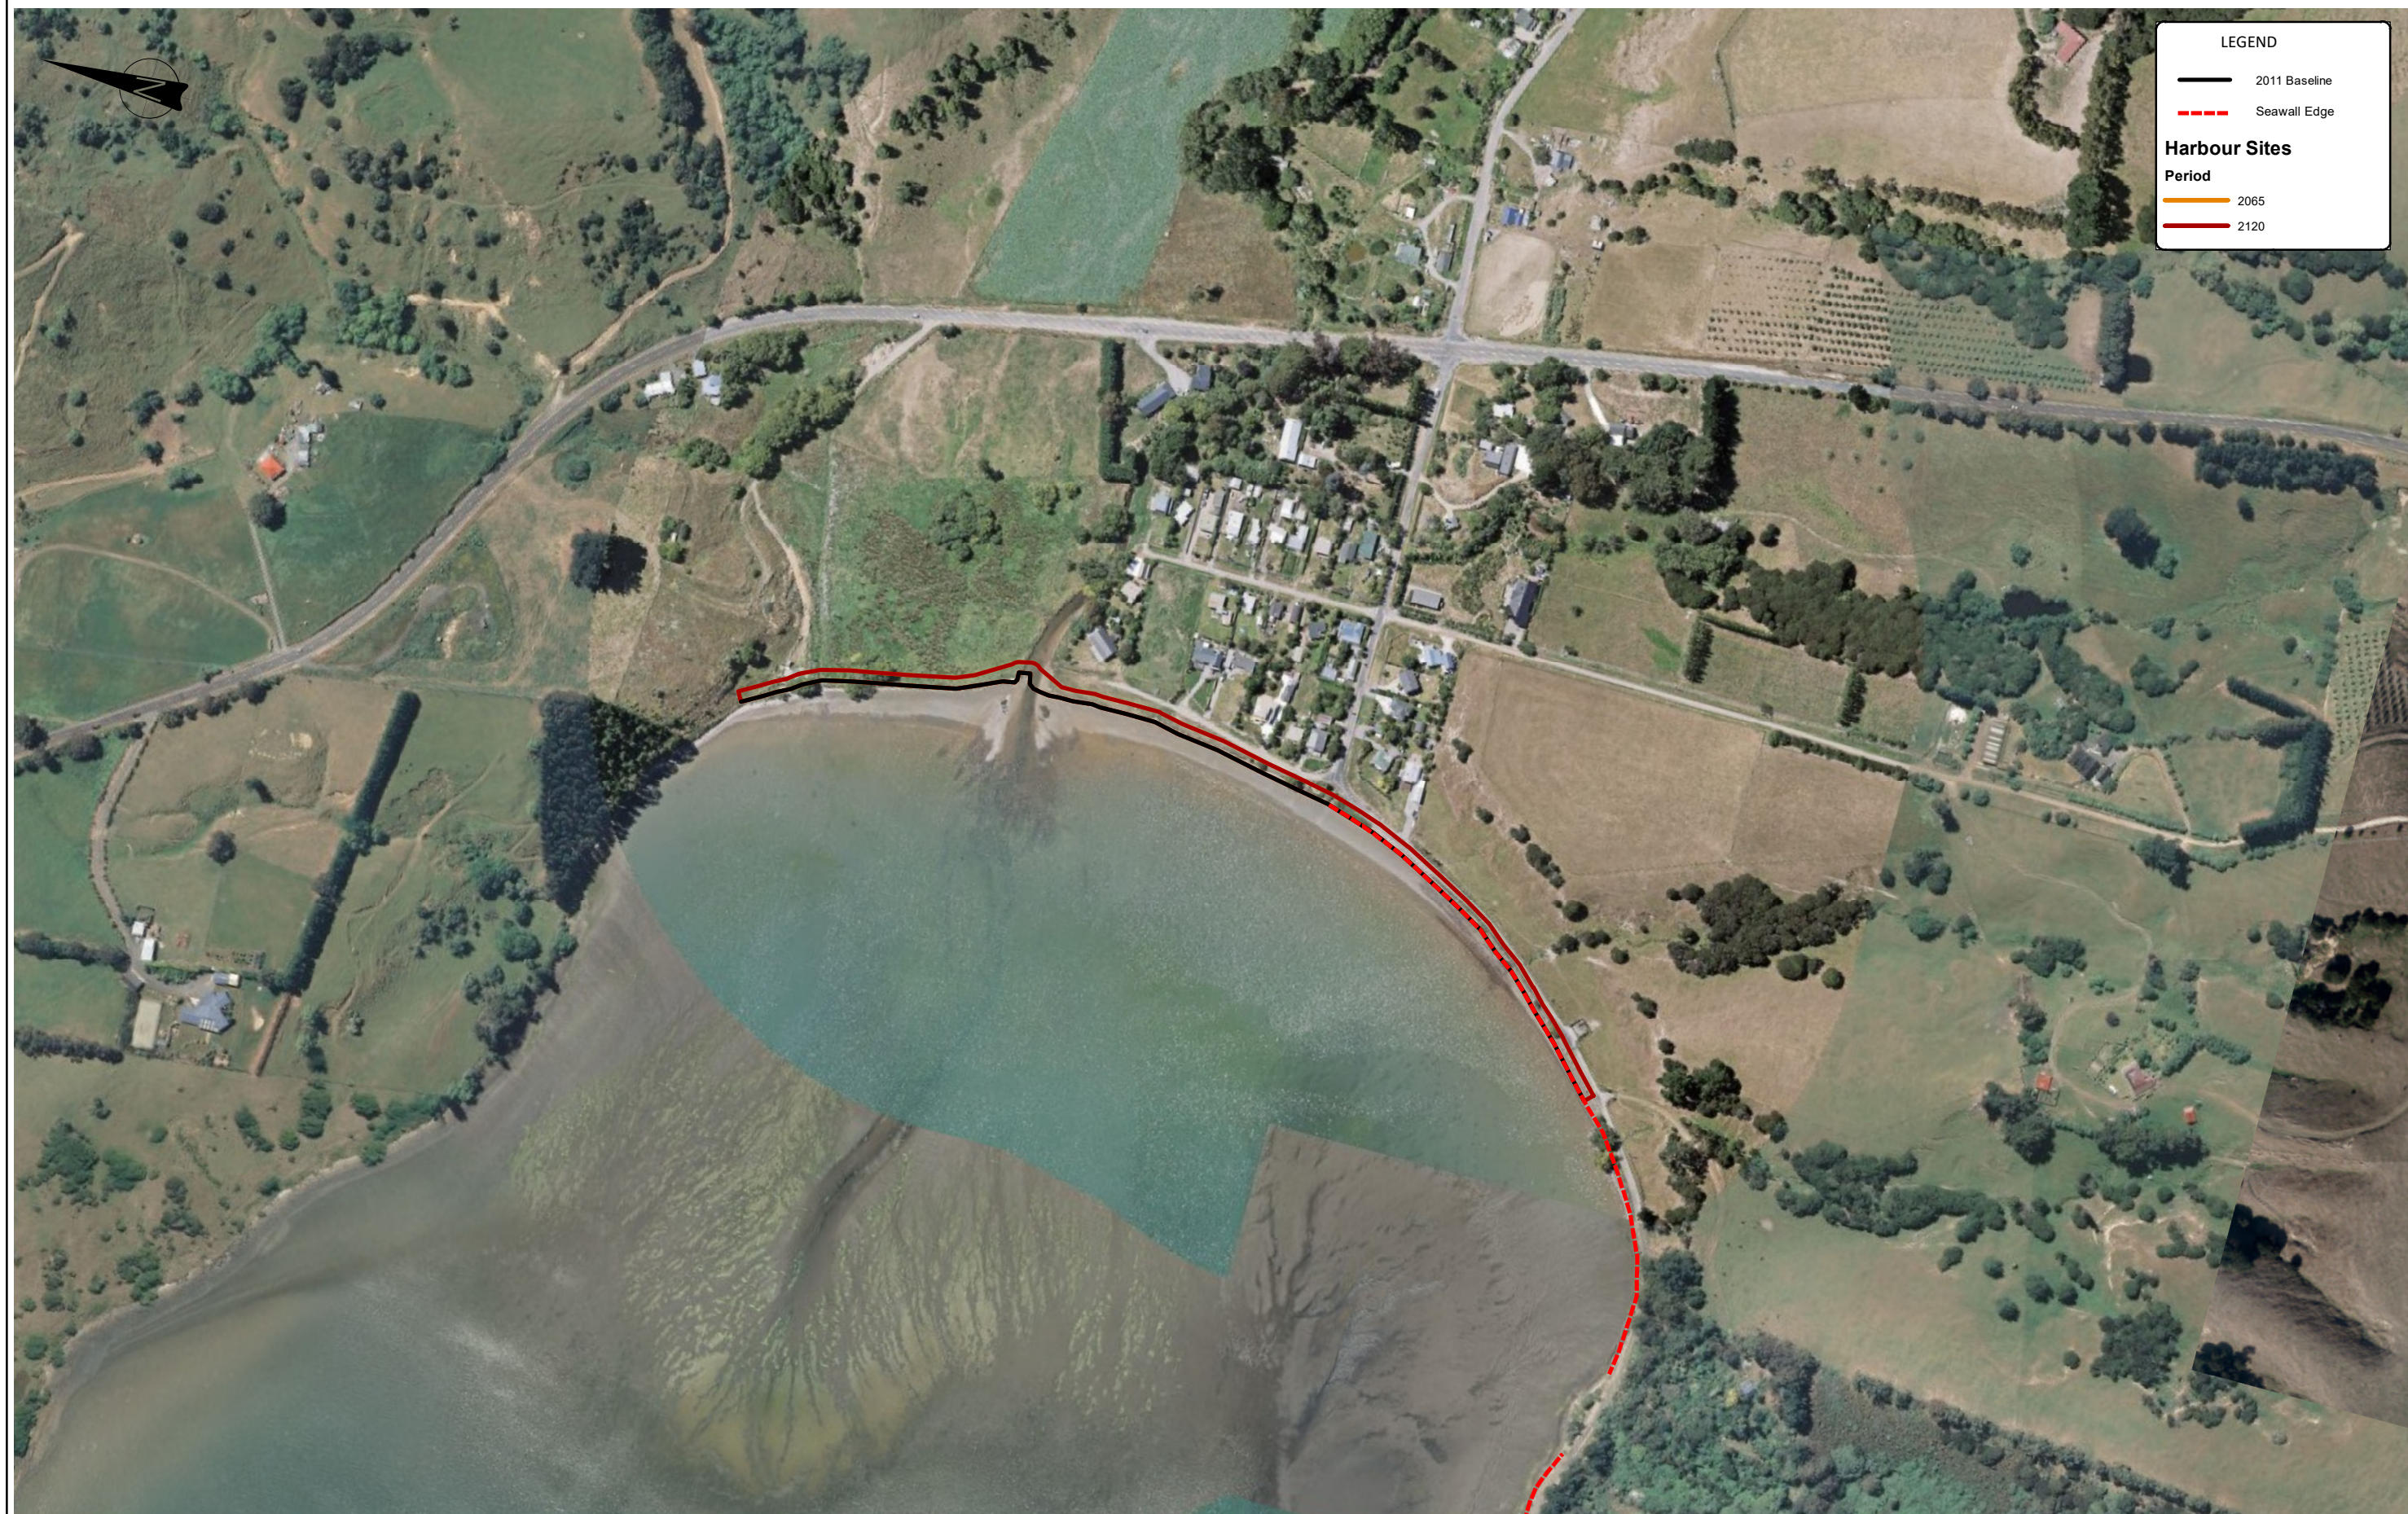
CHRISTCHURCH CITY COUNCIL COASTAL HAZARD ASSESSMENT Takamatua Erosion Hazard Zones		
FIGURE No.	Figure H -48	Rev. 0

The CEHZs have been assessed by splitting up the shoreline in behaviour cells with the end/boundary of a coastal behaviour cell indicated with a shoreline-perpendicular CEHZ line. The CEHZs are only mapped for the study area (refer to report).  
Refer to note on map limitations on the front page of Appendix H.
