**COMMUNITY, RECREATION AND CULTURE
COMMITTEE
AGENDA**

TUESDAY 2 APRIL 2013

3. FACILITIES REBUILD PLAN MONTHLY STATUS UPDATE

1. To provide a monthly update to the Council on the Facilities Rebuild Programme (FRP) and associated TOP 30 priority projects.

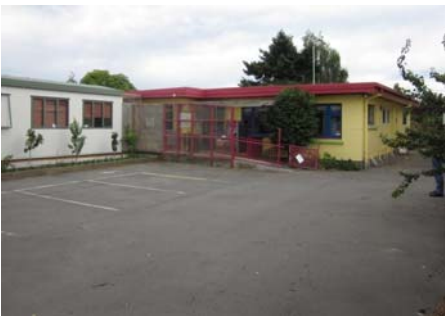
<p>Sydenham Pre School (crèche)</p>

<p>Building Status: CLOSED</p>	
<p>DEE: L5 – 8% NBS Strengthening to 34% & 67% completed Jan 2013 Costs to strengthen \$83,500 completed Feb 2013 Insurer approved repair estimate \$7,636 Council EQ repair estimate \$155,500 completed July 2012 Total Sum Insured \$324,205</p>	
<p>Update:</p> <ul style="list-style-type: none"> • The Council’s insurer completed their Damage Assessment (DA) following a site visit the w/c 11/3. • Further assessments are on hold until the Council DA RFP process is completed. • A strengthening report, including site levels, was received on the 28.1.13 including pricing. Costs to strengthen to 34% and 67% are the same at \$83,500 • Site level results confirmed within DBH guidelines so no further action is necessary to re-level. • Current QS repair estimate of \$155,500.88 does not cover full scope of damage – awaiting comprehensive DA to resolve.

<p>Next Steps:</p> <ol style="list-style-type: none"> 1. Complete a DA to be able to agree a position with the Council’s insurer. Dependant on the above, options available include repair, rebuild a new facility or utilise available re-locatable units (short to medium term option).Places and Spaces Managers preference is to repair if possible. 2. Following above agree strategy to repair/rebuild/divest 3. The ability to return to service is expected late 2013. 	
<p>Fendalton Community Centre</p>

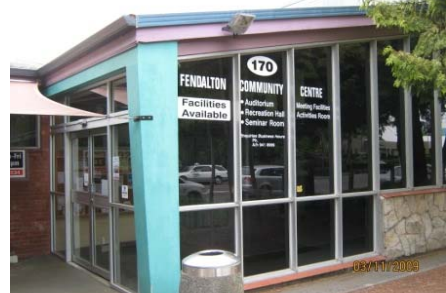
<p>Building Status: CLOSED (but will be opened by June 2013 due to revised NBS%)</p>	
<p>DEE: L5 Received 6/12/12 - 50% NBS</p>	
<p>Update:</p> <ul style="list-style-type: none"> • Damage Assessment works completed by Citycare on 11.3.13, estimated at \$211,226 (although this includes some works that are not EQ related). Council to review and submit relevant components as part of their insurance assessment of position (AOP). • No betterment work has been requested at this stage. • Fire, accessibility and strengthening reports will not be required at this stage. • Building opening steps have been agreed including updated BWOF

<p>Next Steps:</p> <p>Review the Citycare DA estimate and submit to the Council’s insurer for approval. Works planned for completion 9 weeks from Council approval (and subject to consent). Target completion end June 2013.</p>

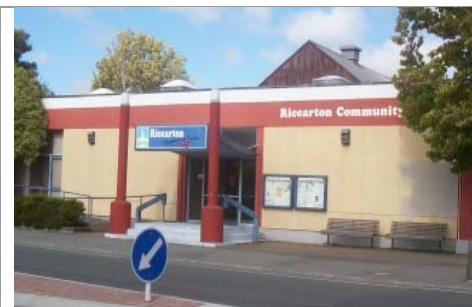
<p>Riccarton Community Centre (Also See – Riccarton Voluntary Library)</p>

<p>Building Status: CLOSED</p>	
<p>DEE: 2% Orig Bld 5% (1960) 100% (1968)</p>	
<p>Update:</p> <ul style="list-style-type: none"> • Damage Assessment OOS (offer of service) agreed on 8.3.13 for Stage 1 investigation only - enabling a firm fee offer to be agreed • Strengthening options to 34% & 67% received on the 28.1.13 and pricing completed on the 8.2.13. Costs ranged from \$474,626- \$614,096 • Insurance updated SOP due w/c 11.2.13 is still outstanding • Current QS repair estimate of \$908,400 does not include all EQ damage. This scope is to be completed in line with the contracted role for Damage Assessment above. • The insurers contacted Council for access to the building to undertake their own Damage Assessment. We believe this has been done but no report has been issued. 	
<p>Next Steps:</p> <ol style="list-style-type: none"> 1. Site levels being undertaken directly by Council. 2. Resolve the DA process to be able to agree a position with the Council's insurer. 3. The asset owner has multiple options for this site subject to the finalization of the insurance position which should be being discussed further 4. Target works complete late 2013 early 2014

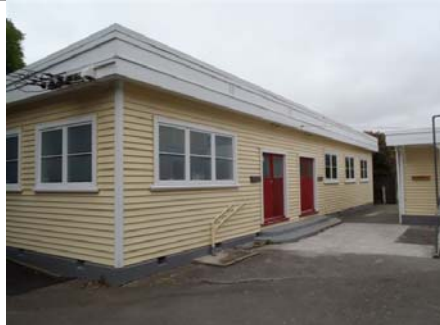
<p>Risingholme Community Centre Craft Rooms (non heritage)</p>

<p>Building Status: CLOSED</p>	
<p>DEE: L4 Received – 17.5% NBS</p>	
<p>Update:</p> <p>The building has suffered minor EQ damage to perimeter footings, ceiling lining, window joinery and floor lining. It has been deemed EQ Prone due to low NBS - 17.5%.</p>	
<p>Next Steps:</p> <p>Assessment of position being collated on repair strategy and cost of repair to be taken to the Insurer for approval before repairs commence.</p>

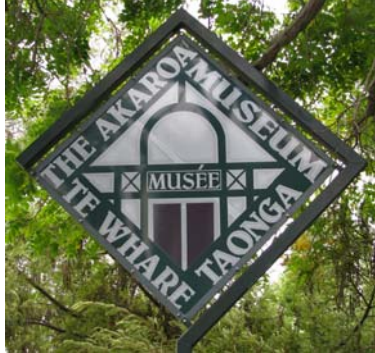
<p>Akaroa Museum</p>

<p>Building Status: CLOSED</p>	
<p>DEE: 12%-38%NBS</p>	
<p>Update:</p> <p>The main building has 6 separate structures of different ages and constructions are of different strengths. Temporary propping possible but permanent repair / strengthening may be complicated.</p> <p>3 on site and 1 off site heritage properties are being considered by the feasibility study.</p> <p>Project team focused on 2013/14 summer opening. A temporary (partial) opening of the Foyer area is currently being investigated. This would mean public would have access to view limited items, while a permanent repair strategy is developed.</p>	
<p>Next Steps:</p> <p>Complete feasibility study on repair options.</p>

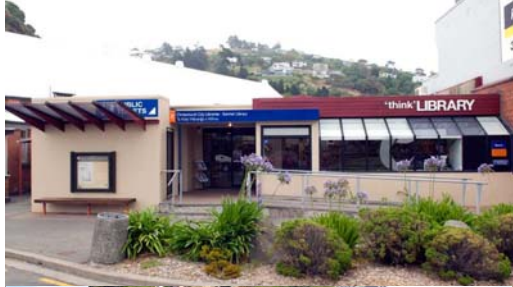
<p>Sumner Community Centre</p>

<p>Building Status:</p> <p>Sumner Library: CLOSED 11% NBS Sumner Museum: DEMOLISHED Sumner Community Centre: DEMOLISHED</p>

<p>DEE: Level 5 assessments completed.</p>	<p>Update:</p> <ul style="list-style-type: none"> • Draft Sumner Master Plan public consultation period has closed • Sumner Library demolition is now complete with the bare land fenced off.
<p>Next Steps:</p> <ul style="list-style-type: none"> • The insurance Statement of Position (SOP) is still to be finalised but agreed in principal. • Options for different transitional projects are being explored with the relevant Council units.

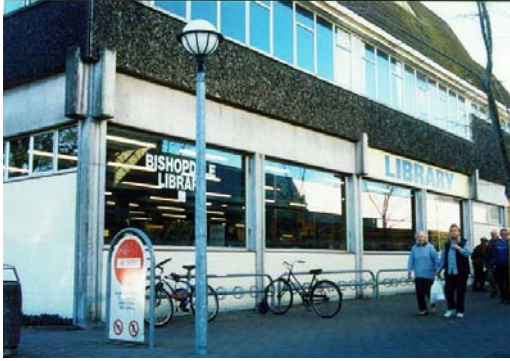
<p>Bishopdale Library and Community Centre</p>

<p>Building Status: CLOSED 4% NBS</p>	
<p>DEE: Lvl 5 October 2012 Strengthening cost estimate to 34%, 67% & 100% completed June 2012</p> <p>Costs to strengthen range from \$803,800-\$1,161,500 completed July 2012 – this excludes cosmetic repairs and damage to building services.</p> <p>LAT approved repair estimate yet to be confirmed</p> <p>Estimated cost to demolish and reinstate \$3,969,000</p> <p>Total Sum Insured \$3,079,101</p>	<p>Update:</p> <ul style="list-style-type: none"> • Council’s insurers advise they have recently completed a Damage Assessment (DA) of the building. This report is yet to be released to Council. • Strengthening options have been completed and priced, as above • An access plan is being prepared to allow council to access the building and complete a full assessment of all EQ damage to the building • Damage Assessment will be completed once engineers are satisfied that the risk of accessing the building are at a reasonable level.

<p>Next Steps:</p> <ol style="list-style-type: none"> 1. Approve safe access design and arrange for propping works - Target access available by end of April 2. Undertake DA - 5 weeks from approved access. Target mid June 3. After 2) above issue Council Assessment of Position (AOP) them resolve the insurance Statement of Position (SOP) 4. Transitional solutions still being explored

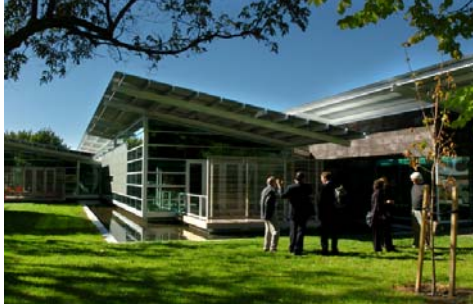
<p>South Library/Service Centre/Learning Centre (incl Distribution Centre)</p>

<p>Building Status: Open</p>	
<p>DEE: Temporary Repairs complete, bring building to 34% NBS.</p>	
<p>Update: South Library opened late December 2012 after repairs resulted in increasing NBS to at least 34%. Investigations into the Long term solution for this building are ongoing. Draft geotechnical report received, awaiting updated report incorporating comments. Foundation recommendations for permanent solutions included in report. Settlement has affected foundation.</p>	
<p>Next Steps: Complete Damage Assessment report to allow for cost and methods for repair/reinstatement. Discuss and agree recommendation to Council with Libraries team. Reach agreement with LAT on insurance position.</p>

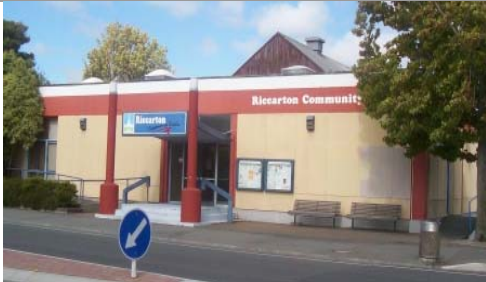
<p>Riccarton Voluntary Library (Within Riccarton Community Centre)</p>

<p>Building Status: Open</p>	
<p>DEE: L5 – 100% (within the 1968 building)</p>	
<p>Update: Included within the community facility. See Riccarton Community Centre overview for more information.</p>	
<p>Next Steps: See Riccarton Community Centre overview for more information.</p>

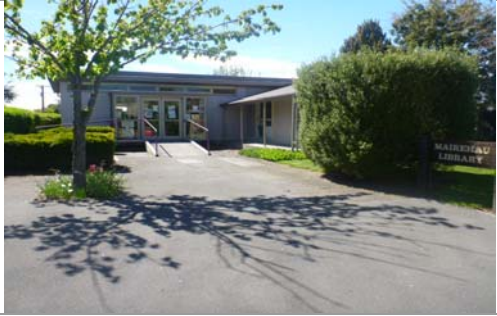
<p>Mairehau Voluntary Library</p>

<p>Building Status: OPEN</p>	
<p>DEE: L4 - 80%</p>	
<p>Update: Minor EQ Damage.</p>	
<p>Next Steps: Complete Damage assessment. Pursue sign off with the LAT. Undertake repair works subject to required level of Council approvals under delegation (estimate repair costs will be within staff delegation).</p>

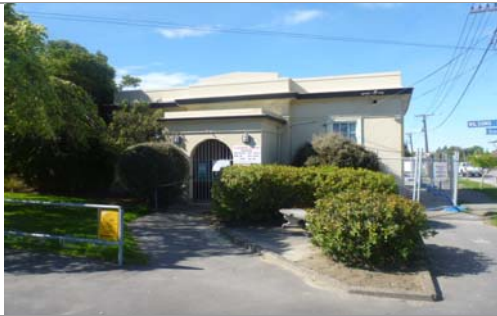
<p>St Martins Voluntary Library</p>

<p>Building Status: CLOSED</p>	
<p>DEE: Part demolished, Extensive EQ Damage, L4 Qualitative 0-30% NBS</p>	
<p>Update: Partially demolished, approximately 70% of building, due to CERA Section 38. Remaining building has suffered significant damaged and differential settlements (up to 100 mm). Voluntary library staff requested retrieval of items. Engineer advised that risk to safety for value of remaining items was not prudent. Have reopened in a new location (on New World site) last week. SCIRT are currently using demolished footprint.</p>	
<p>Next Steps: Damage Assessment required to confirm insurance position.</p>

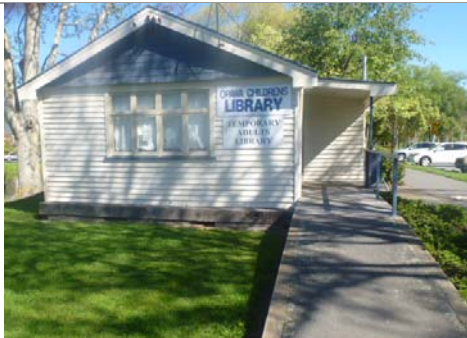
<p>Opawa Childrens Library</p>

<p>Building Status: Open</p>	
<p>DEE: L5 34% NBS</p>	
<p>Update:</p> <p>Quantitative DEE finalised. Damage Assessment commissioned</p> <p>Prior to earthquakes 3 voluntary libraries operated within 2 km of each other (Opawa and St. Martin). Currently Children’s is only open facility. Need to assess future facilities (Opawa and St. Martin badly damaged).</p>	
<p>Next Steps:</p> <p>Review Damage Assessment report on receipt, which will determine scope of EQ repair work. Pursue agreement with LAT. Programme EQ repair works for mid 2013.</p>

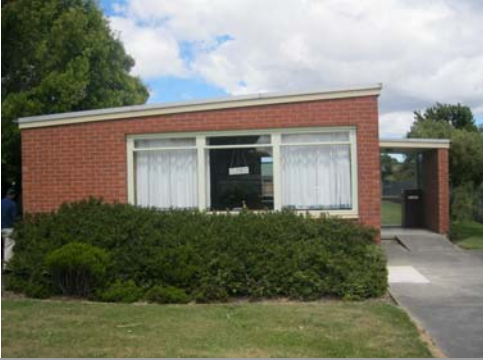
<p>Hoon Hay Voluntary Library</p>

<p>Building Status: OPEN</p>	
<p>DEE: L5 Quantitative 42% NBS</p>	
<p>Update:</p> <p>Minor EQ Damage, though on TC3 land. DEE complete. Current library service to remain onsite.</p> <p>Level survey has been requested to be completed by internal staff. Once level survey complete will determine if additional damage assessment items need to be completed.</p>	
<p>Next Steps:</p> <p>Review level survey on receipt. Commission Damage Assessment, which will determine scope and cost of EQ repair work.</p> <p>Receive agreement with LAT on insurance position. Programme works for completion in 2013.</p>

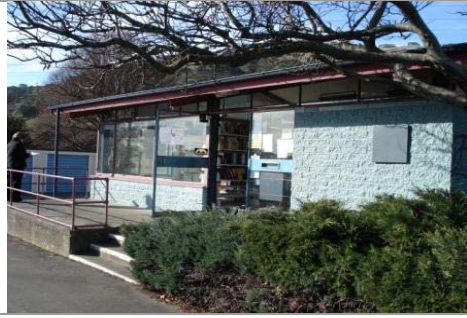
<p>Heathcote Voluntary Library</p>

<p>Building Status: CLOSED</p>	
<p>DEE: N/A - Extensive EQ damage.</p>	
<p>Update:</p> <p>CERA issued a demolition notice section 38 for this facility. Total loss agreed with LAT. Council requested staff to send request to CERA to halt demolition on Heathcote Voluntary Library, and respond with “make safe” plan on 5 March. Staff to update Council on cost for repair or rebuild options by no later than 24 April.</p> <p>Staff forwarded Make Safe Plan to CERA on 13 March.</p>	
<p>Next Steps:</p> <p>Receive estimate for repair. Receive quotes/estimates for rebuild.</p> <p>Receive agreement on Make Safe Plan from CERA and then implement plan.</p> <p>Present costings to Council no later than 24 April.</p>

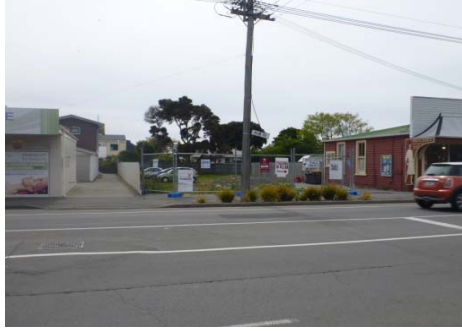
Redcliffs Voluntary Library

Building Status: DEMOLISHED	
DEE: N/A - Demolished	
<p>Update:</p> <p>Facility demolished. The Voluntary Library service is currently operating out of the local tennis club. Total loss agreed with LAT. Rebuild/strategic options assessment required. N.B Library has taken 5 year lease on the existing library site.</p>	
<p>Next Steps:</p> <p>Council report will be prepared in due course.</p>

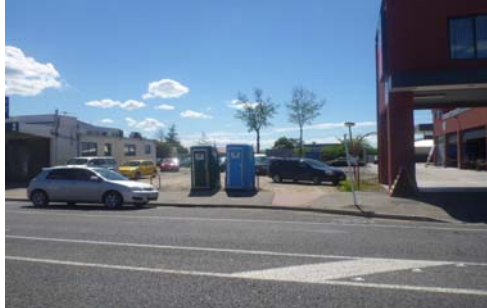
Woolston Voluntary Library

Building Status: CLOSED	
DEE: N/A - Demolished	
<p>Update:</p> <p>Demolished due to CERA Section 38 notice. Total loss agreed with LAT.</p> <p>Mobile library is stopping at site once a week. Voluntary library service currently operating at Scout Den.</p> <p>Rebuild costs/strategic options under review.</p>	
<p>Next Steps:</p> <p>Council report will be prepared in due course.</p>

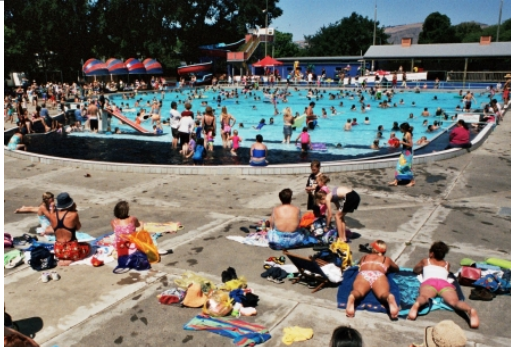
<p>Waltham Pool</p>

<p>Building Status: CLOSED</p>																			
<p>DEE: L4</p>

Next Steps:
 Damage assessment and detailed level survey to be completed.

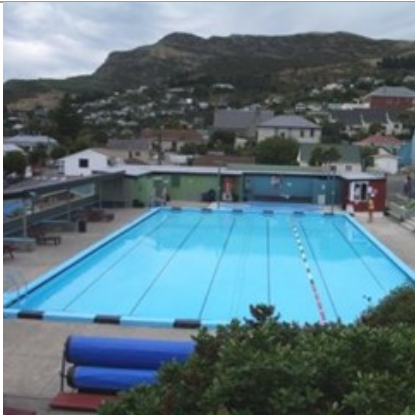
<p>Norman Kirk Memorial Pool – Lyttelton</p>

<p>Building status: CLOSED</p>														
<p>DEE: L4 Received</p>

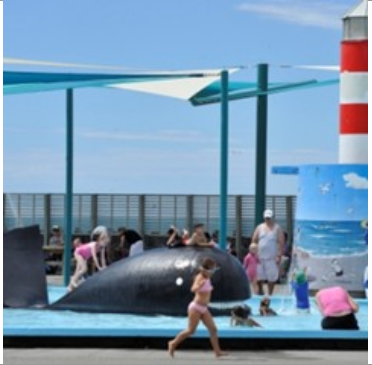
<p>Whale Paddling Pool New Brighton</p>

<p>Building status: RE-OPENED</p>	
<p>DEE: N/A for Paddling Pools.</p>	
<p>Update:</p> <p>Repair work was completed on Whale Pool at the end of October 2012. A community event was held with great success on Saturday 17th November which marked the formal reopening of the pool. This facility has been enjoyed by many throughout the 12/13 summer season.</p>	
<p>Next Steps:</p> <p>Currently in negotiation with insurer to claim back cost of repairing EQ damage.</p>

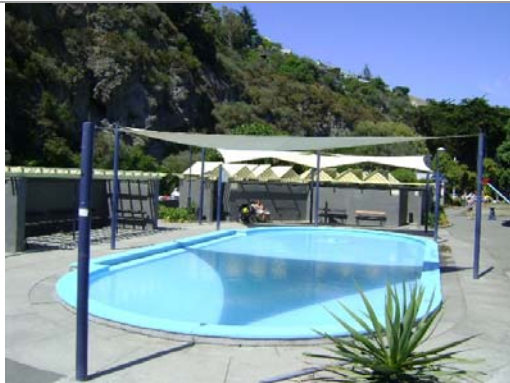
<p>Scarborough Paddling Pool</p>

<p>Building status: CLOSED</p>	
<p>DEE: N/A for Paddling Pools.</p>	
<p>Update:</p> <p>Investigations and high level costs to repair have been collated and staff recommendation has been submitted via report to CRAC Committee and Council.</p>	
<p>Next Steps:</p> <p>Awaiting full Council decision to demolish on 28 March.</p>

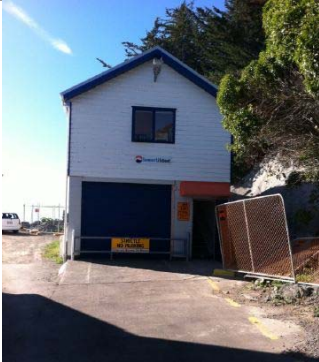
<p>Scarborough Jet Boat Building</p>

<p>Building Status: CLOSED</p>	
<p>DEE: L5 Quantitative 10% NBS</p>	
<p>Update:</p> <p>Current WTP/City Care repair estimate \$84,000. Insured value \$74,930, the cost of replacement would exceed the insured sum.</p> <p>The L5 Quantitative assessment and Fire report were received on 05/02/13. Conceptual strengthening options to 34%, 67% and 100% NBS were received 15/02/13 along with a rough order of cost for each of the strengthening proposals. Consultants have estimated that to strengthen to :</p> <ul style="list-style-type: none"> • 34% NBS = \$88,000.00 • 67% NBS = \$185,000.00 • 100% NBS = \$448,000.00. <p>A level survey has also been requested internally.</p> <p>As the cost to repair the building exceeds the total sum insured, information has been sent all of the information through to the insurers to claim as a total loss.</p> <p>Greenspace have gained official approval for the jet boat and its towing vehicle to be temporarily housed in the Sumner Police Station Garage. It is now situated there until the Jet Boat Building can be repaired.</p>

<p>Next Steps:</p> <p>Following settlement of the insurance claim Council will conduct a quick exercise to determine a cost estimate to re-build the building so this value can be compared with the repair cost.</p> <p>The club wishes to retain the building if feasible.</p>

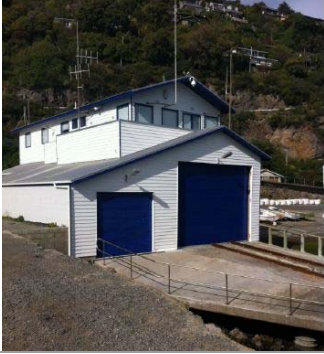
<h2 style="color: #0070C0;">Scarborough Life Boat Building</h2>

<p>Building Status: OPEN</p>	
<p>DEE: L4 Qualitative 50% NBS (Final)</p>	
<p>Update:</p> <p>As the NBS value has come in over 34% it has been decided that at this stage no strengthening will be performed on this building.</p> <p>A level survey has been requested internally.</p>	
<p>Next Steps: Awaiting a full damage assessment.</p>

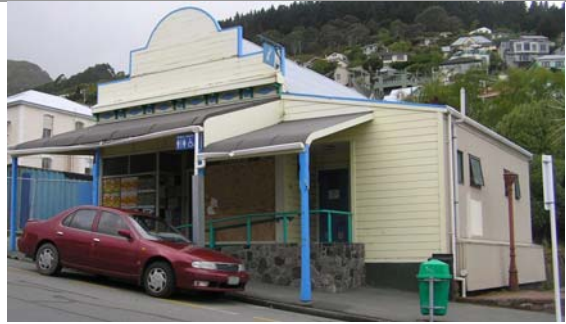
Lyttelton Visitors Centre and Toilet

Building Status: Toilets Open, Main Building to be reopened March 2013

DEE: L5 DEE Finalised – 78% NBS

- Public toilets now open and repairs are complete.

- Reopen main building.
- Continue with engineering solution to retaining wall issues behind the building.

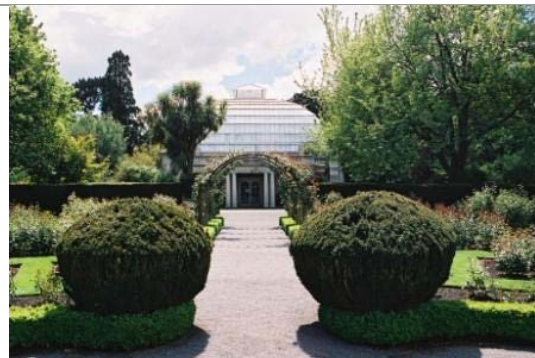
Botanic Gardens Glasshouses

Building Status: CLOSED

- Cunningham – Investigate the need for L5 DEE Final. Seek OOS for Damage Assessment & strengthening to 34% & 67%
- Foweraker - Seeking OOS for Damage Assessment. OOS received for strengthening to 67% NBS awaiting Council review and approval.
- Fernery - Seeking OOS for Damage Assessment. OOS received for strengthening to 67% NBS awaiting Council review and approval. Proceeding down track to open the building as NBS>33%. Design fee received for recommended strengthening work awaiting Council review and approval
- Garrick and Gilpin – Seeking OOS for Damage Assessment. OOS received for strengthening to 67% NBS awaiting Council review and approval
- Townend - Seeking OOS for Damage Assessment. OOS received for strengthening to 67% NBS awaiting Council review and approval

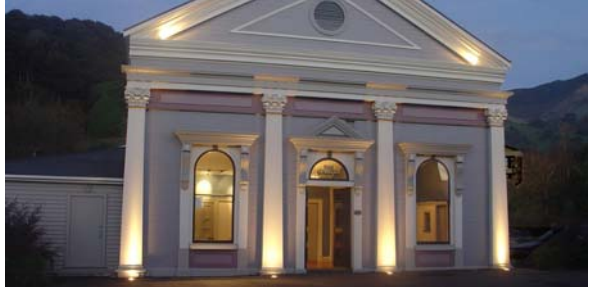
<p>Akaroa Gaiety Hall</p>

<p>Building Status: closed</p>	
<p>DEE: 24%NBS</p>	
<p>Update:</p> <p>The building has suffered significant damage. The hall requires repair works that will require detailed design and consents. Further intrusive investigations have been undertaken.</p> <p>The project team focussing on opening for 2013/14 summer. Consideration was given to partially opening the main hall, but the results showed no cost/time advantage in doing this.</p> <p>Revised strengthening concepts and report have recently been issued by engineer. Strengthening estimates for 34%, 67% and 100% have been completed for this building. Recent intrusive investigations and subsequent report that have been completed for building structure have identified a substantial amount of non structural repairs to substructure areas and framing structure of building. Engineer has advised that although these repairs are non structural remediation will still be required to meet overall strengthening to building structure.</p>

<p>Next Steps:</p> <p>The Engineers need to ensure building condition will meet strengthening requirements. Following this the CCC Heritage team will review the Strengthening concepts and make a recommendation, that can be taken to Council for approval</p>

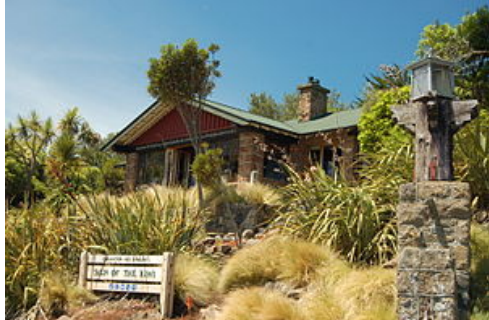
<p>Sign of the Kiwi</p>

<p>Building Status: CLOSED</p>	
<p>DEE: 9.5%NBS</p>	
<p>Update:</p> <p>The building has suffered damage and will require significant works to reinstate. DEE assessment completed. Intrusive investigations to confirm suitability of repair solution have been completed.</p> <p>A reduced revised estimate has been submitted for proposed post tensioning option by contractor, an estimate has been submitted to the CCC heritage team to advise the preferred option to be put forward for council report.</p>	
<p>Next Steps:</p> <p>Maintenance, betterment and accessibility scopes and estimates still need to be finalised for this project.</p> <p>A Draft Project Summary Review Document has been developed and issued to staff for review.</p> <p>The next stage being preparation of Detailed Design, to enable the Insurer to issue a 'Statement of Position'.</p>

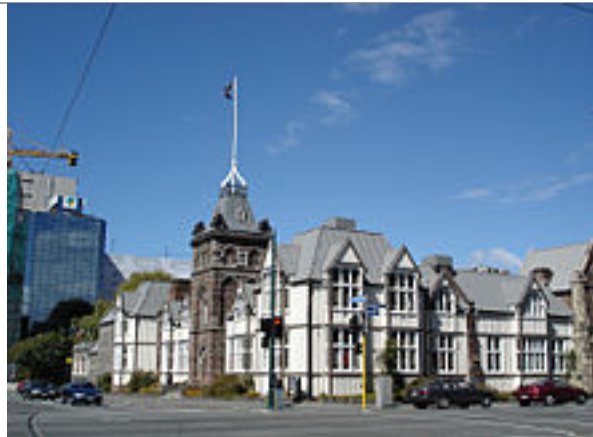
<p>Canterbury Provincial Chambers</p>

<p>Building Status: CLOSED</p>	
<p>DEE: Stabilisation underway before DEE assessment can be commenced.</p>	
<p>Update:</p> <p>Building is severely damaged. Potential land issues. Rebuild of significant portions of the building necessary. Reinstatement cost could be well in excess of insured amount.</p> <p>A revised stabilisation plan has been developed. This plan incorporates the remaining deconstruction and stabilisation works as a result of gaining access to damaged areas not previously available and further deterioration. Due to the extent of the revised stabilisation plan and engineering resources Insight Unlimited decided to stage the documentation allowing</p>

Future repair strategy requires detailed consideration and consultation with CCC, DOC and NZHPT.

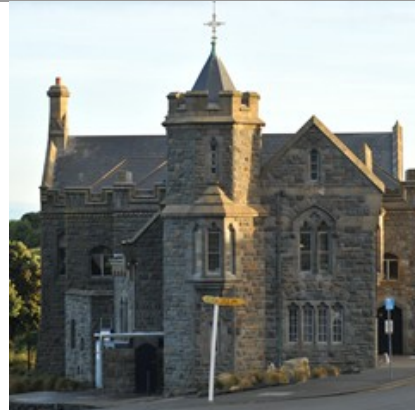
Building Status: CLOSED

DEE: 30%NBS

Intrusive investigations underway to confirm suitability of repair options. Further stabilisation works and weather proofing underway.

The project is currently in the detailed design stage for the repair and strengthening option.

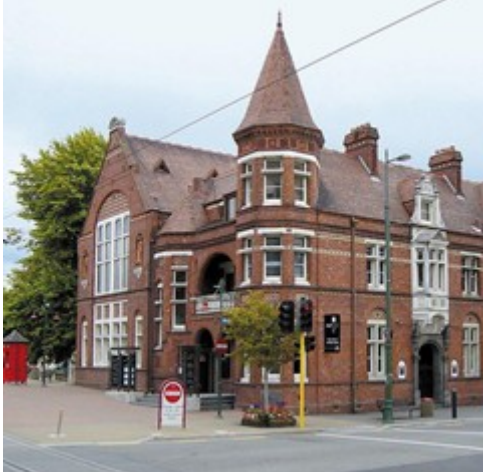
<h2 style="color: #4F81BD;">Our City Otautahi</h2>

<p>Building Status: CLOSED</p>	
<p>DEE: too dangerous for internal inspections</p>	
<p>Update:</p> <p>Building is stabilised but severely damaged. Rebuild of significant portions of the building necessary. Reinstatement cost is well in excess of insured amount.</p> <p>Two options have been put to staff for review:</p> <ul style="list-style-type: none"> • one being a traditional engineering strengthening solution to 67% NBS (not costed yet) • the other being a base isolation solution (estimated at \$10.5M) <p>The insured value (\$5.8M) is not expected to cover either option, therefore it is expected that Council will meet the difference in the chosen repair strategy.</p>	
<p>Next Steps:</p> <p>The repair and strengthening options are being reviewed by staff, in preparation of a report to Council, recommending the option.</p>

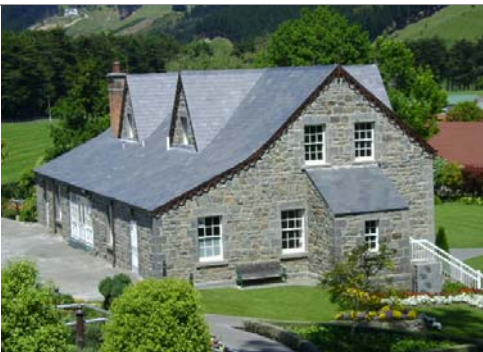
<h2 style="color: #4F81BD;">Old Stone House</h2>

<p>Building Status: CLOSED</p>	
<p>DEE: Quantative and Qualative) 10% NBS</p>	
<p>Update:</p> <p>The Old Stone house has had the following completed:</p> <ul style="list-style-type: none"> • Accessibility report • Electrical report • Fire report • Chimney securing and stabilisation methodology • North Store securing and stabilisation methodology • Methodology for Mezzanine propping • Visual Geotech assessment of land damage
