Approved Resource Consent
Document

Application for Land Use Consent

Harewood Investments Limited

30-64 Harewood Road, 22 Chapel Street
and 41 Langdons Road, Christchurch

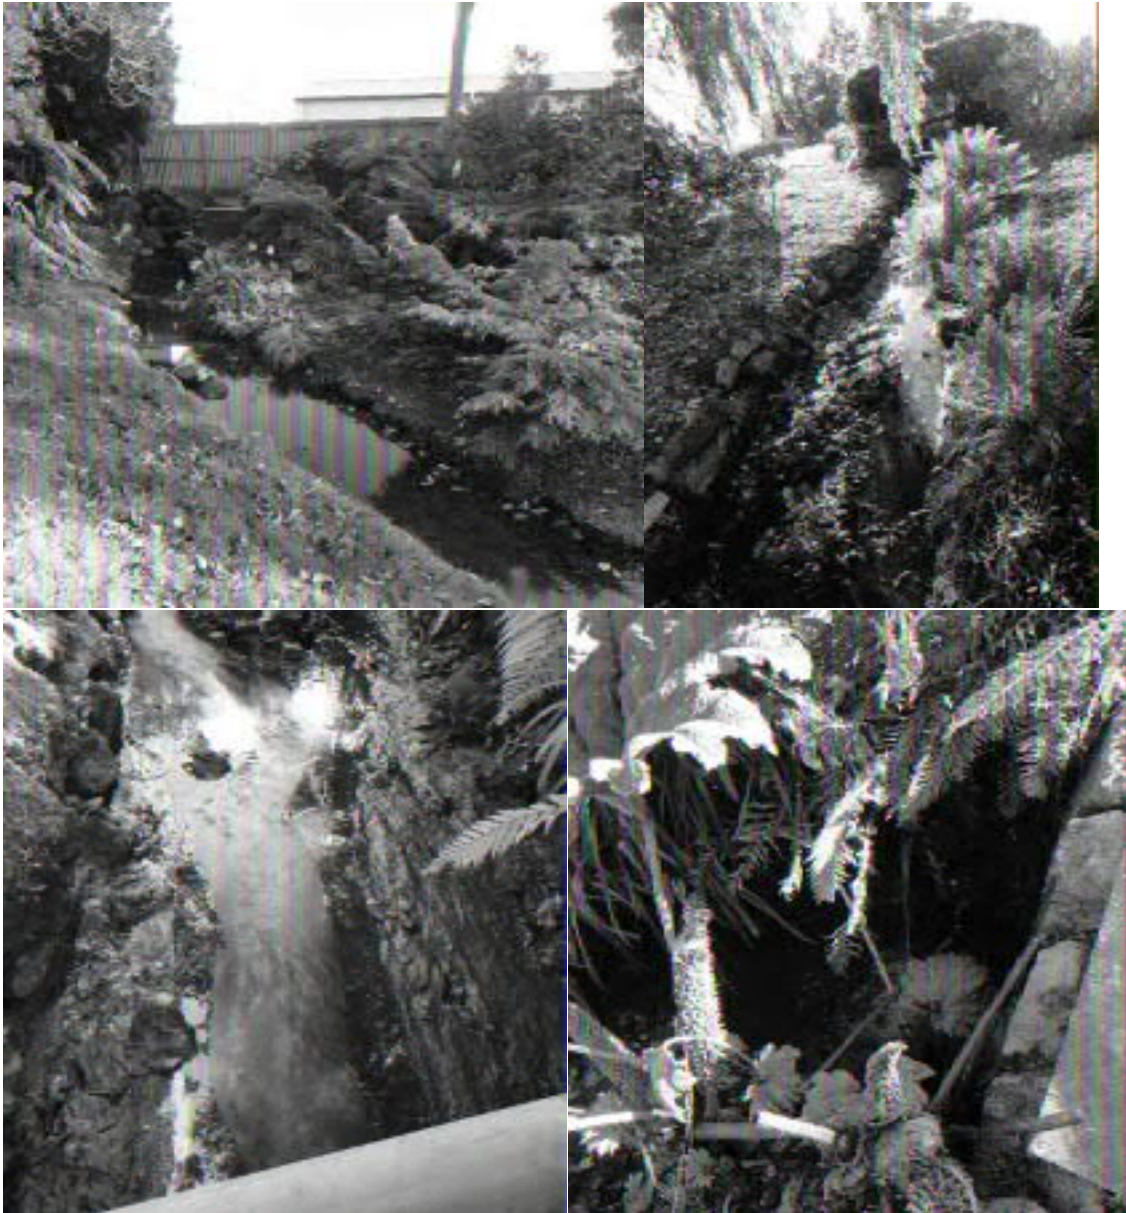
Figure 2. The 130 m reach of Kruses Drain within the Sanitarium site from upstream (top left), mid (top right and bottom left) to downstream (bottom right). Note the negligible flow, high in-stream organic and sediment conditions and sparse exotic riparian plantings along much of the waterway.

Riparian vegetation was limited in places, with manicured lawns to the water's edge along much of the waterway. Some tall exotic trees, such as willows, rhododendrons and other evergreen species were present in the wider riparian margin. Nevertheless, there was little effective shading from riparian vegetation, except in the mid sections, where the introduced *Gunnera* and native ferns were abundant. No algae was visible growing on the substrates and macrophytes were virtually absent from the waterway, except for two small patches of the native *Nitella hookeri* in the upper section of the reach.

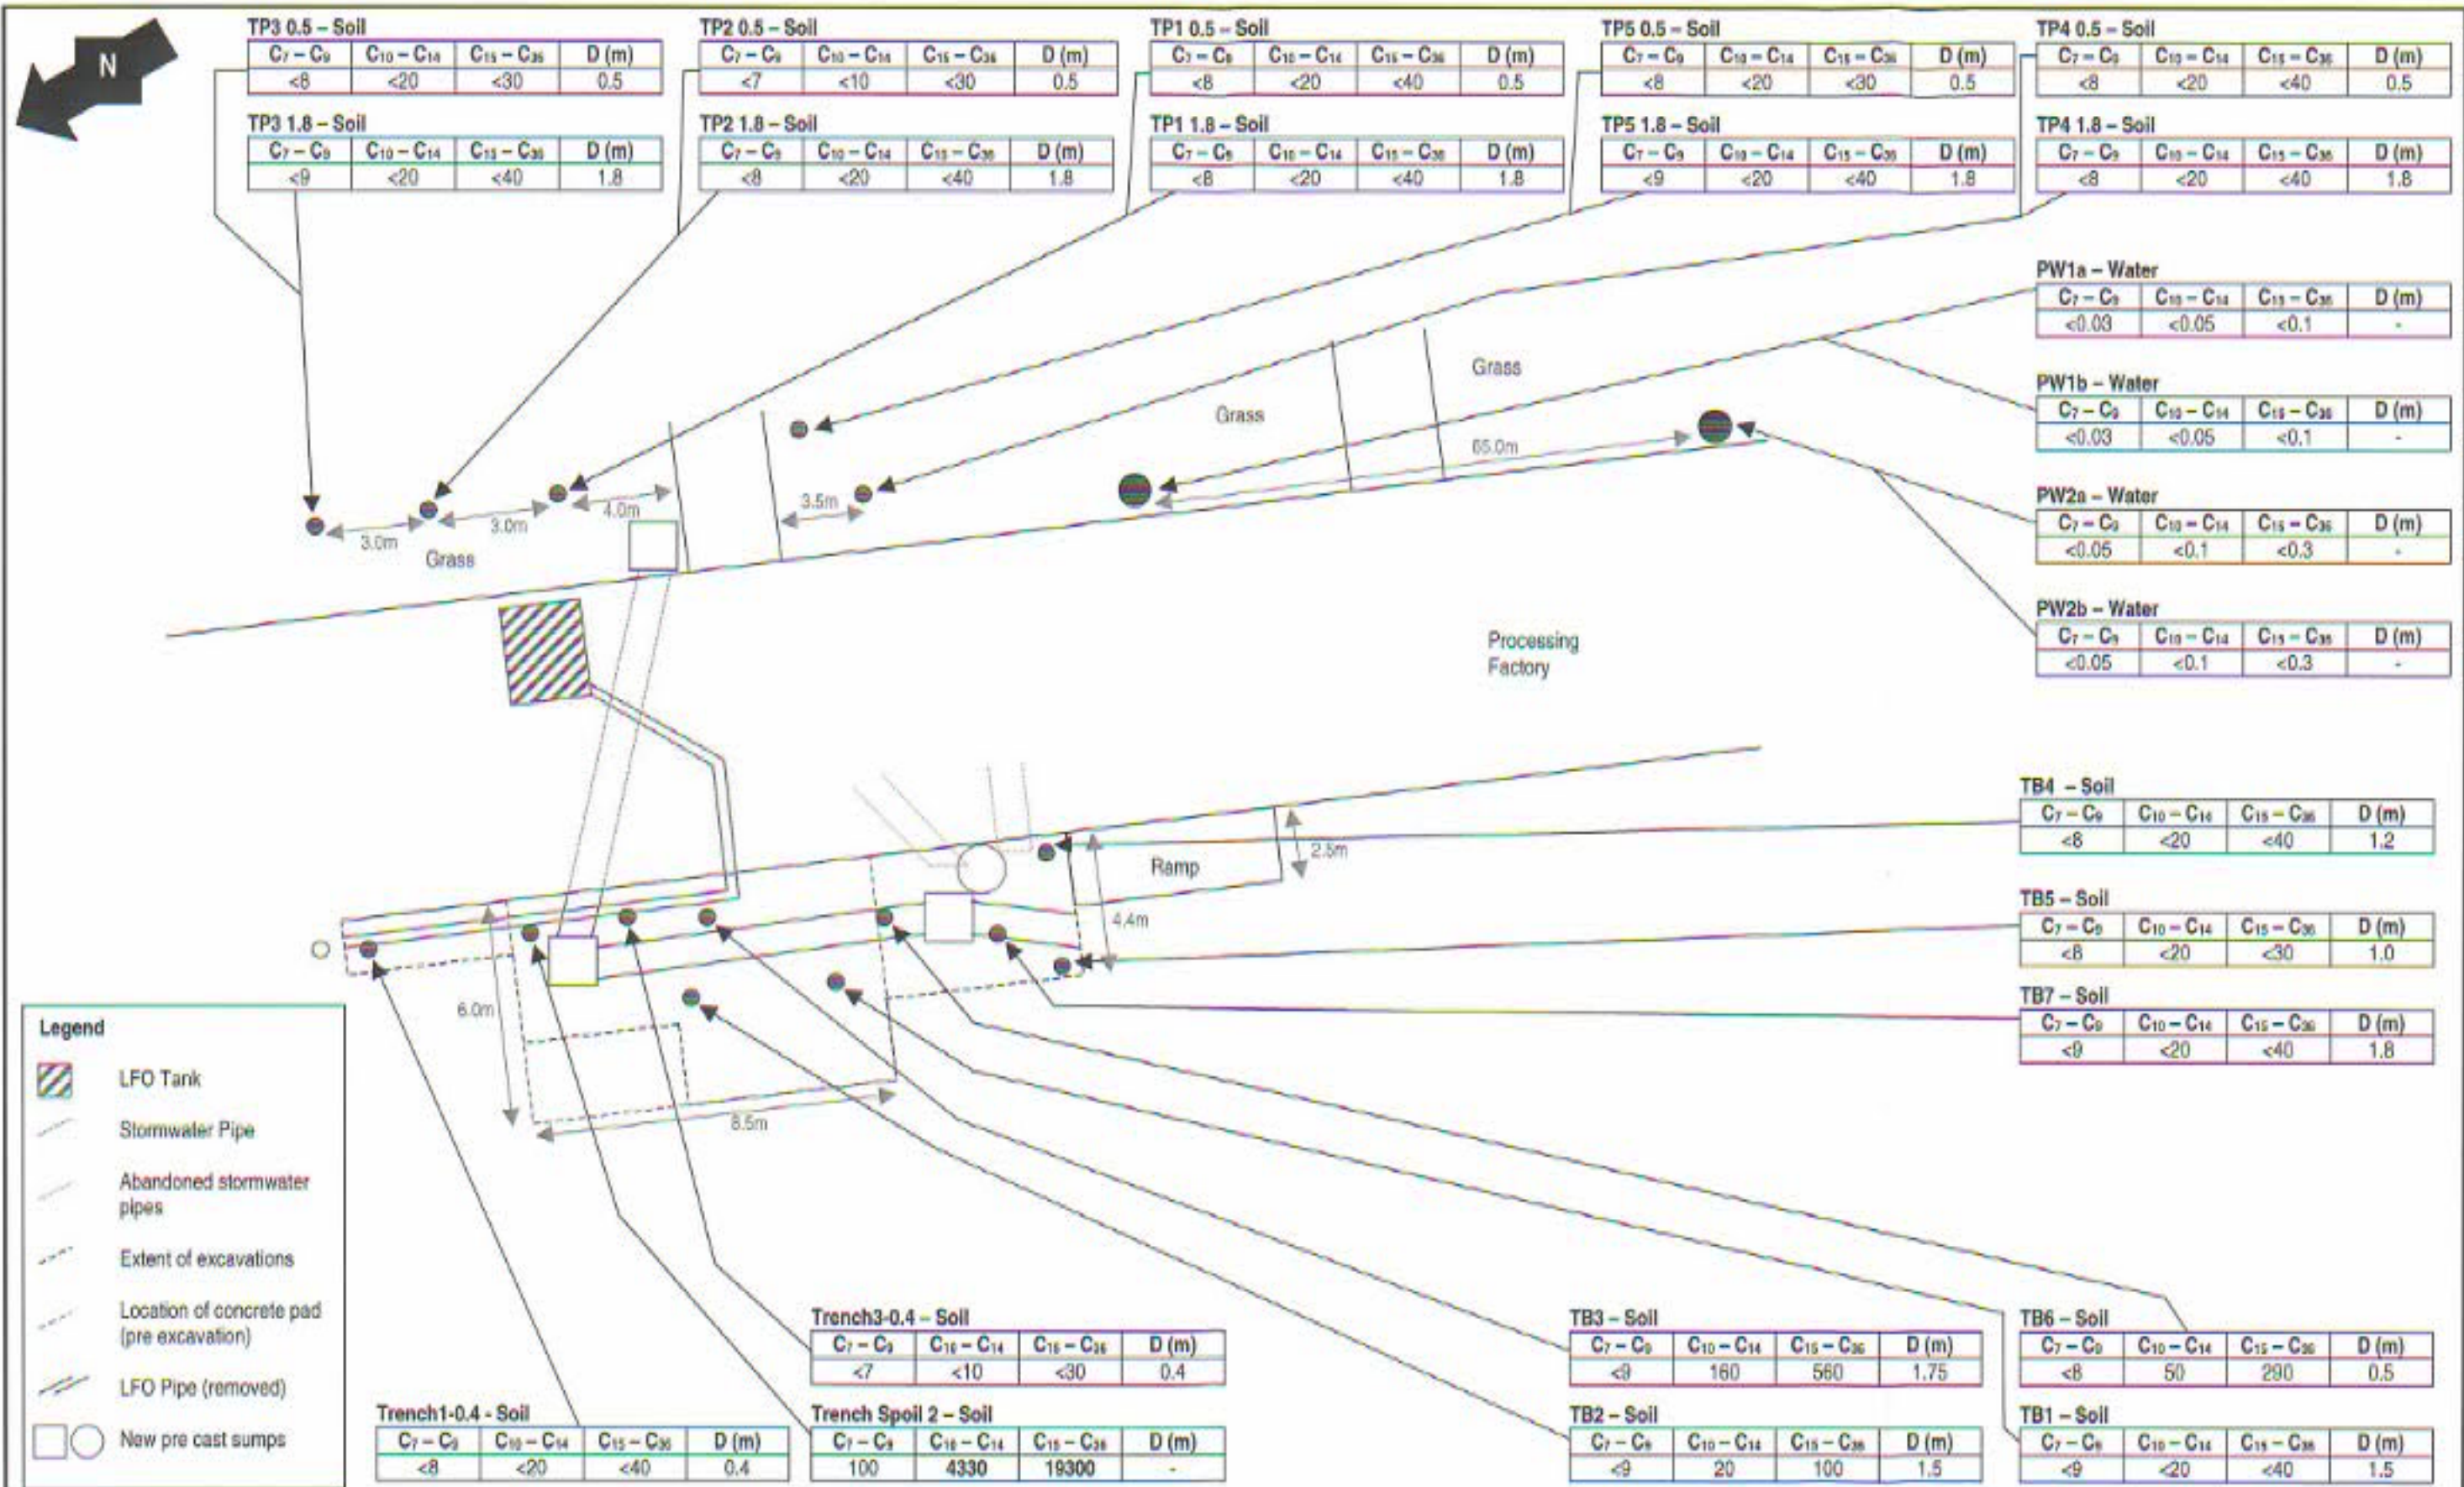
SCALE: As Indicated on Plan			Sanitarium Health Foods Co. Light Fuel Oil Investigation		Status: Final	
DESIGNED	SS	09/06				Date: September 2006
DRAWN	SS	08/06				
CHECKED	CD	09/06				
APPROVED	AG	09/06				
FIGURE 3: Sanitarium Health Foods Co. - Sampling locations and analytical results			Job No. Z1412200		Sheet No. 01	
					Rev. A

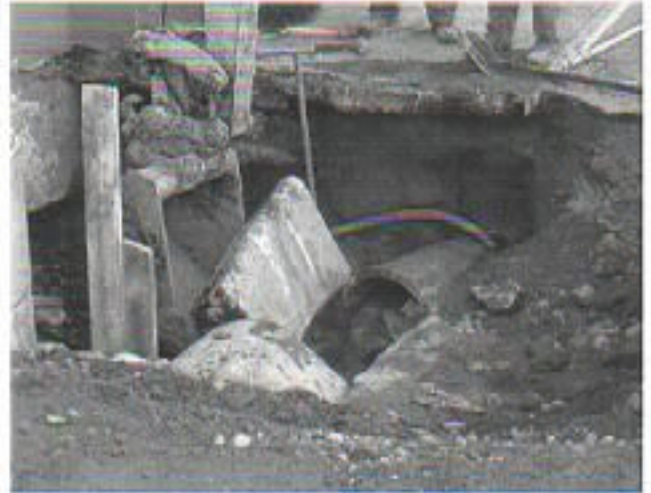
Photo 14 - Removing the Old Brick Sump to be Replaced with a New Pre-Cast one

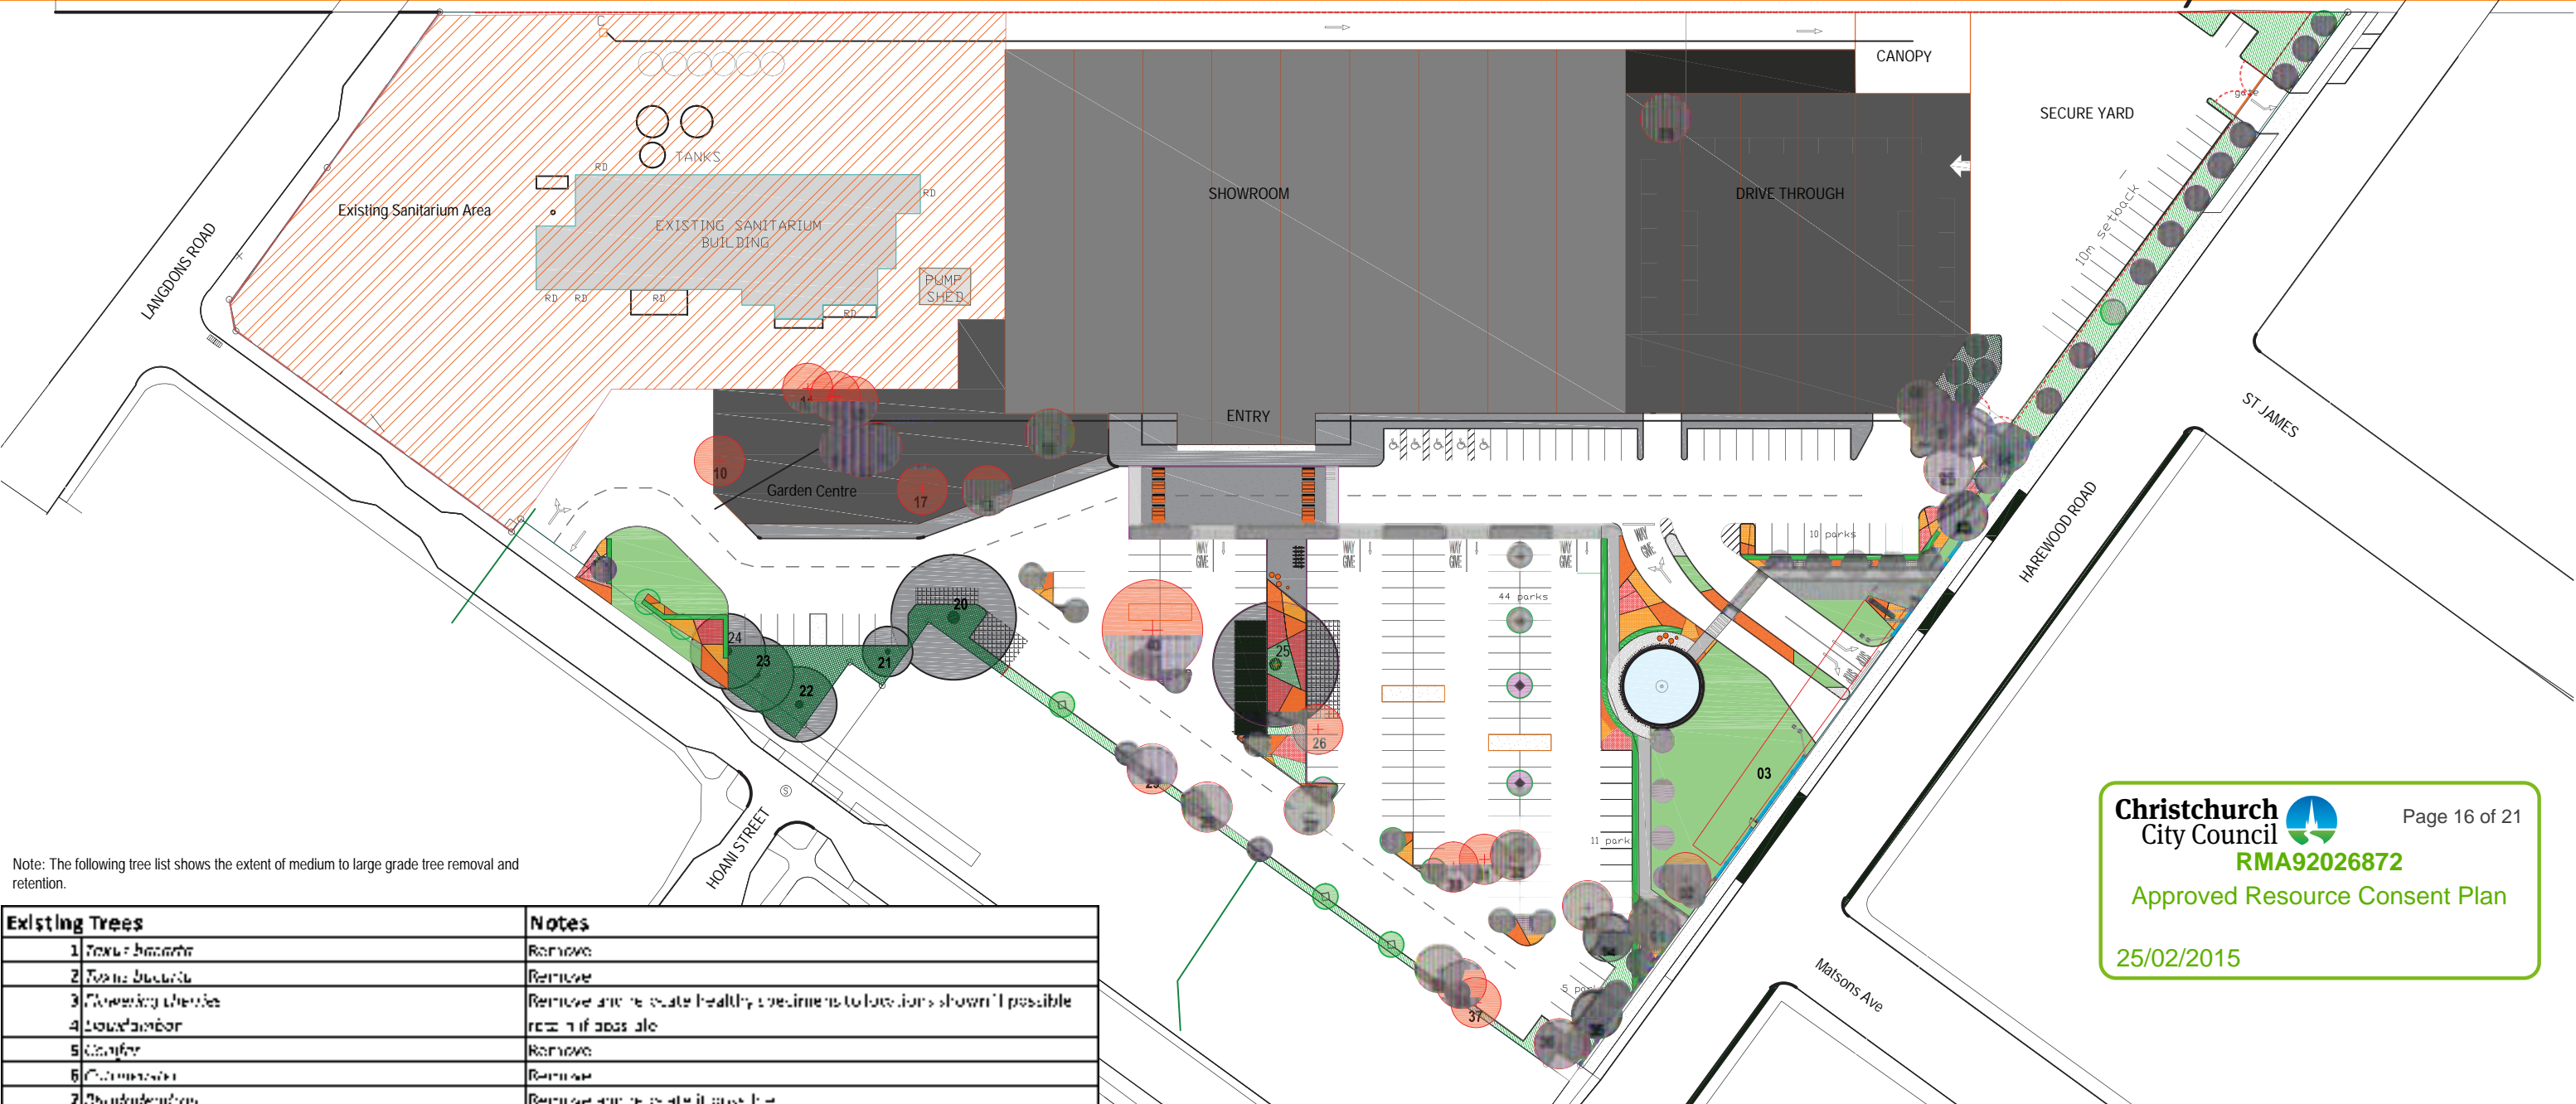
MITRE 10 MEGA HAREWOOD ROAD EXISTING TREES TO BE REMOVED/RETAINED

Note: The following tree list shows the extent of medium to large grade tree removal and retention.

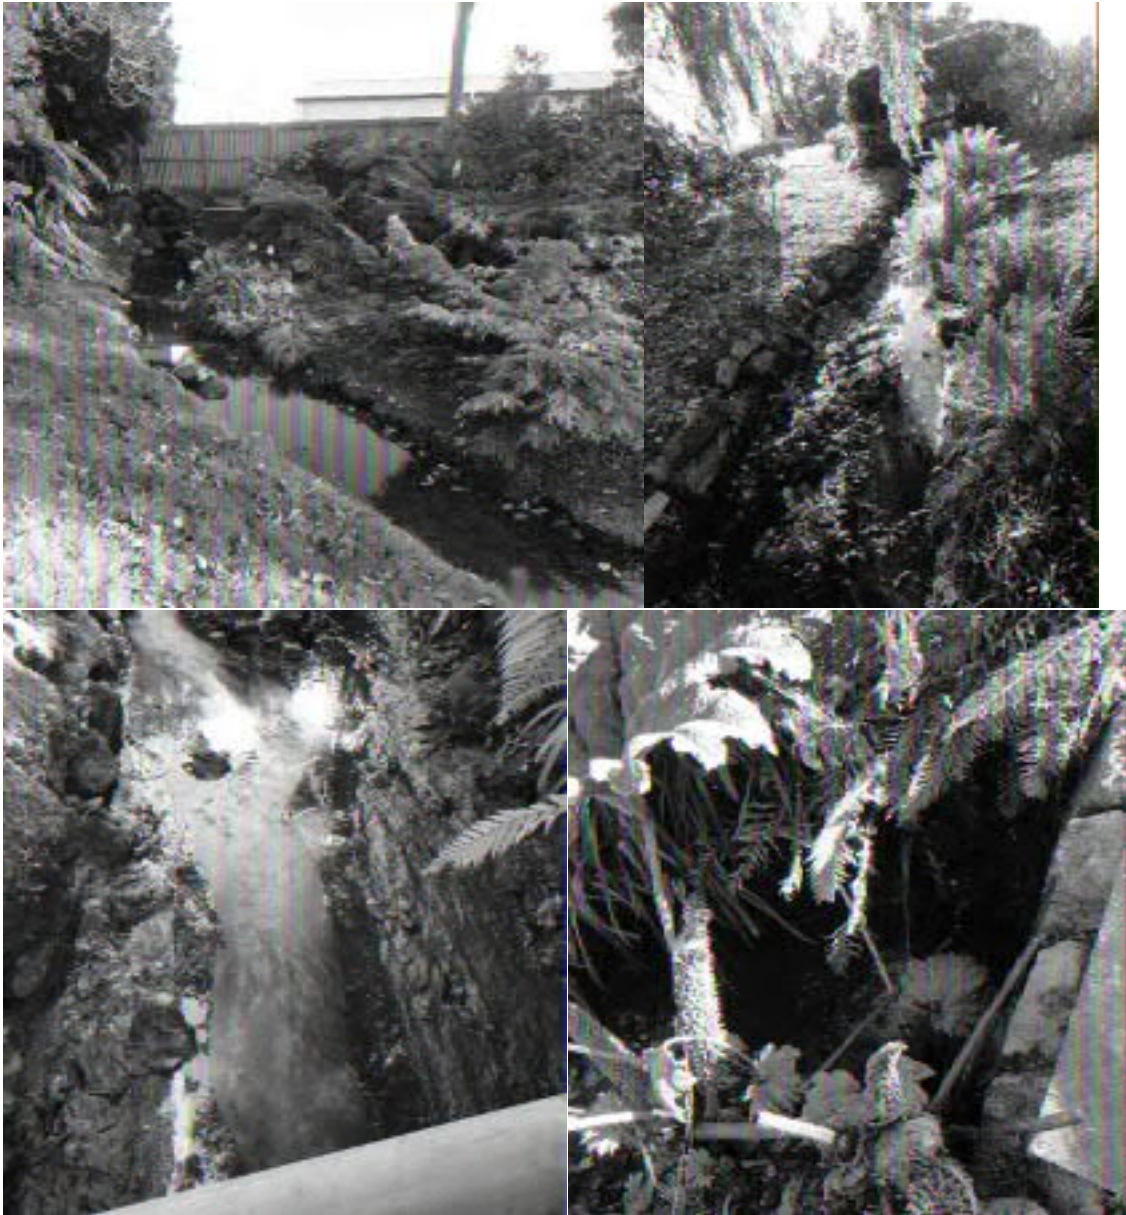
Figure 2. The 130 m reach of Kruses Drain within the Sanitarium site from upstream (top left), mid (top right and bottom left) to downstream (bottom right). Note the negligible flow, high in-stream organic and sediment conditions and sparse exotic riparian plantings along much of the waterway.

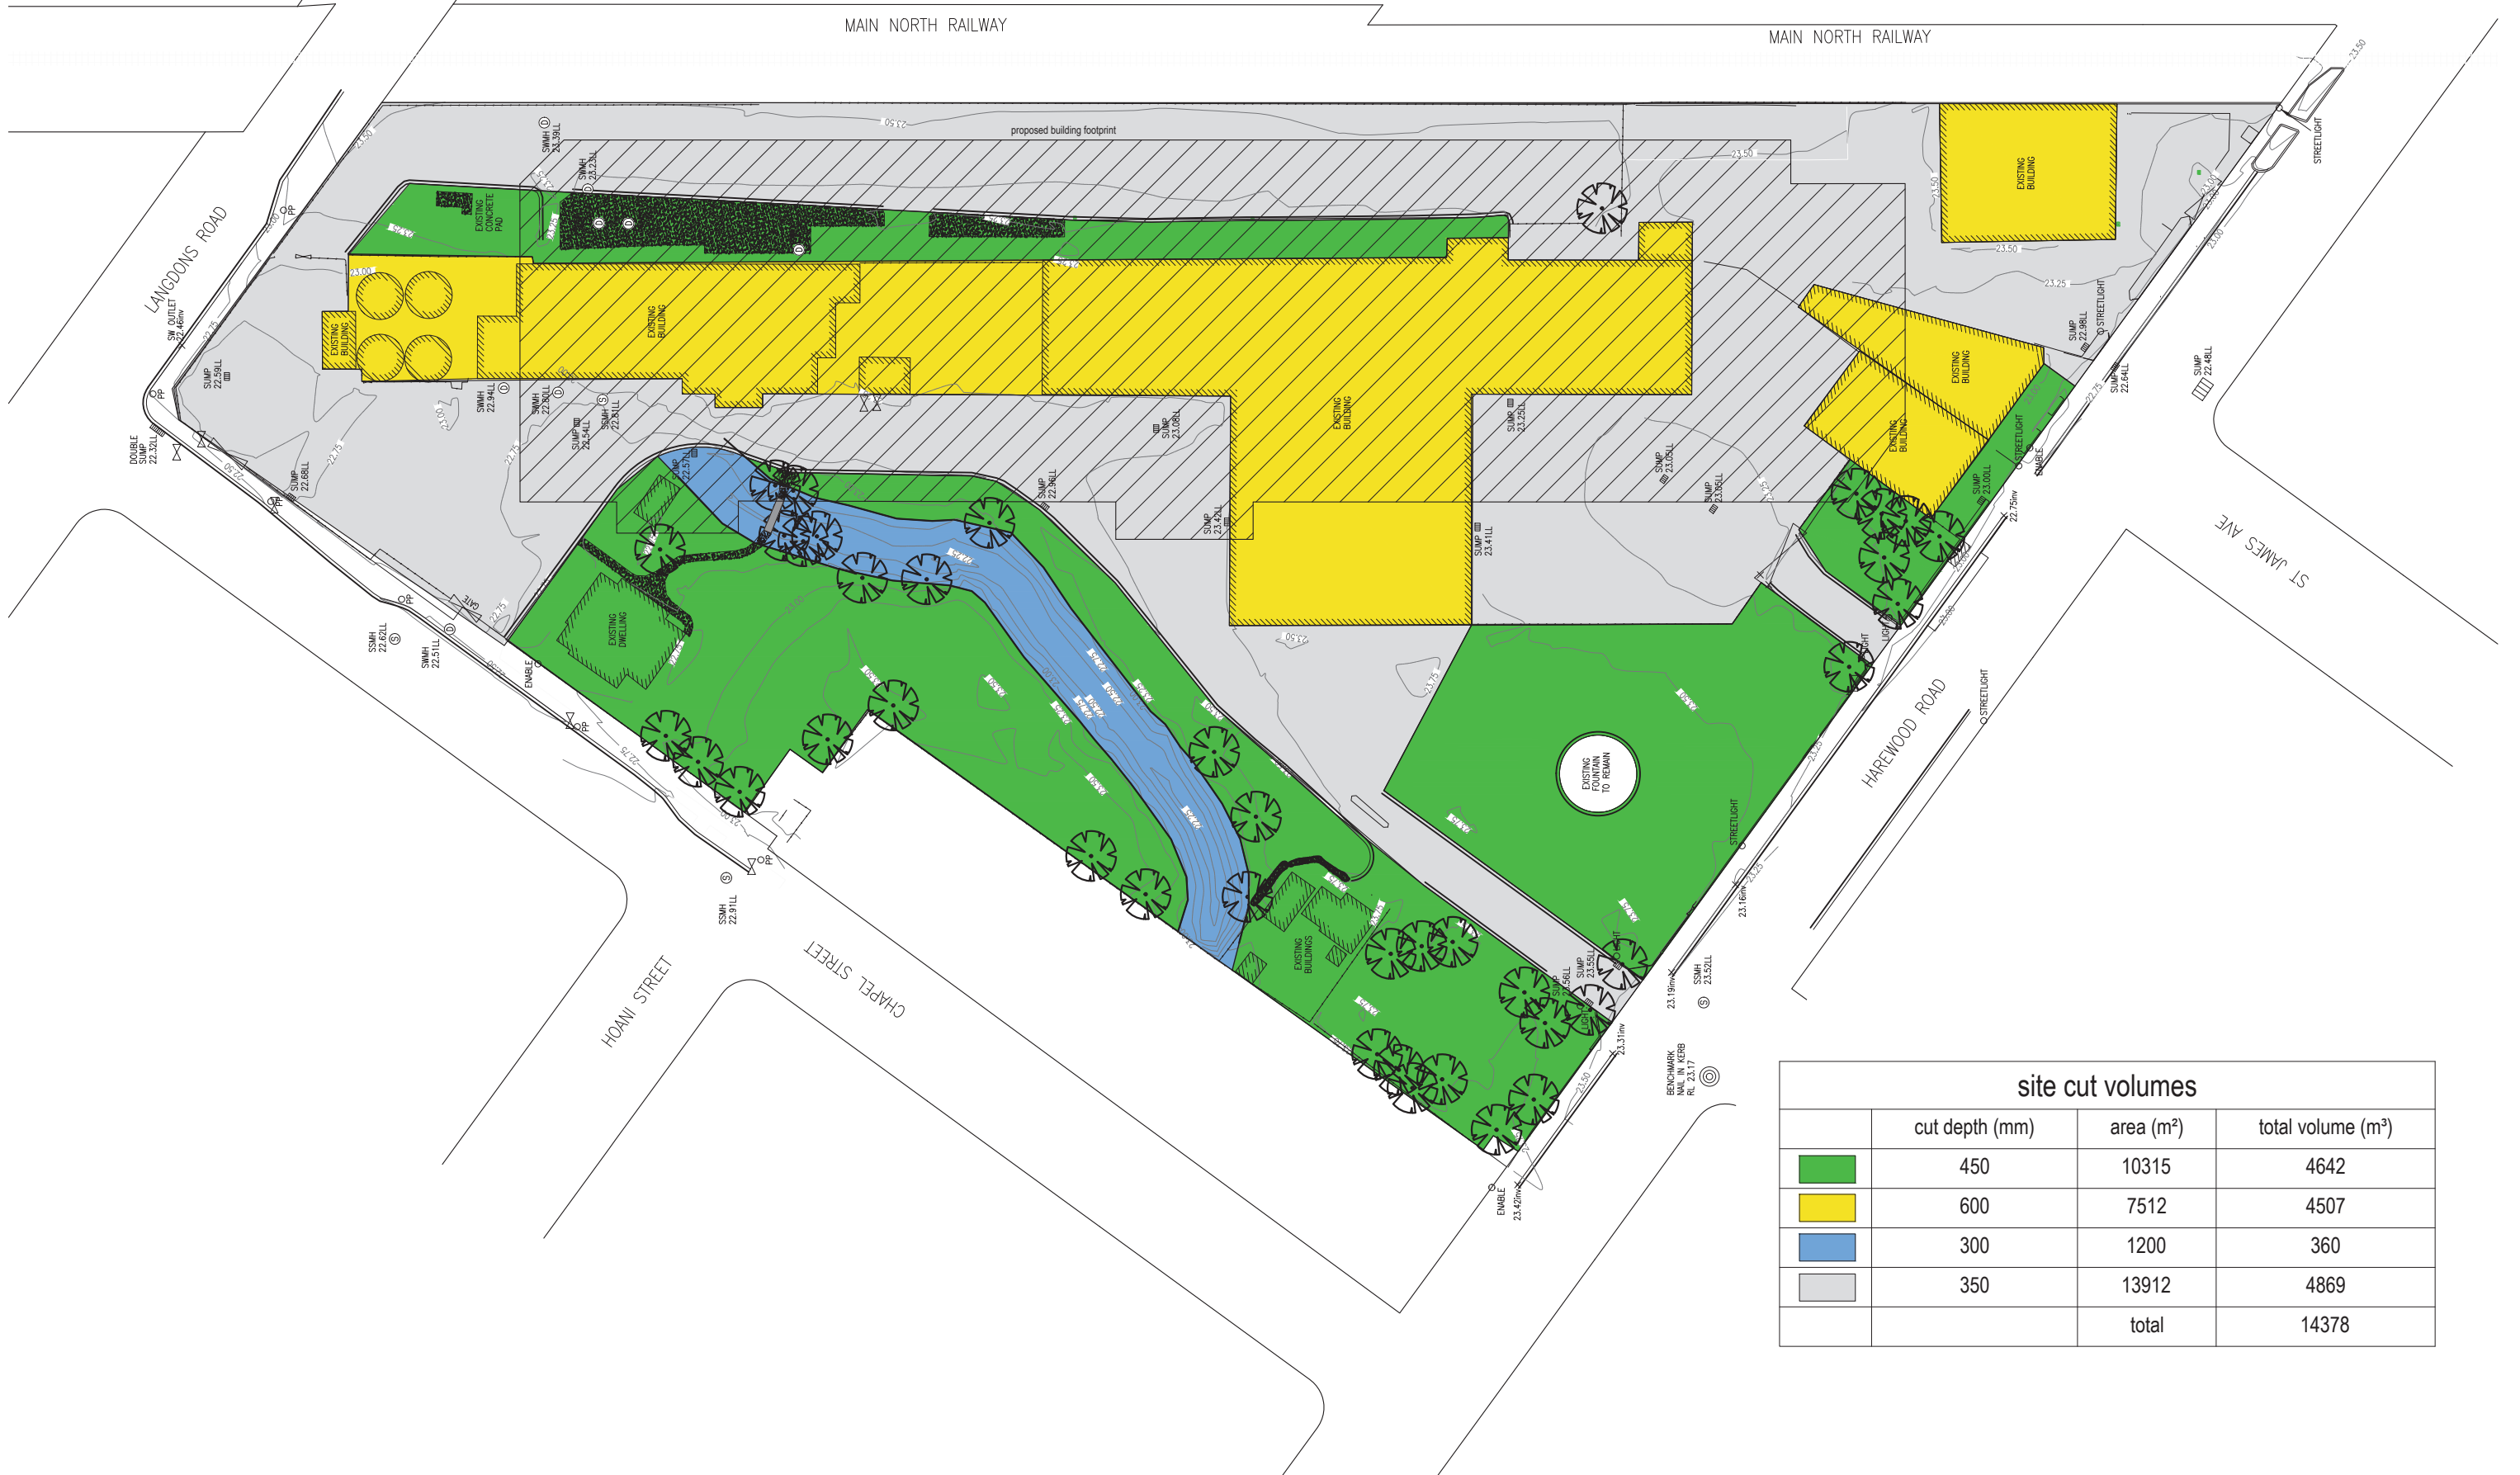
CUT 12038
A

site cut volumes			
	cut depth (mm)	area (m ²)	total volume (m ³)

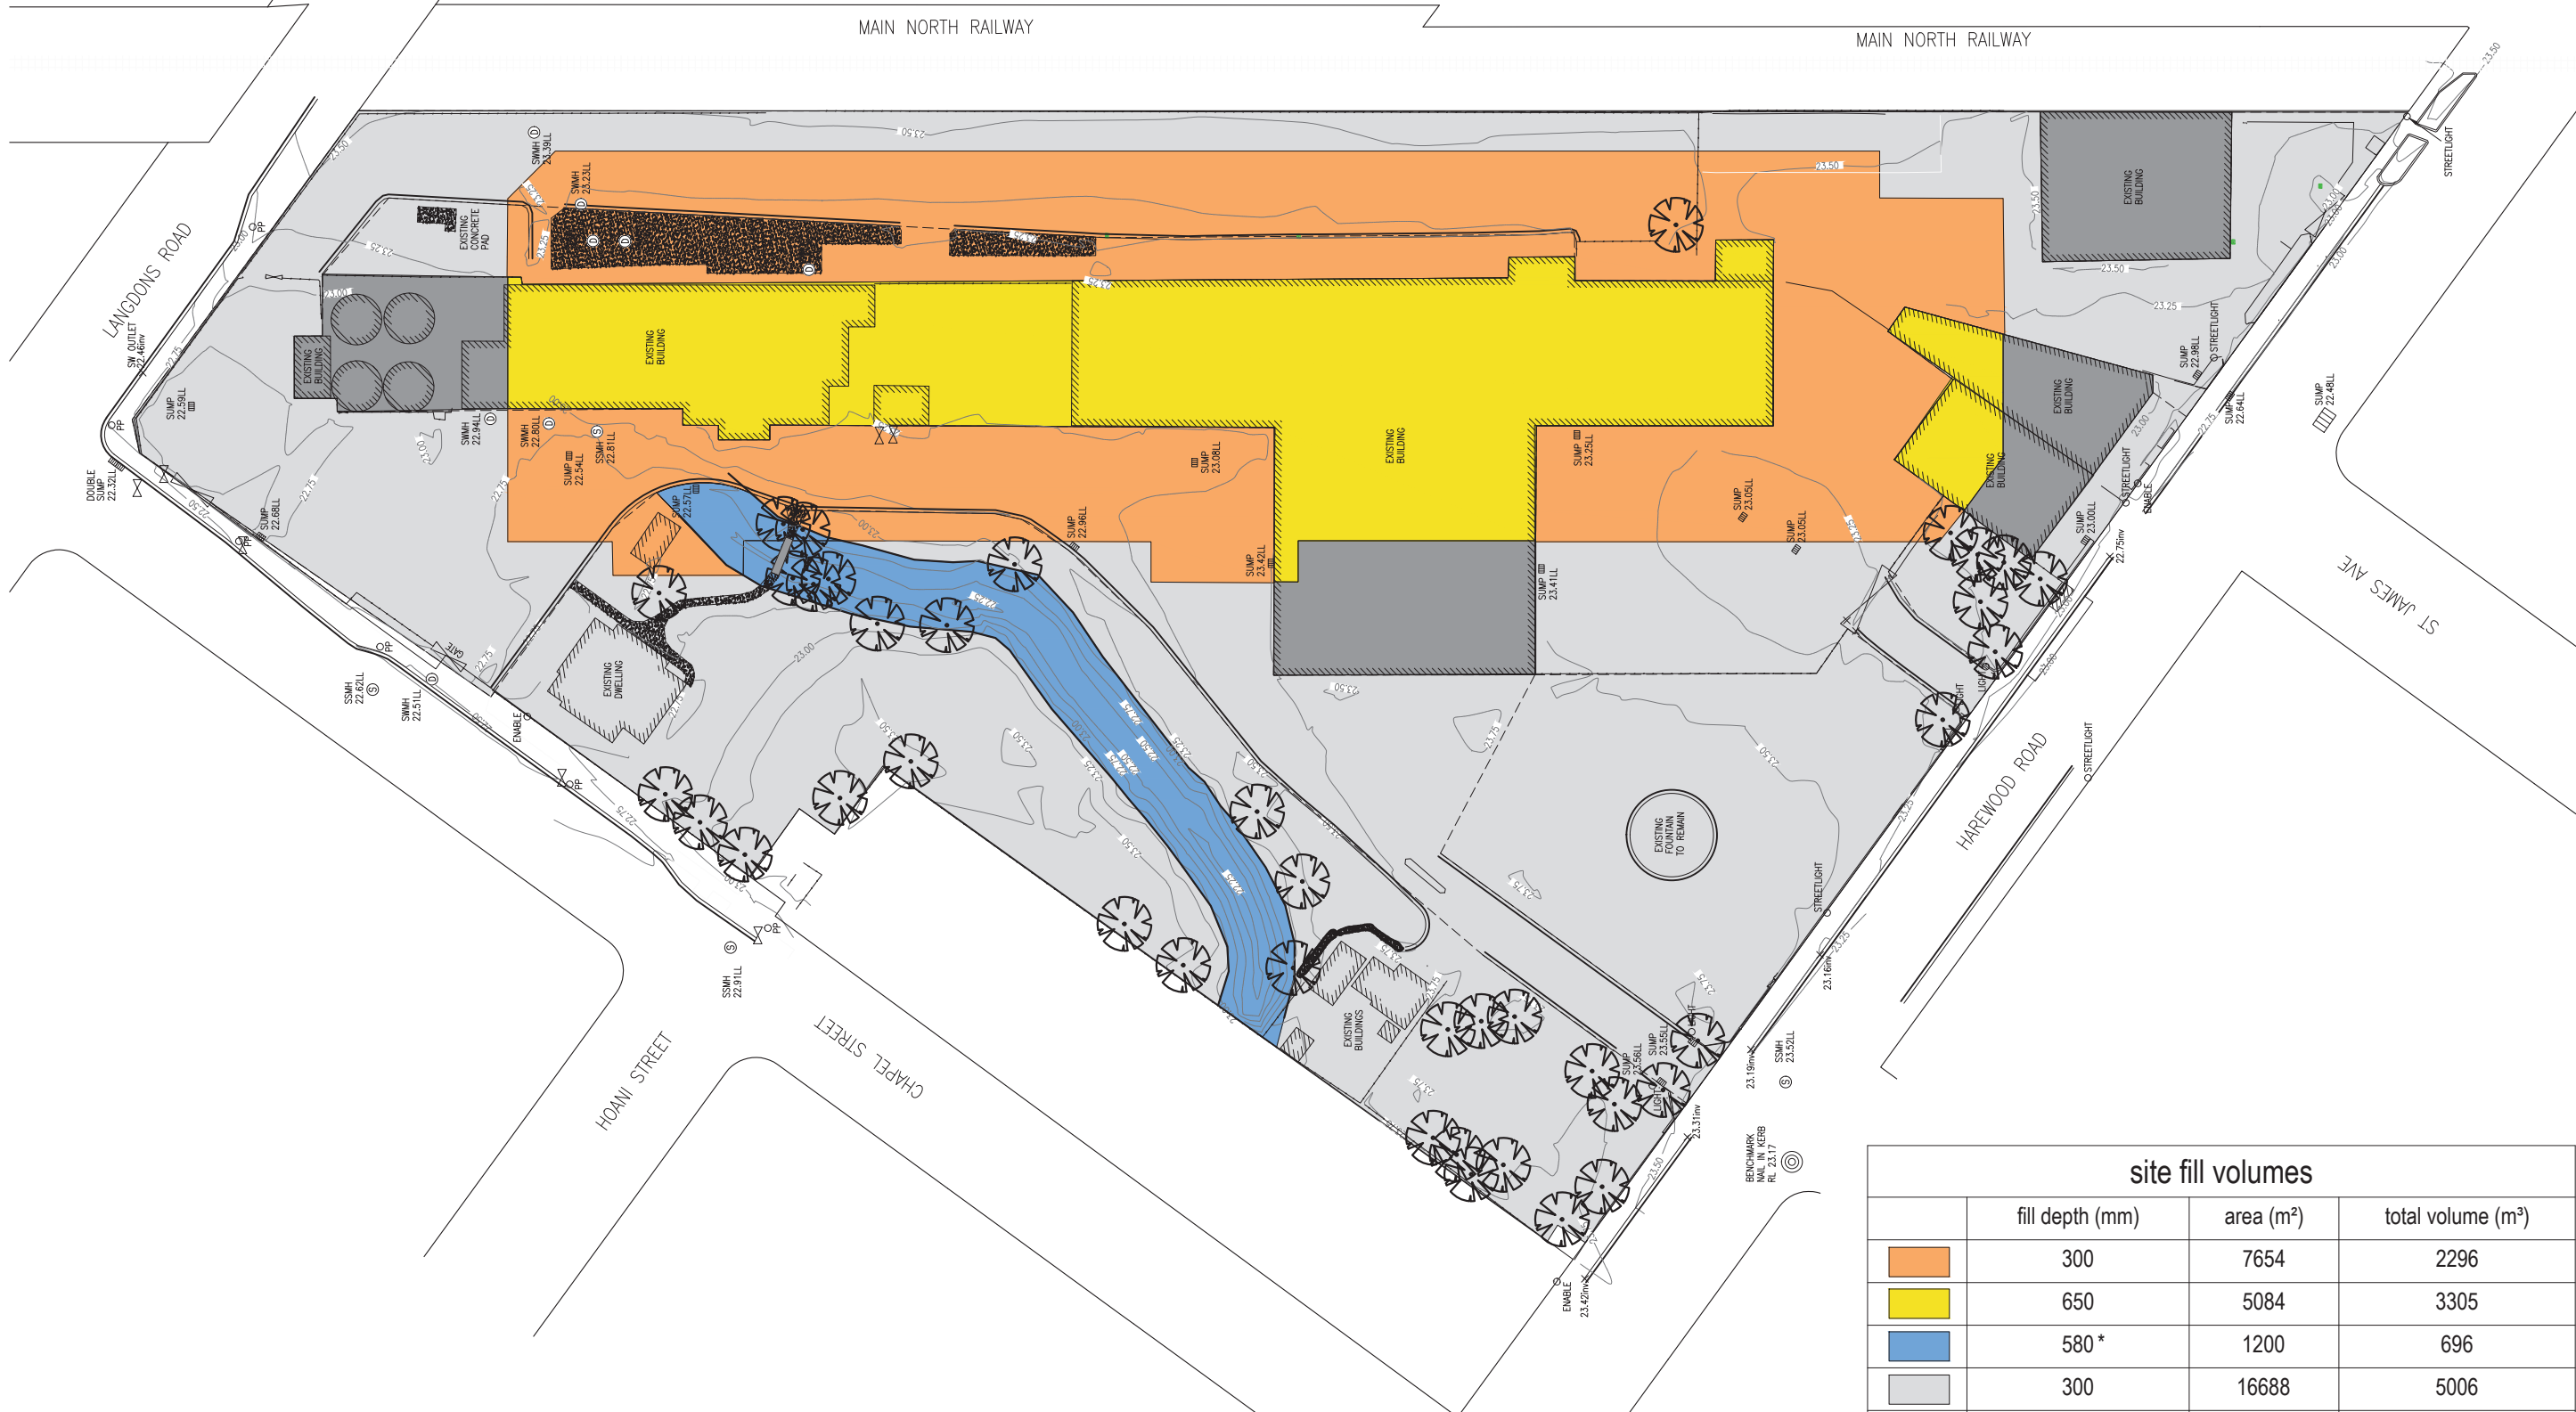
FILL 12038 A

site fill volumes			
	fill depth (mm)	area (m ²)	total volume (m ³)

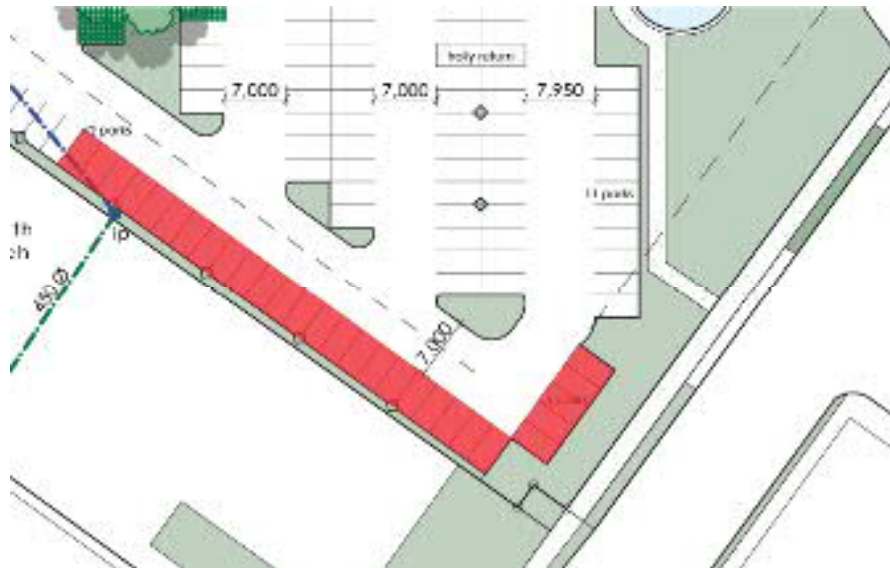
Figure 2: Provisional Location of 28 Stage 1 Staff Parking Spaces
