Appendix 31: Landscape Review of the Operative City Plan Living Taylors Mistake Bach Zone

TAYLORS MISTAKE BACHES – MEMORANDUM OF H LEWTHWAITE, CHRISTCHURCH CITY COUNCIL

12-02-2015

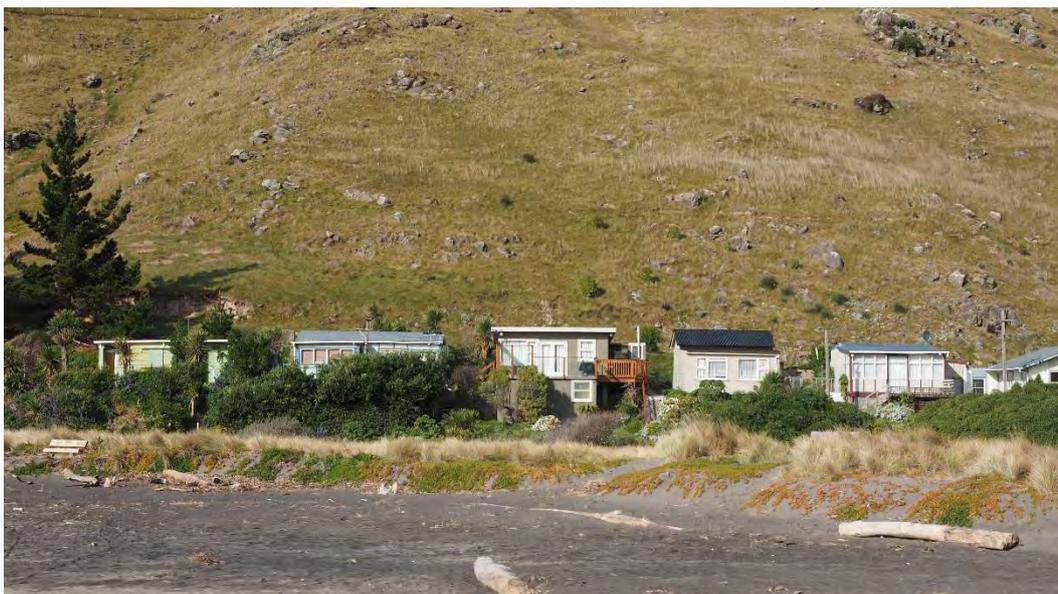
Existing baches and foreshore (1)

2.4 Thirteen baches are located on the western side of the valley between elevations of 5 and 10m amsl (not including the 3 baches adjacent to the Taylor's Mistake Bay walkway). These are generally of small size with an average footprint of between 80 and 100m² and single storied (see photographs in Appendix One). The baches are currently (mostly) located within the Conservation 1 Zone and have a generally north facing aspect.

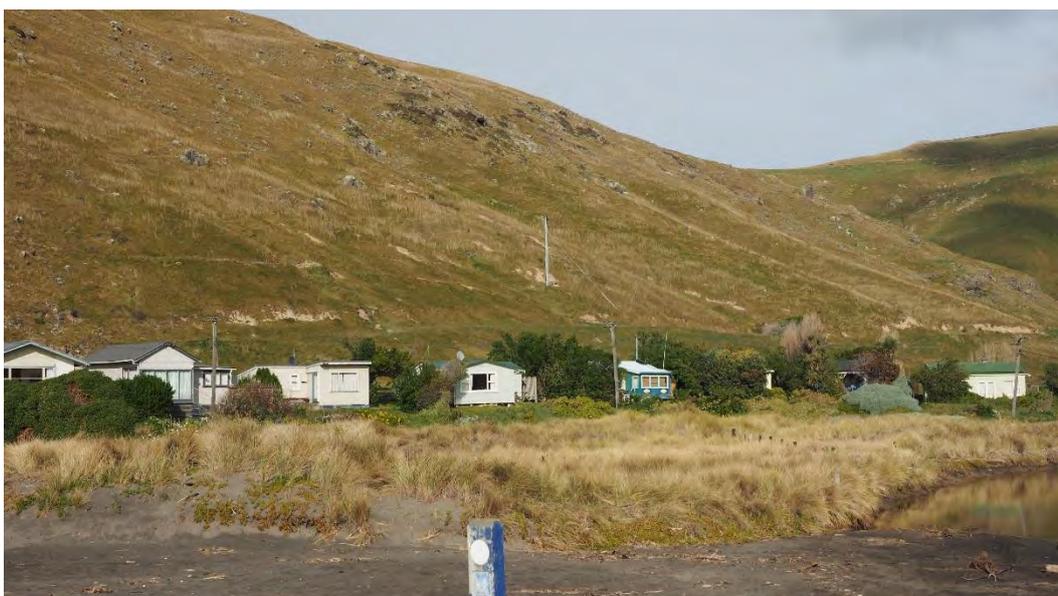
Existing baches and foreshore (2)

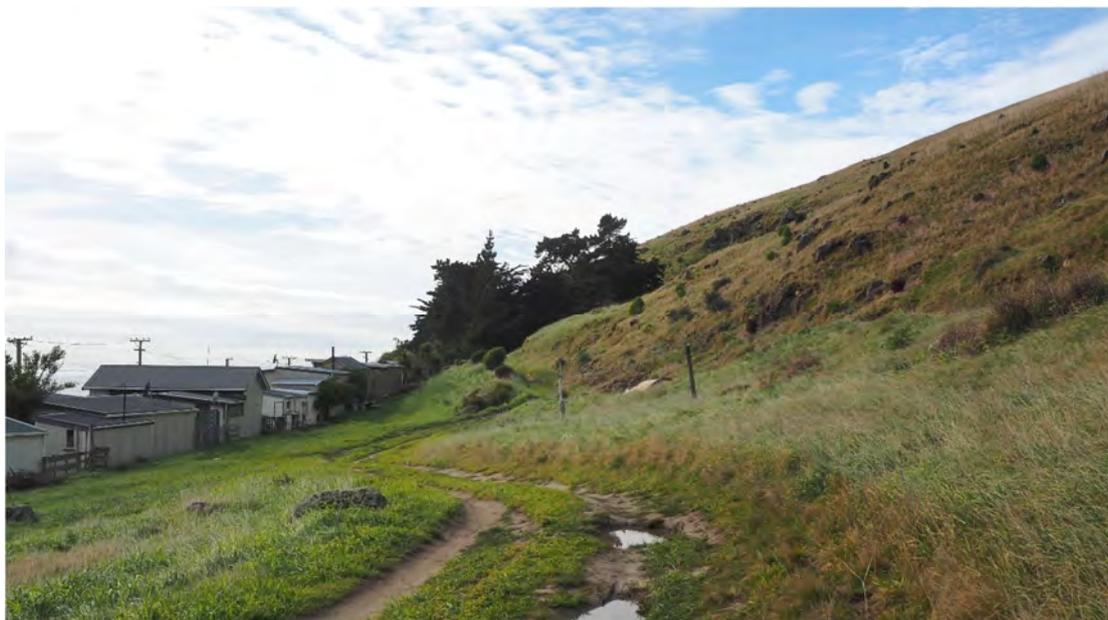
View of existing baches from the existing 4 wheel drive track to the south of the baches

3.4 While this area is included within the Outstanding Natural landscape overlay at a district level, at a finer scale 'site by site' assessment the area immediately behind the existing baches is already reduced by the presence of the baches and the existing 4 wheel drive track (refer to photographs in Appendix One). It is noted that this area still has important values however as it is located at the foot of the undeveloped hillside and is on the boundary between the more modified valley floor and the relatively natural landform of the steeply sloping north facing hillside.

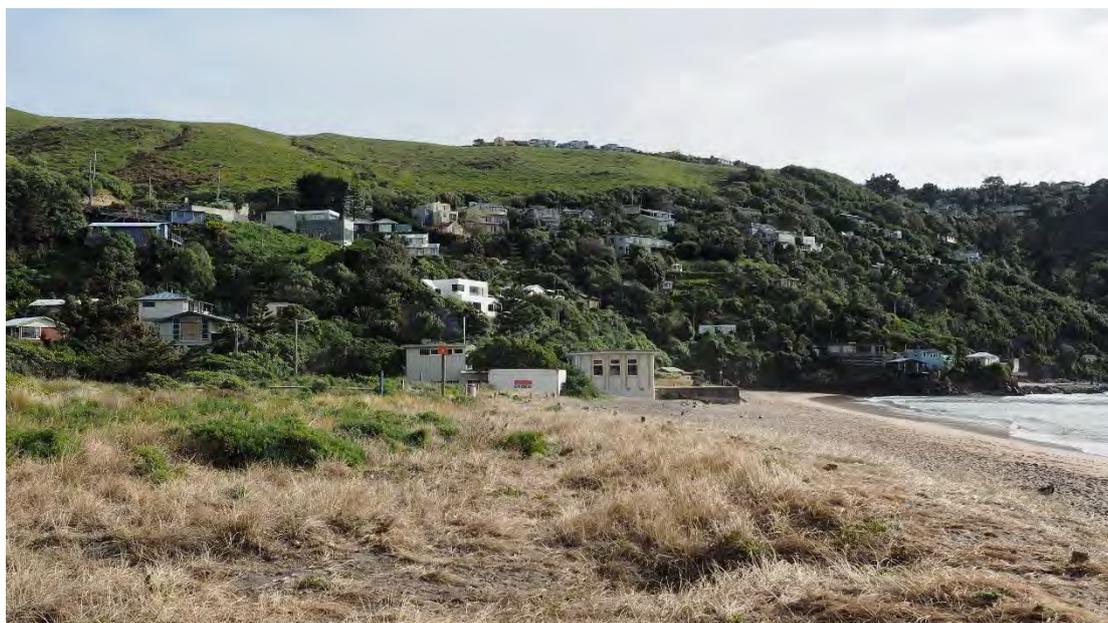
View of the existing LH zone form the foreshore

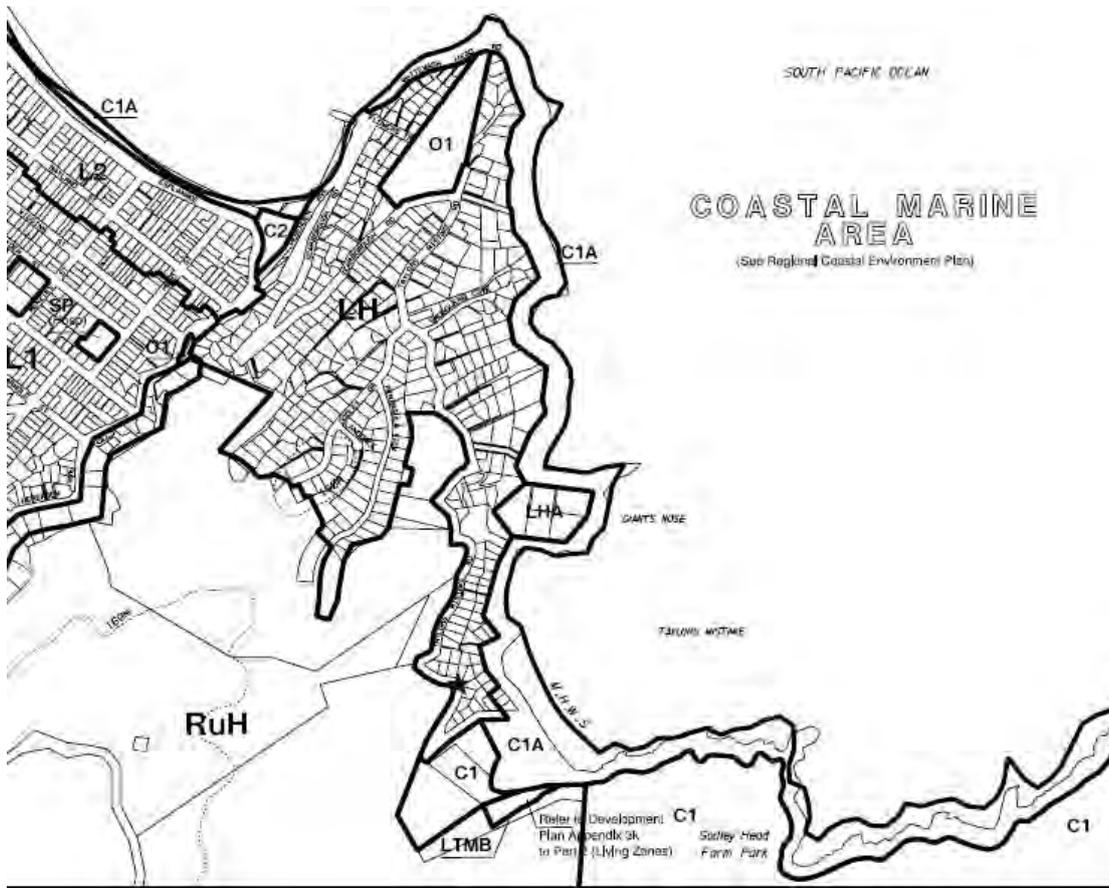
Christchurch City Plan Planning maps showing operative zones

2.6 A number of different zones exist on the valley floor and surrounding hillsides which are as follows:

1. Conservation 1A (Coastal margins on the foreshore above MHWS and in the recreation area to the south);
2. Living Hills (in the residential area to the north).
3. The wider Port Hills are zoned Rural Hills in this vicinity – except for Godley Head Peninsula which is zoned Conservation 1.

2.7 Maps showing the various City Plan zones are attached in Appendix Two.

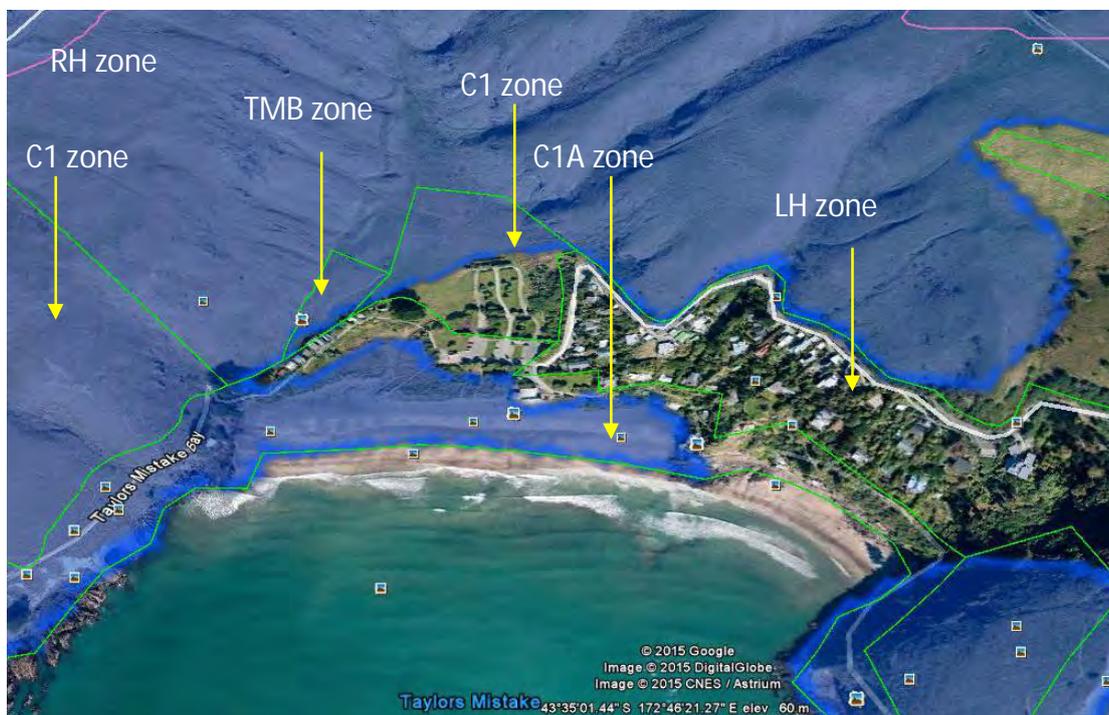
Snapshot from Google Earth showing the Outstanding Natural Landscape area from Draft Christchurch Landscape Study (in blue). Zone boundaries are shown in green.

- 2.10 It is noted that this area has been considered in the Draft Christchurch Landscape Study 2014. The findings of this report are that at a district level the unbuilt portions of the valley and those not modified by the car parking area qualify as part of the wider Outstanding Natural Landscape of the Coastal Port Hills.

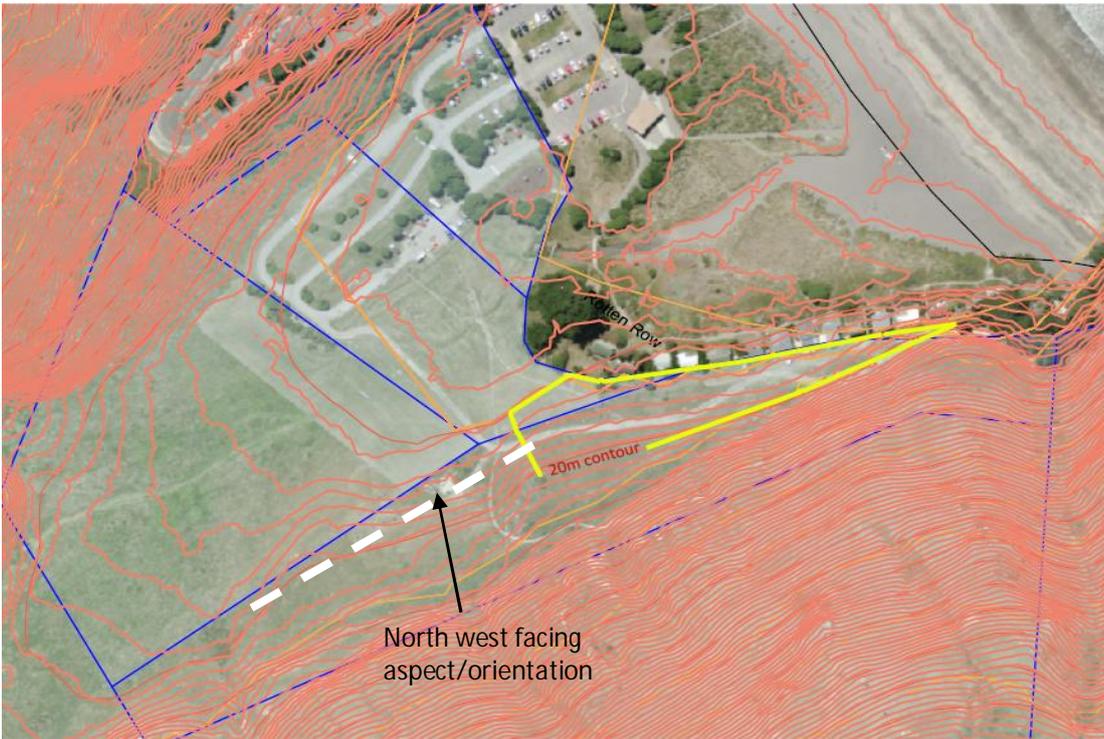
Potential area for Bach expansion (in yellow).

- 3.3 In terms of the capacity for an extension to the existing bach development it is my view that the area immediately to the south and south west of the existing baches could accommodate an extension of baches (assuming that any new baches were of the same size and scale as the existing baches). This area is demarcated in Appendix 3.

3.5 Landscape sensitivity and vulnerability, opportunities, risks and threats
In terms of capacity there are some important parameters or boundaries which define what I would consider an appropriate extent of new bach development. These are defined by the existing characteristics of the site including the elevation, orientation and topography (contours). These are important because they define boundaries beyond which I would consider that the potential adverse effects on the natural character and amenity of the wider valley would be significantly adversely affected. These boundaries are defined at a broad scale on the graphic attachment in Appendix Three.

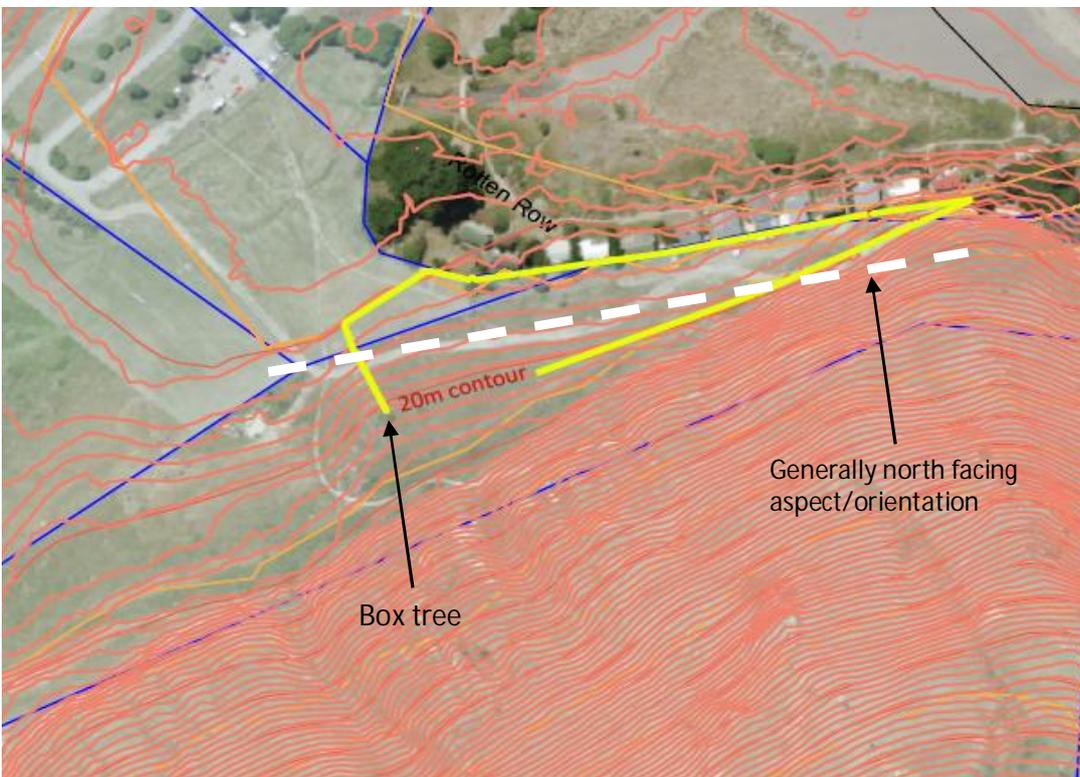
Closer view of potential area for Bach expansion (in yellow).
