Appendix 30 – Review of unscheduled baches and impact on public access

Recreation access and amenity assessment – Taylors Mistake Baches TRIM 15/113115

Kelvin McMillan, Senior Policy Planner, Strategic Support 4 February 2015

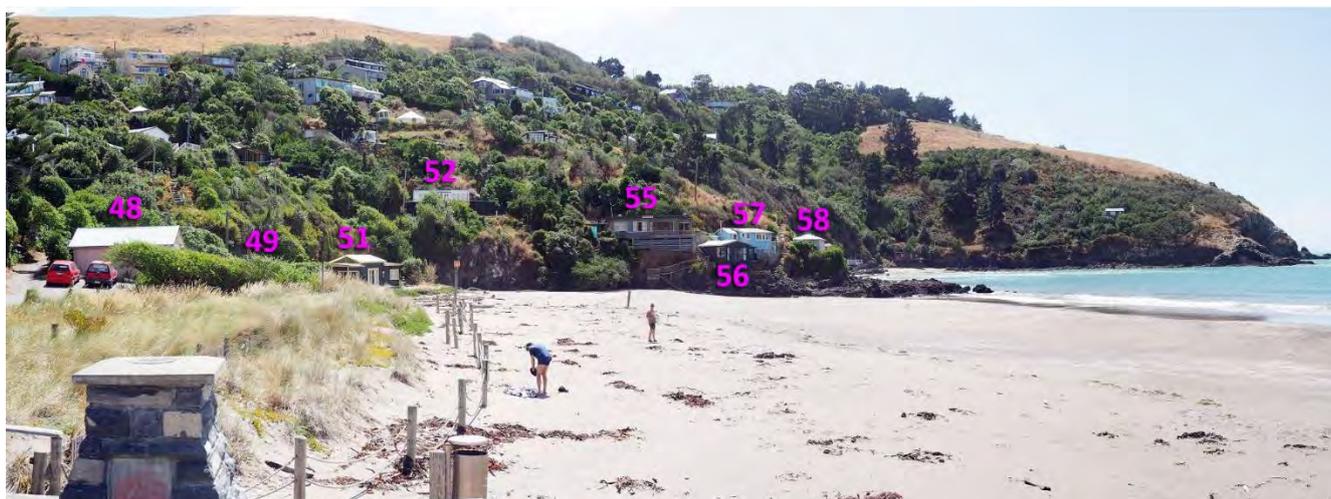
Photograph 1; Taylors Mistake Beach north of the surf club - looking toward baches 48-58.

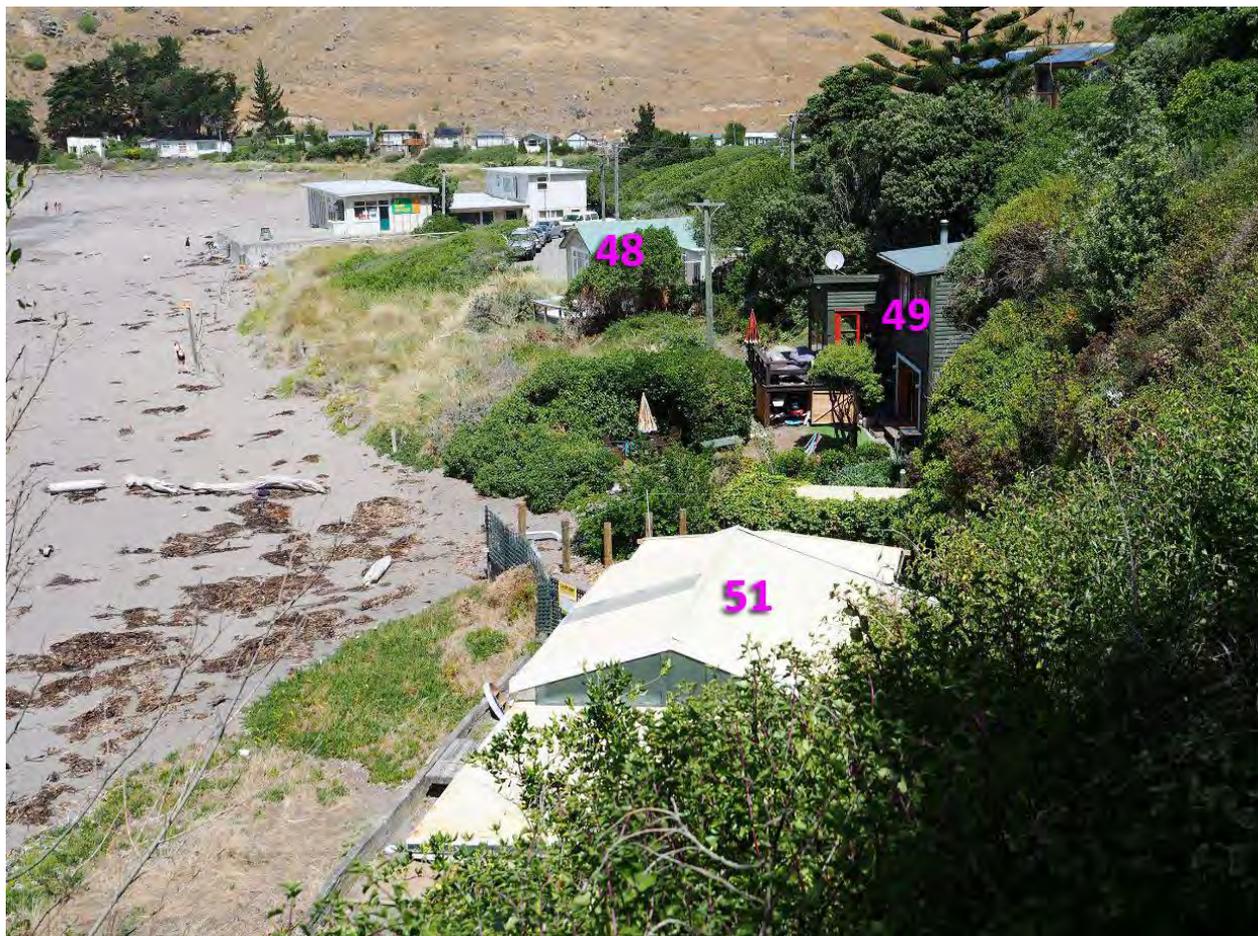
These baches are situated between the beach and associated vegetated flat dunes and the base of the hill. All baches are linked to the beach by generally narrow pathways. From a management perspective these baches contribute to sand stability by dissuading public access over this area. The Council's aim is to actively discourage people from walking on dune areas and nearer the clubhouse a rope fence and keep off the dunes sign is installed. Opening up the areas occupied by the three baches is likely to make it more difficult to manage the dune area.

There are also potential health and safety issues in providing for public use of the clearings occupied by the baches. The baches do not appear to impede public access to any significant destinations. The affect of the baches on the visual amenity of the beach area is in my opinion negligible as they have a foreground of beach vegetation and merge into the wider built backdrop of Taylors Mistake settlement.

Photograph 2; planted dune area in front of baches 48, 49 and 51

Baches 48, 49, 51: Recommend that the three baches be retained. Removal of these baches would not significantly increase beach access space without compromising the integrity of the vegetated sand areas between the baches and the beach. There may also be health and safety issues if the clearings occupied by the three baches are available for public use as they would be somewhat secluded. The baches do not inhibit public use of any main access routes or use of the beach. In my opinion the baches have no greater affect on the visual amenity of the public use area than the broader backdrop of Taylors Mistake dwellings.

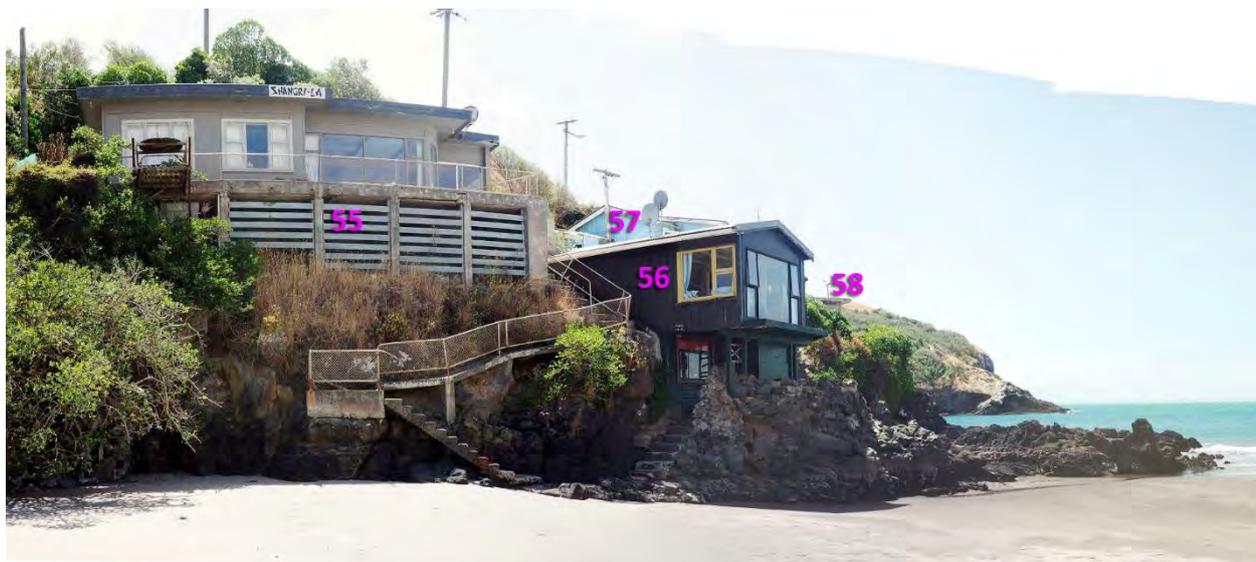
These baches are situated on the rocky promontory between Taylors Mistake Beach and Hobsons Bay. Bach 55 (Shangri La) is sited higher on the promontory with concrete stairs connecting it to the beach. The location is not the sort of place that the Council would encourage recreation use on and does not impede recreation access. In my opinion the bulk of the building and especially the building's lower supporting structure detracts from the visual amenity of the beach area.

Photograph 3: baches 55, 56, 57 and 58 and rock platform to the right.

In my opinion these four baches do have an affect on the naturalness of the rocky outcrop from a natural coastal character perspective, however visually they are a extension of the overall Taylors Mistake settlement including houses and plantings and form an interesting contrast to the natural coastal rock platform below. See photograph 1 page 3. I do not believe that they significantly detract from recreation use however. The main rock platform with its channels is easily accessible when the tide is lower.

Bach 55: Recommend that it be retained as this bach does not impede recreation use. However in my opinion the building's lower retaining wall structure detracts from the visual amenity of the beach area and it may be desirable to visually mitigate it.

Baches 56, 57 and 58: Recommend that all three be retained. On balance I consider that whilst the three baches do intrude onto the coastal rocky promontory the intrusion is not abrupt and can be considered a seamless extension of the Taylors Mistake settlement. They do not appear to reduce the utility of the tidal rock platform for users. The recreation route under the building overhang of bach 56 can be considered undesirable or desirable depending on a recreation user's perspective. Use of the steps over the rock outcrop is possibly a deterrent, especially if there are residents occupying the baches, however the route is clearly sign posted. Possibly some people may be intimidated by the close proximity of these baches 'overhanging' the beach, however on busy days I understand that this does not act as a deterrent to beach use.

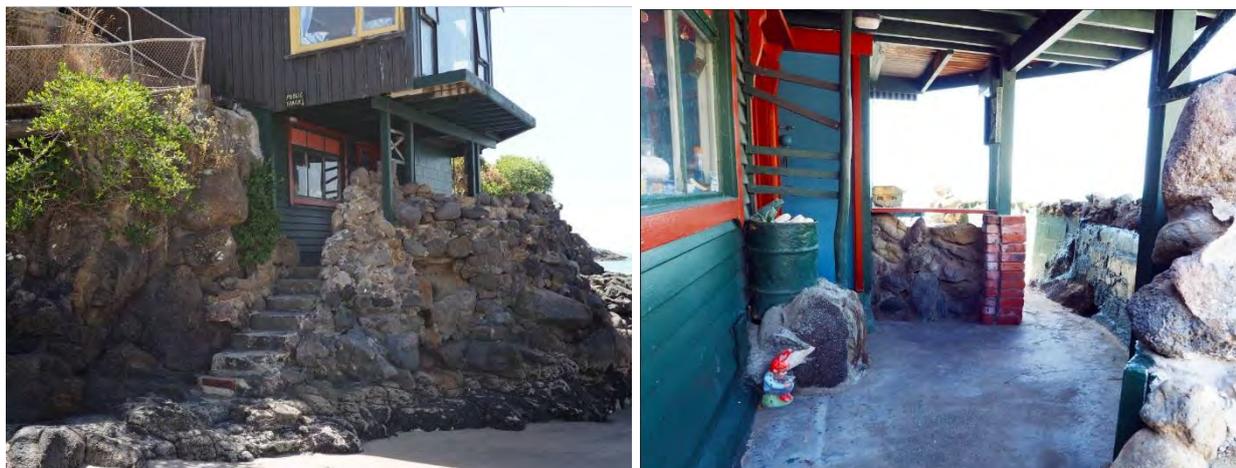
Bach 56 has a sign indicating that public access is permitted up steps from the beach and via the bach veranda to the track leading to Hobsons Bay. Whilst public access is clearly marked some recreational users may find an access route passing about one metre from the bach windows and within the building confines psychologically uncomfortable, or not, depending on the recreation users' personality and whether the bach is occupied. Others may find it interesting and quaint. Irrespective most users (not familiar with Taylors Mistake) would probably feel that the route traverses private space.

Photograph 4 & 5: Left, bach 56 steps, and right recreation path passing under the bach 56 upper story overhang.

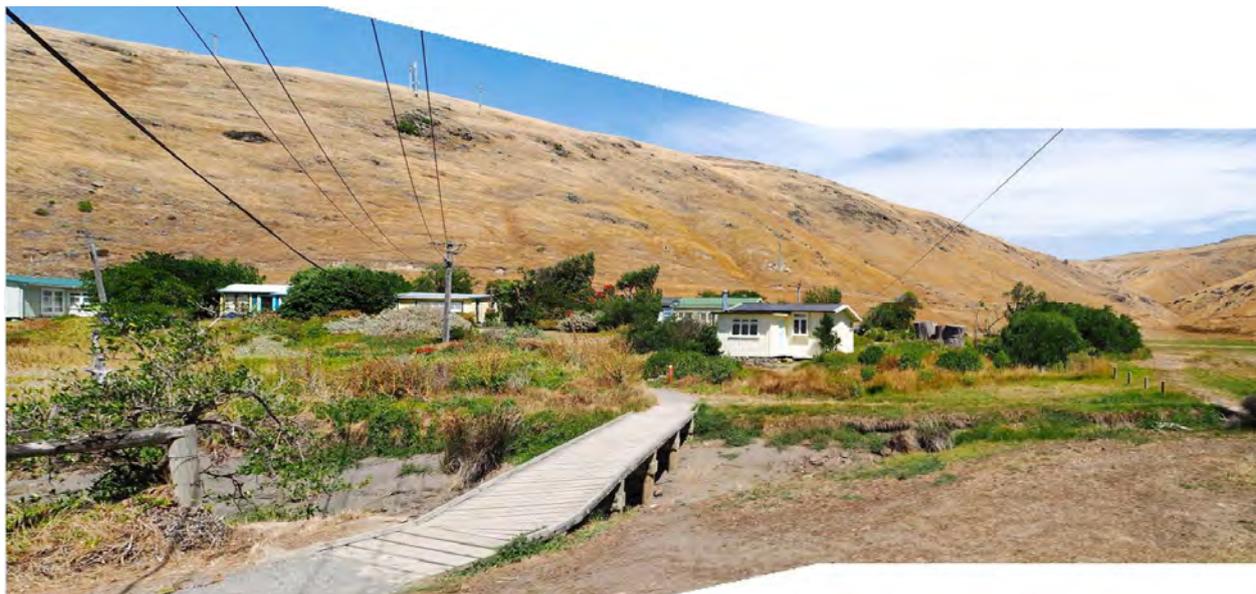
Bach 47 does not impede public access and is partially screened by planting. The building and garden planting contributes to the area's seaside garden character and in my opinion contributes to the quality of the Taylors Mistake beach park experience. Unfortunately the old macrocarpa tree adjacent to the bach has been

Photograph 6: bach 47 (white, centre right) with the Godley Head coastal path in the foreground.

Baches 47 and 28: Recommend that both be retained as they do not impede public access and in the case of bach 28 is in a position that the Council would not normally encourage use of for health and safety reasons. Potentially the space occupied by bach 47 could be used by the public. However in my opinion the character of the bach and plantings contribute to the amenity quality of the area and should be retained.

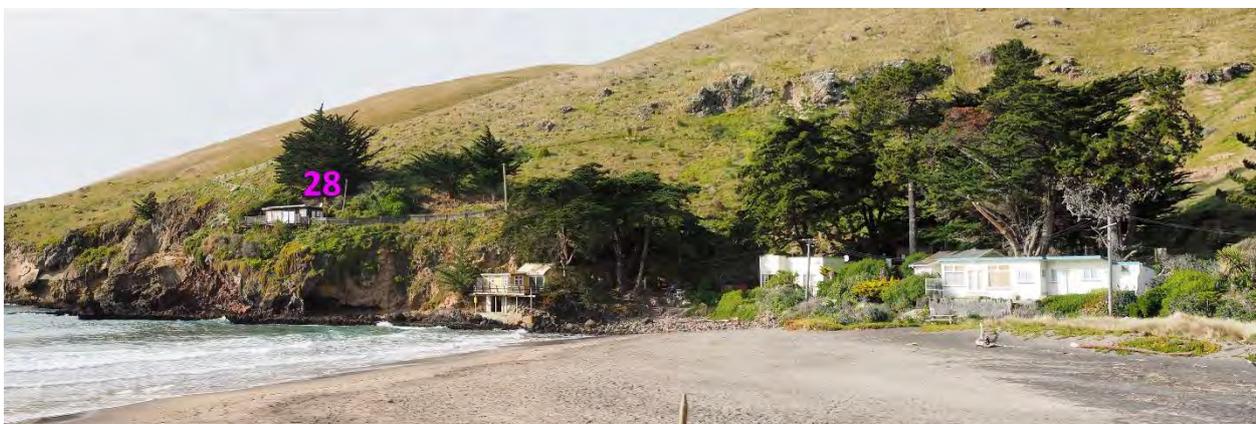
Bach 28 is also sited in a location that does not impede public access. Its cliff edge location is potentially hazardous for recreation users. The Godley Head recreation route above the bach has been fenced where it is near the cliff edge to protect users. The effect of the bach on the visual amenity of users is considered to be nominal. However it would be desirable if the bach roof was painted a recessive colour as it is very obvious and reflective when viewed from the Godley Head recreation route above.

Photograph 7: Bach 28 sited above the beach and below the Godley Head Coastal path.
